Military versions: AF, AN, AP, SN, UF, UN

# ALERT SERVICE BULLETIN

**DOORS - Sliding doors**  
**Addition of a label on the sliding door cover**

[ASB AS555-52.00.15](https://www.airbushelicopters.com/techpub/ASB_AS555-52.00.15)

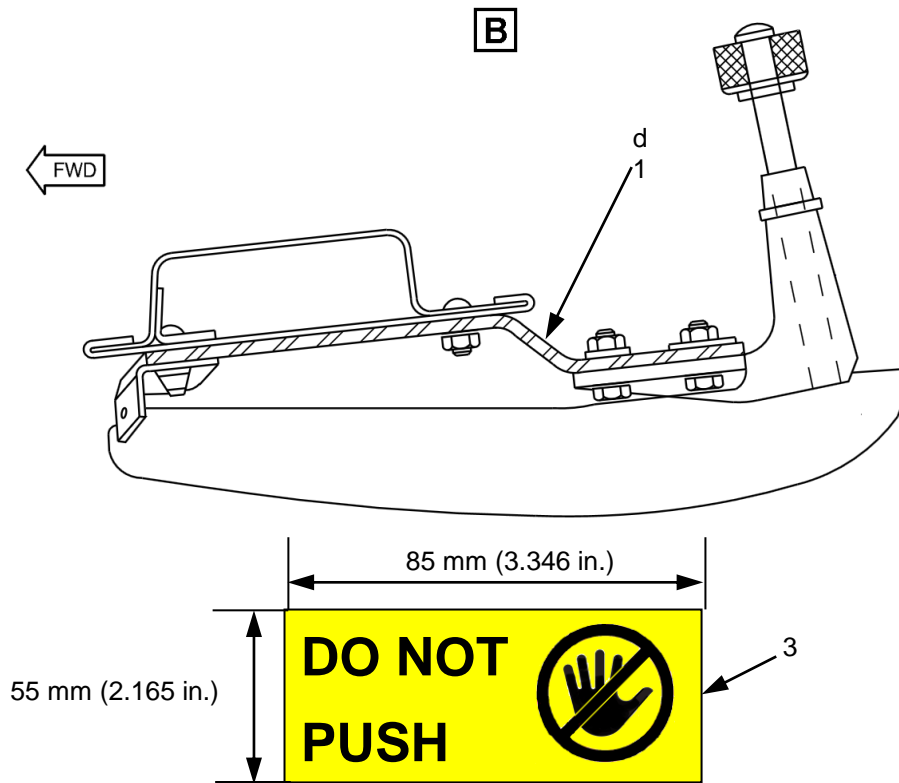
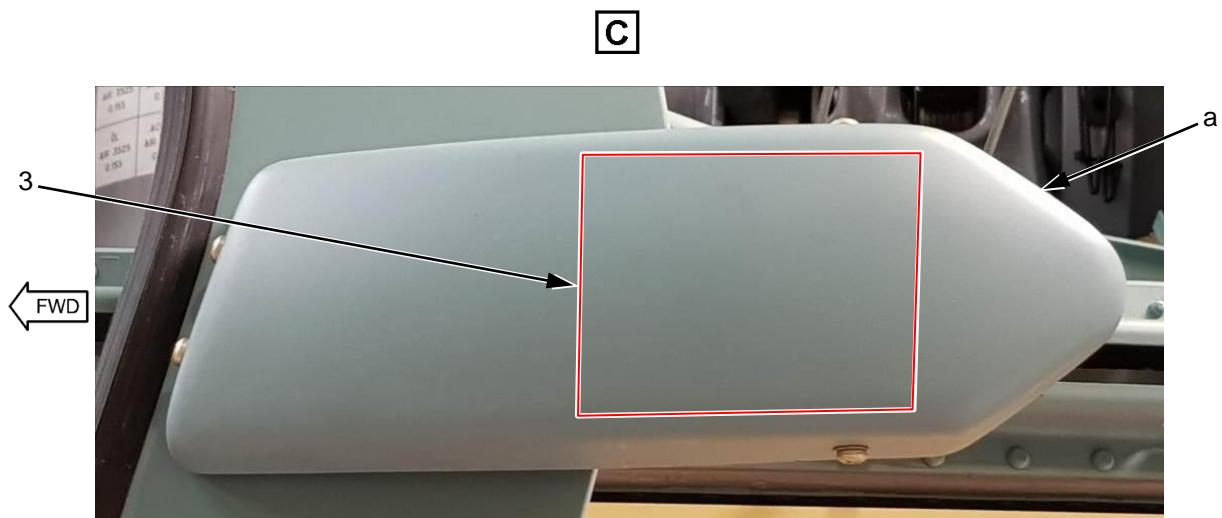
Figure 2

Airbus Helicopters was informed that the LH rear support that attaches the rear intermediate roller of the sliding door was found cracked.

After investigation, it was confirmed that pushing on the rear part of the rear support was the root cause of the crack appearance. Airbus Helicopters thus makes it mandatory not to push on the rear part of the LH and/or RH rear support covers when closing the door.

- Make sure that there is no crack on the LH rear support (d) ([Figure 2](#)).
- . If there is no crack on the LH rear support (d):
  - .. install the cover (a) as per paragraph 3.B.2.d.
- . If there is a crack on the LH rear support (d):
  - .. replace the LH rear support (d) as per paragraph 3.B.2.c.,
  - .. if the LH rear support (1) is not available:
    - ... flights are authorized until receipt of the LH rear support (1) if the door is kept closed,
    - ... bond a locally made label "DO NOT OPEN IN FLIGHT" (4) ([Figure 3](#)) to the inside of the LH sliding door so that the label is visible and legible to passengers,
    - ... on receipt of the LH rear support (1) install the LH rear support (1) as per paragraph 3.B.2.c.

- Remove the LH rear support (d), ([Figure 2](#)) as per the principles of Work Card 52-91-10-403 (MET).
- Install the LH rear support (1) as per the principles of Work Card 52-91-10-403 (MET).
- Remove the label "DO NOT OPEN IN FLIGHT" if previously installed.
- Install the LH rear support cover (a) as per paragraph 3.B.2.d.

- Remove the locally made label from the cover (a), if necessary.
- Install the LH rear support cover (a) ([Figure 1](#)).
- Install the washers (c) and the screws (b).
- Tighten the screws (b).
- Install the locally made label (3) on the LH rear support cover (a) as per Detail C, [Figure 2](#).

Making a self-adhesive label:

Black letters on yellow background for military versions.
