COMPONENT REPAIR REPORT

| 1. Customer: Galaxy Aerospace | 4. Cust PO#: RMN-23-909 | 7. TSN /CSN: 3604.4 / - |
| 3. PN #: 524-062 | 6. SN: 1132 | 9. TSR /CSR : - / - |

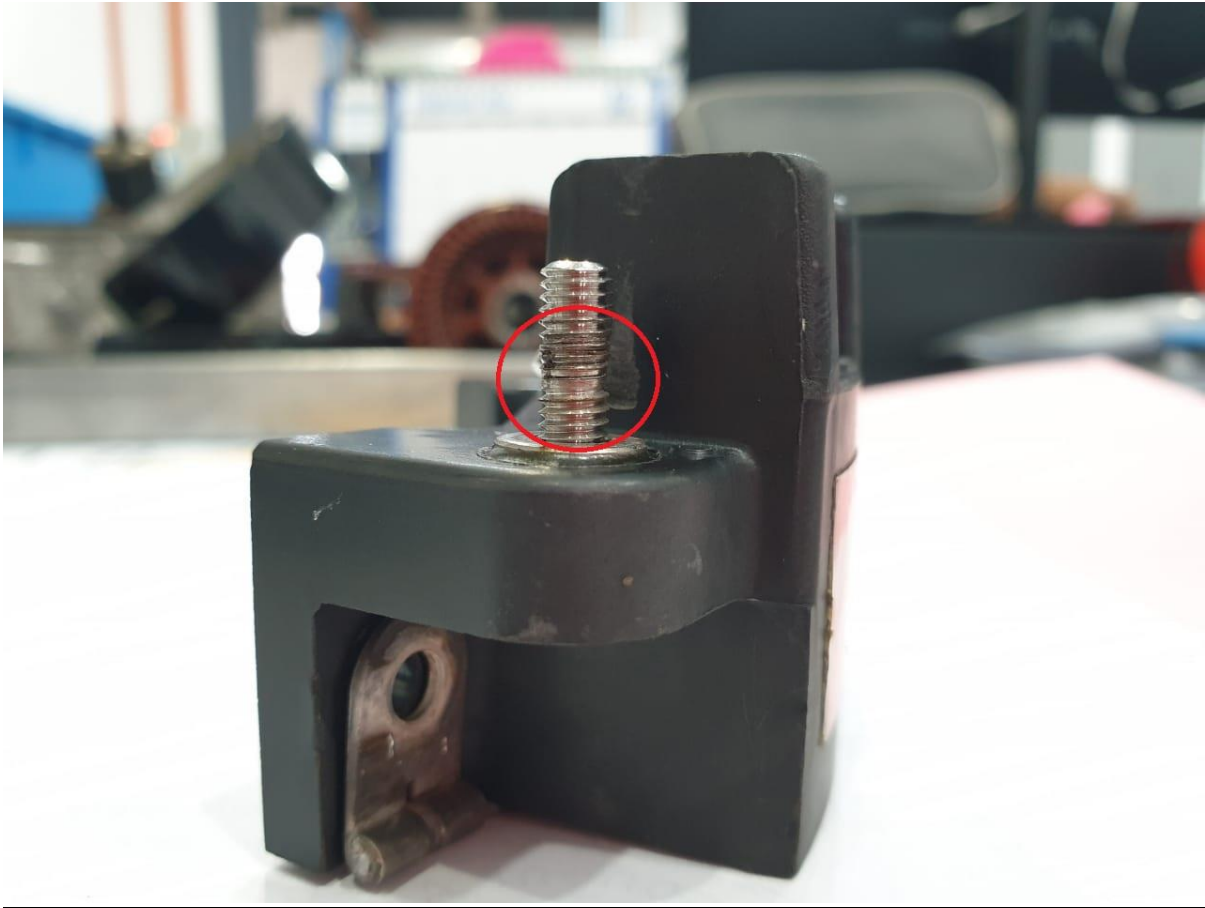
1. Disassembled unit for overhaul, details inspection and replacement of carbon brushes & bearings.
2. Armature (PN P503684) uneven wear on commutator surface. Machine to smoothen commutator surface and rebalance the armature.
3. Terminal block (PN 505416-2) stud D found 6 threads stripped. Required repair. See Photo 1.
4. Other hardware found normal wear and tear.
5. The unit would be overhaul in this shop visit.
6. No SB & AD required to comply in this shop visit.

Photo 1 – Terminal block thread stripped.

| PART NUMBER | DESCRIPTION | QTY | REASON |
|---|---|---|---|
| 505416-2 | Terminal block | 1 | Stud D threads stripped. Repair. |
