COMPONENT REPAIR REPORT

1. Customer: Galaxy Aerospace	4. Cust PO#: GAM/DO/18/041	7. TSN /CSN: - / -
2. WO #: 201	5. Qty: 1	8. TSO /CSO : - / -
3. PN #: 0230390-202	6. SN: 151712	9. TSR /CSR : - / -

Hoist searchlight unable to switch on.

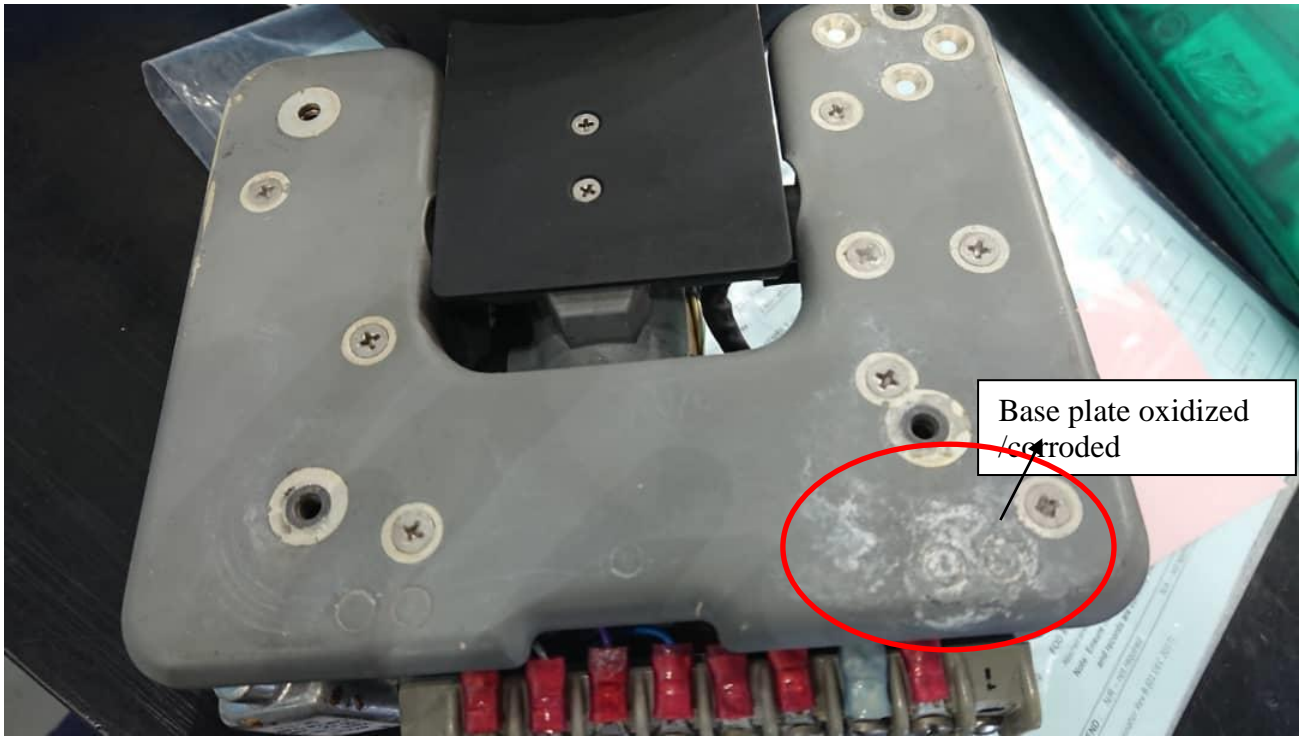
1. Carry out trouble shooting and confirmed unit unable to power up due to nil power supply.
2. Trouble shooting found PWA card assembly (PN 0230480-001) faulty/shorted and Base plate (PN 932-400-02) no ground connection due to oxidization.
3. Replaced new PWA card assembly (PN 0230480-001) and Base plate (PN 932-400-02).
4. Unit cleaned, repaired and final test found serviceable.
5. No SB or AD required to comply in this shop visit.

Photo (1) : Base Plate corroded

PART NUMBER	DESCRIPTION	REPAIR QTY	REPLACE QTY	REASON
0230480-001	PWA card assembly		1	Faulty/shorted Replace new
932-400-02	Base plate		1	No ground connection due to oxidization. Replace new

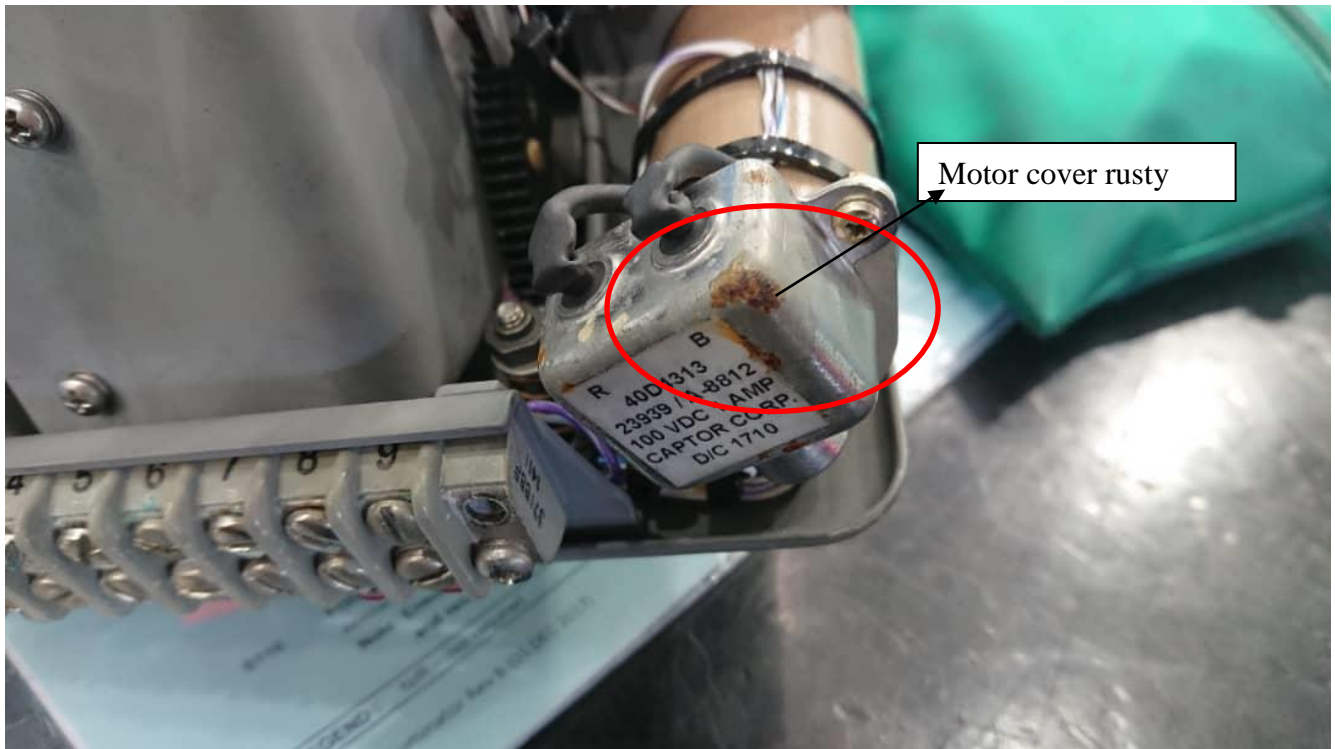
Photo (2) : Motor cover rusty

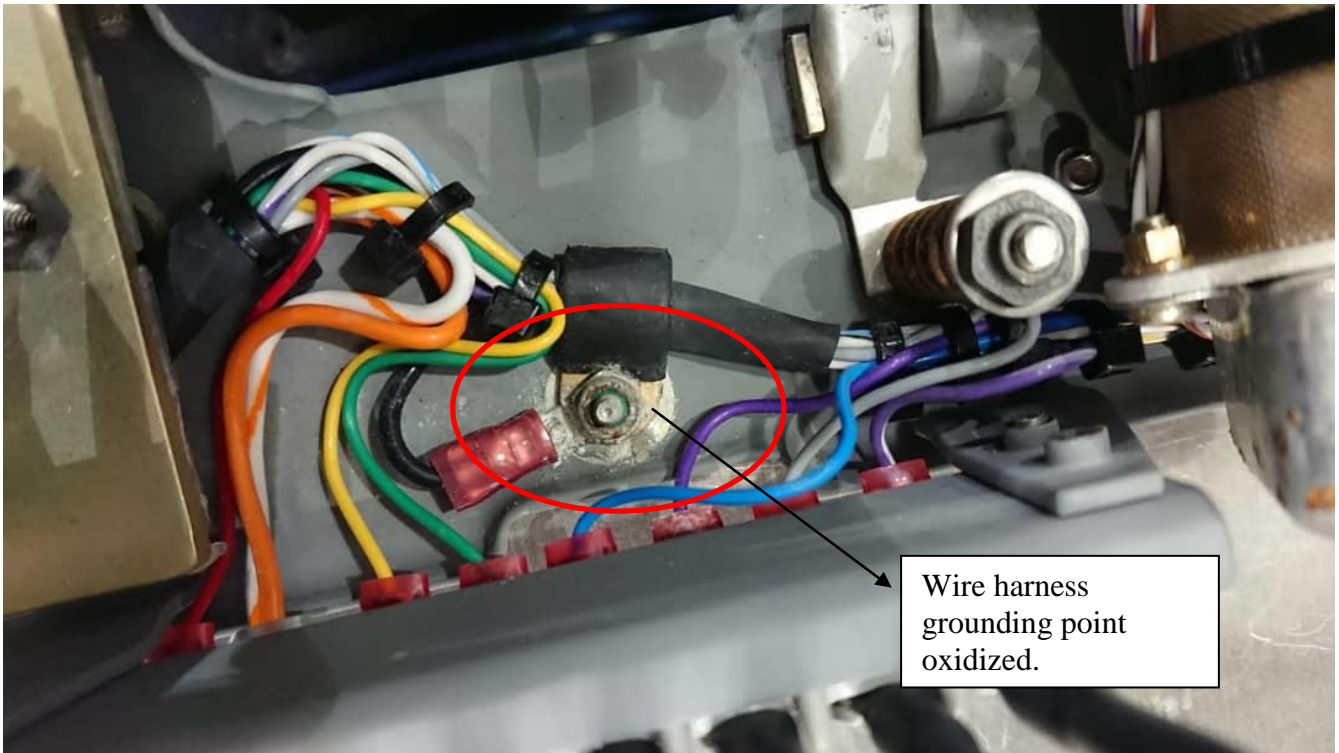
Photo (3) : Wire harness ground connection oxidized

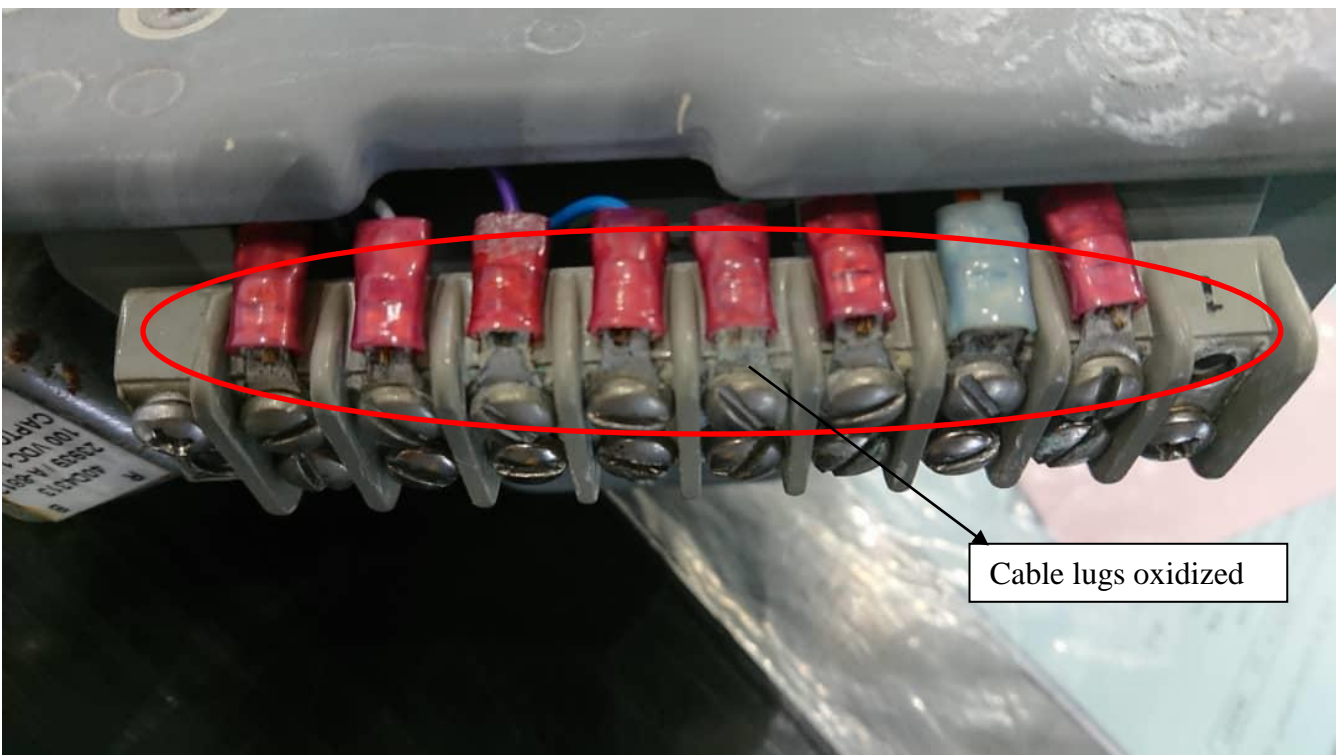
Photo (4) : Terminal block wire lugs oxidized
