## COMPONENT REPAIR REPORT

1. Customer: Galaxy Aerospace	4. Cust PO#: GAM-PO-20-569	7. TSN /CSN: 1239.9 / -
2. WO #: 476	5. Qty:1	8. TSO /CSO : 254.8 / -
3. PN #: 1152546-2 Series 3	6. SN: 1152546-02997	9. TSR /CSR : - / -

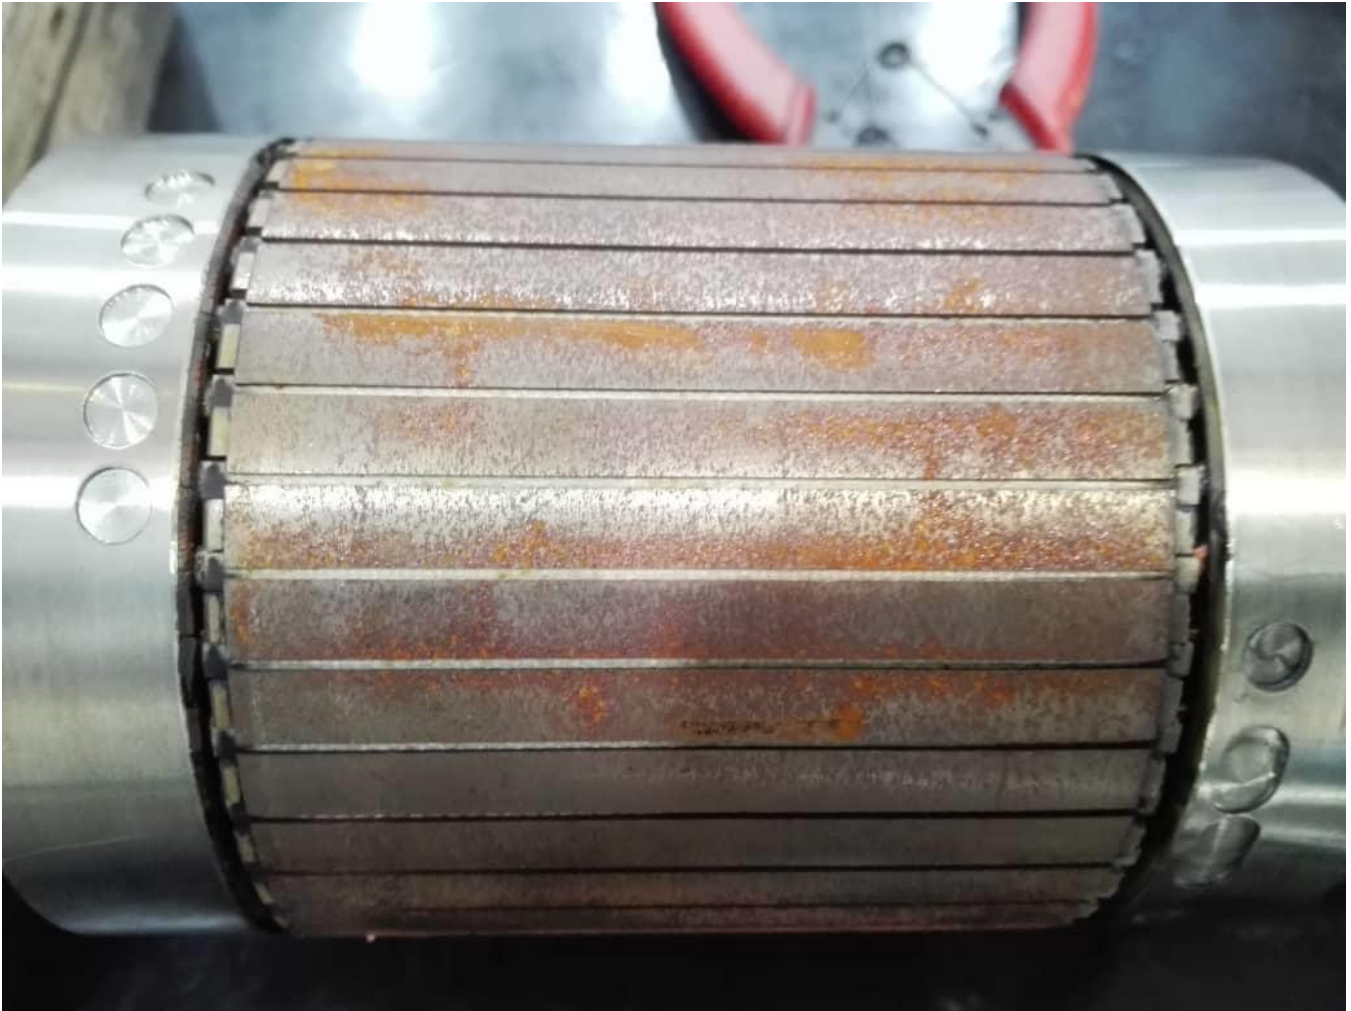
1. Carry out induction run (compounding and commutation load test) and found all parameters are within manual limits.
2. Disassembled the starter generator for details inspection and cleaning.
3. Found sign of rusts and water mark at the bottom half of stator and armature assembly. See Photo (1).
4. Polish to remove rusts and apply insulation coating at stator and armature assembly.
5. Other hardware found normal.
6. The unit is repaired during this shop visit and final test found serviceable.
7. The report defect could not be verified as the induction run found the unit was within manual limits. The reported defect could be due to water ingested into starter generator and the wetness has caused low insulation of stator & armature.
8. No SB & AD required to comply in this shop visit

Photo (1) : Armature assembly – sign of water mark and rust at the bottom half

PART NUMBER	DESCRIPTION	REPAIR QTY	REPLACE QTY	REASON
300SGL1156-19	Stator assembly	1		Polish and apply insulation paint
300SGL1064-2	Armature assembly	1		Polish and apply insulation paint.
M83248/1-113	Packing		1	Discard. Replaced new.
