COMPONENT REPAIR REPORT

1. Customer: Galaxy Aerospace	4. Cust PO#: PO-21-2081	7. TSN /CSN: - / -
2. WO #: 537	5. Qty: 1	8. TSO /CSO : - / -
3. PN #: 0230390-202	6. SN: 111728	9. TSR /CSR : - / -
<u>A. Removal Reason</u>		
Cannot return to original position		
<u>B. Receiving Findings</u>		
<ol style="list-style-type: none"> 1. The unit received in forward extended condition. 2. External condition is dusty. 3. Rotation motor badly corroded. See Photo (1) 4. Scratch marks at the base plate and motor control cover. See Photo (2) 5. The PN 0239390-202 stated in PO was incorrect and corrected to PN 0230390-202 by Galaxy shipping. 6. The SN 102103 stated in PO was incorrect and corrected to SN 111728 by Galaxy shipping. 		
<u>C. Shop Findings</u>		
<ol style="list-style-type: none"> 1. Carry out trouble shooting and confirmed the removal reason “Cannot return to original position”. The defects were due to ext/ret motor (PN 932-130-00) defective. 2. The extend/retract motor (PN 932-130-00) and limit switch (PN 404-040-00) are replaced new in this shop visit. 3. The rotation motor (PN 932-230-00) is replaced new due to corrosion. 4. All scratch marks are polish smooth. 5. Other hardware fo

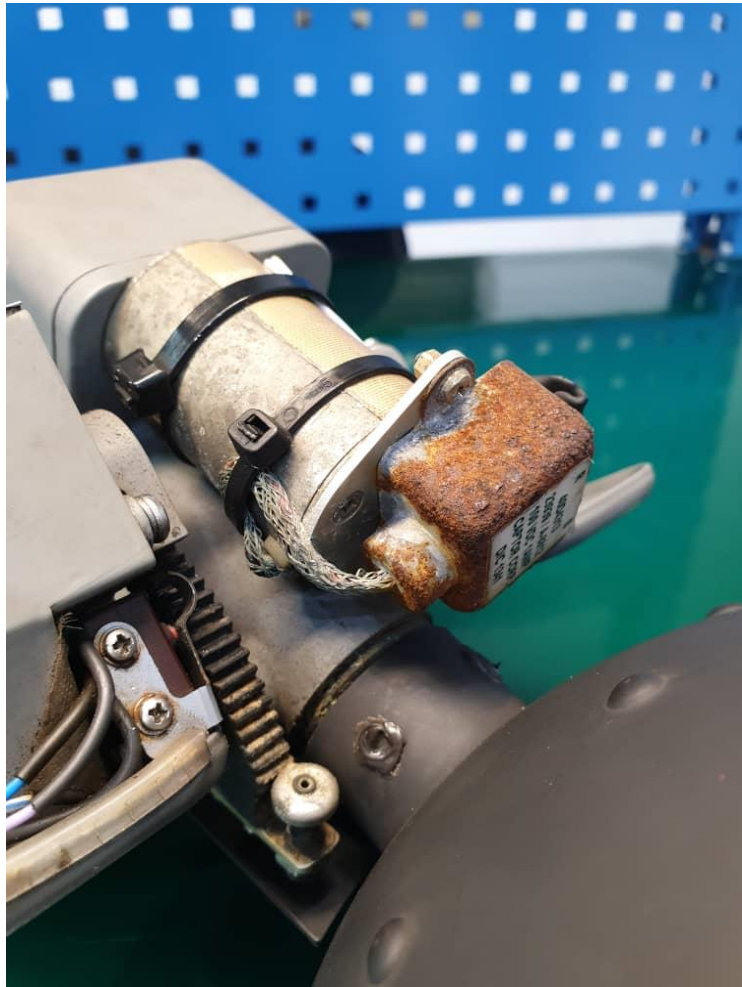
Photo (1): Rotation motor badly corroded

PART NUMBER	DESCRIPTION	QTY	REASON
404-040-00	Limit switch	2	Replaced with motor.
932-130-00	Ext /Ret motor	1	Defective. Replaced new
932-230-00	Rotation motor	1	Badly corroded. Replaced new

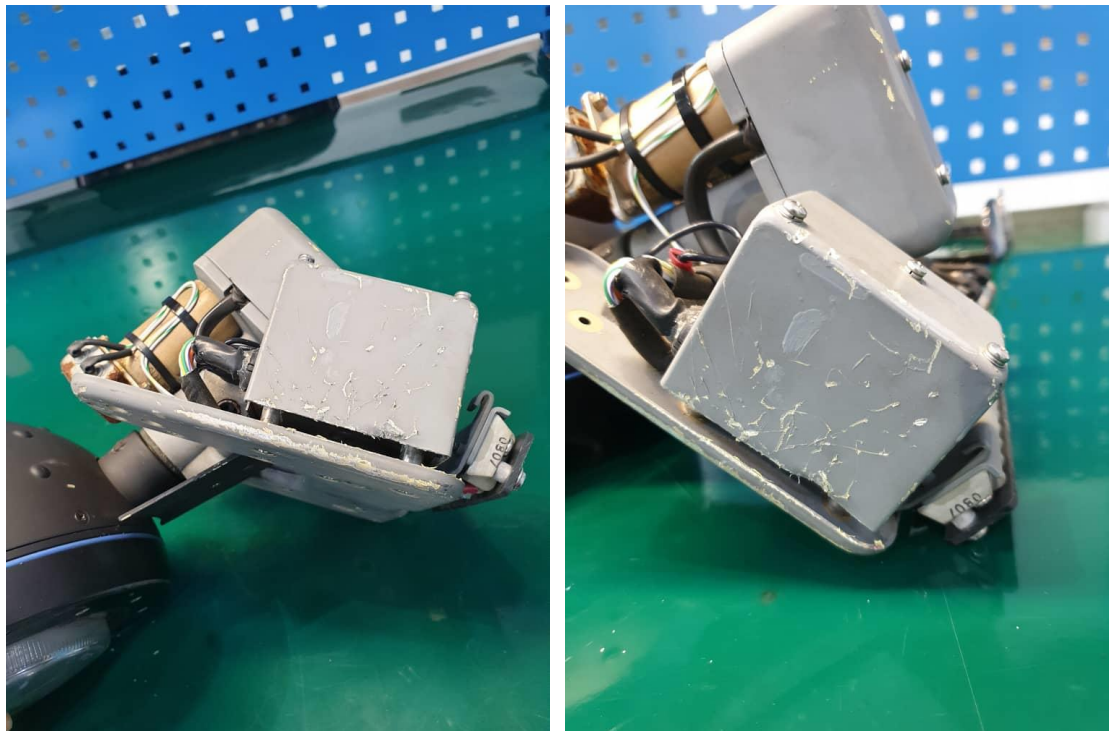
Photo (2): Scratch marks at motor control cover and side of base plate
