Leonardo Malaysia Sdn. Bhd.

Blade Repair Workshop Inspection Report

Customer:	Galaxy Aerospace
Part Number:	3G6210A00131
Serial Number:	V159
TTSN:	4356.3
Date:	27 October 2023

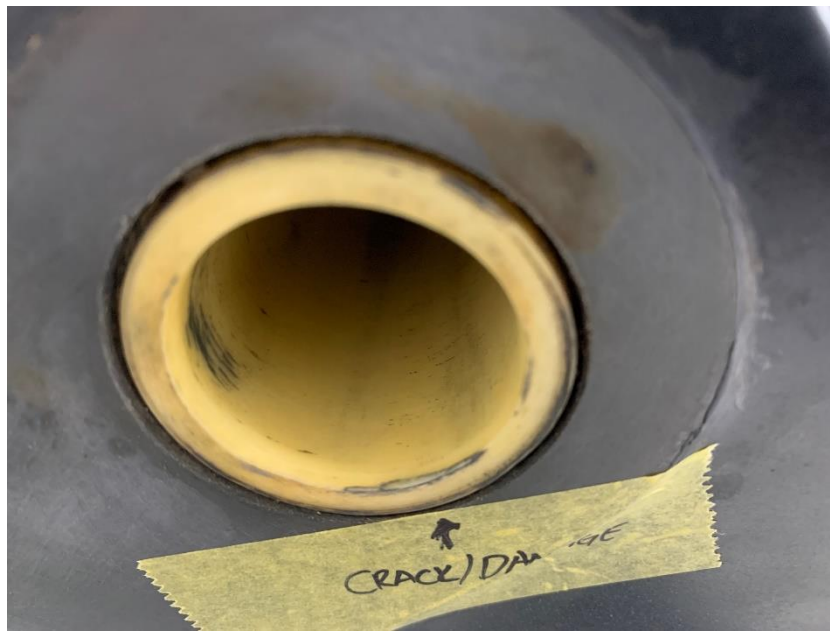
1. Aft Root Bushing found damaged at the edge of the lower surface.

- Aft Root Bushing to be replaced.

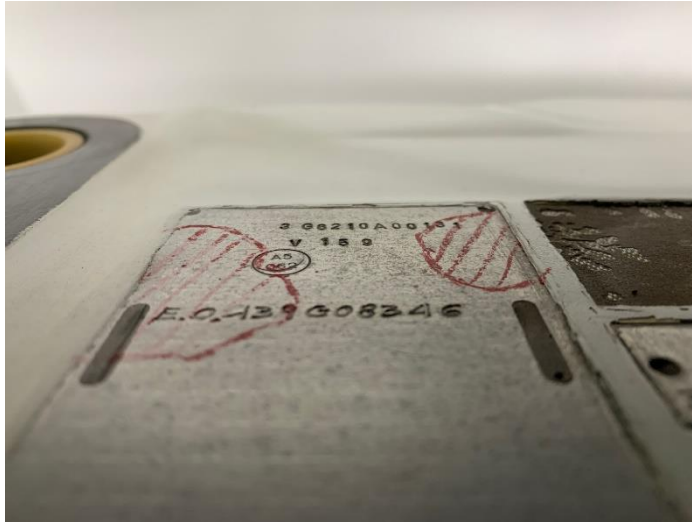
2. Modification Tag found defonded.

- Modification Tag to be rebonded.

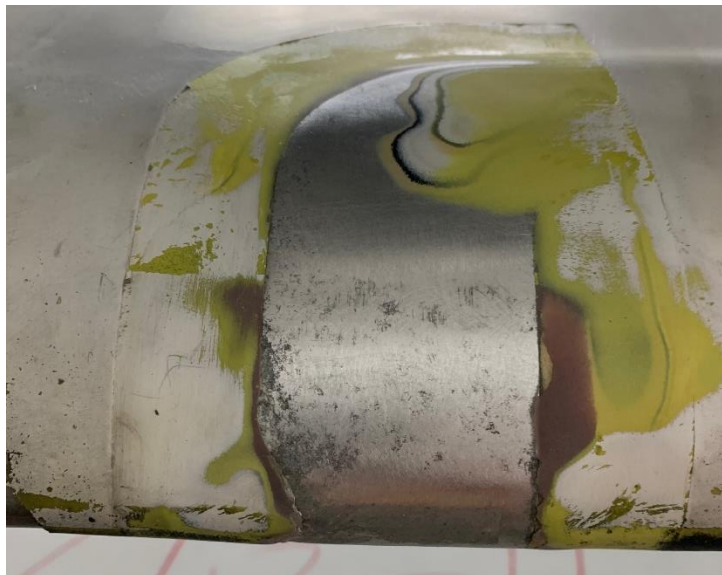
3. Lightning Conductor Strip found heavily corroded.

- Lightning Conductor Strip to be replaced.
- SB139-617 to be complied for corrosion protective layer.

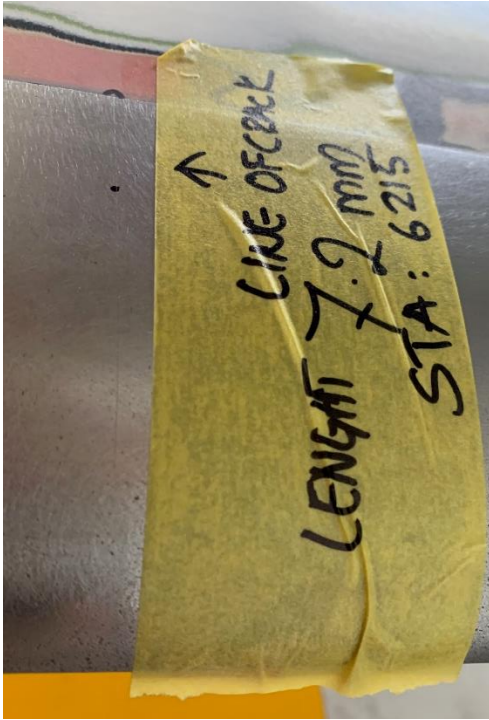
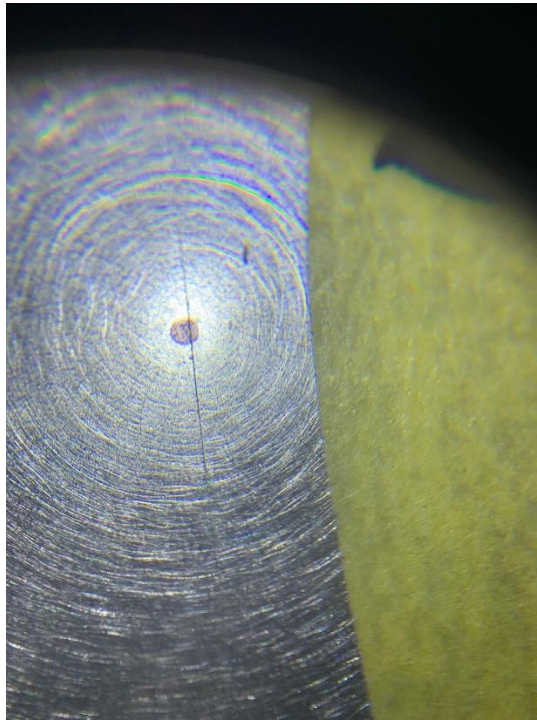
4. Erosion Shield found crack at STA6215

- Erosion Shield to be replaced.
- Leading Edge Closure Cover to be replaced in conjunction with erosion shield replacement.

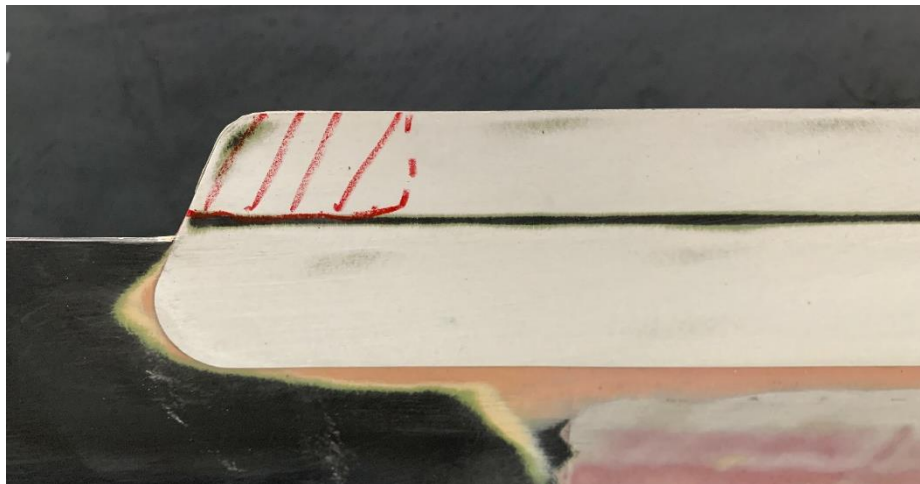
5. Inboard trim tab found debonded and corroded.

- Inboard trim tab to be replaced/upgraded to stainless steel tab.
- Outboard trim tab to be replaced/upgraded in conjunction to Inboard tab replacement.
- Complied with SB139-501 Rev B

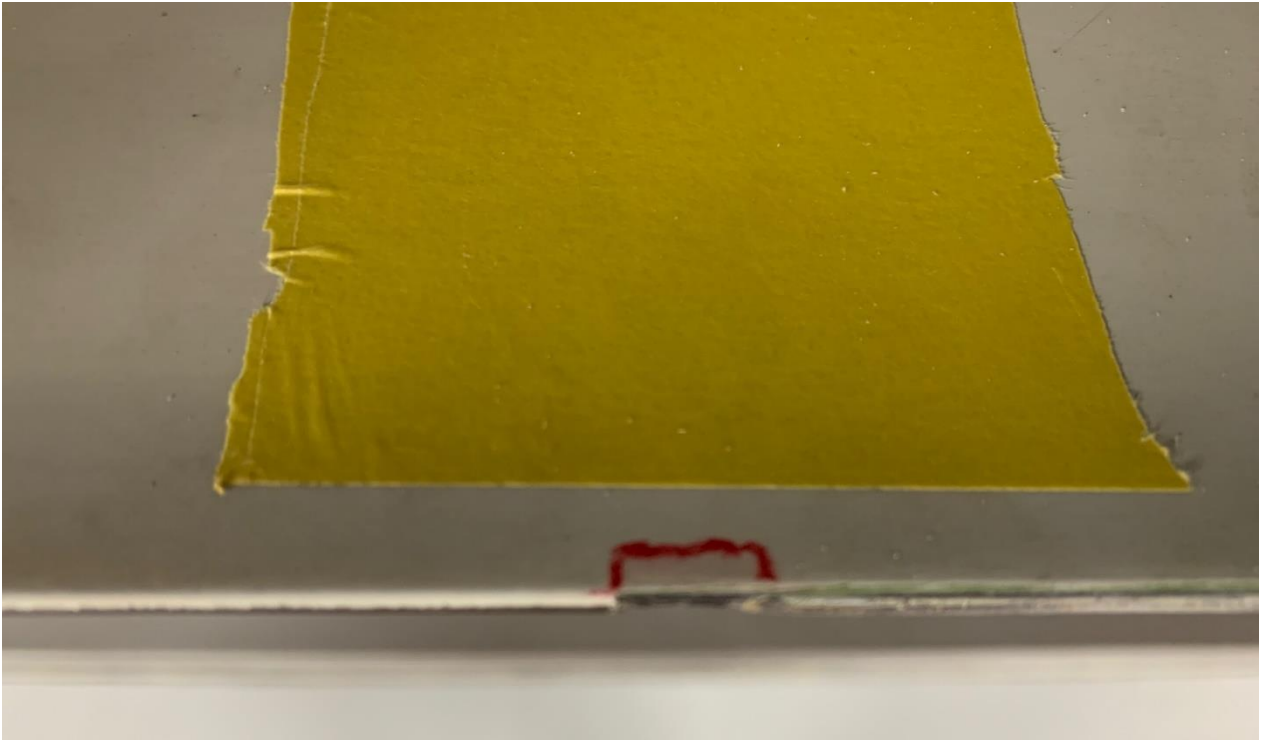
6. Trailing Edge found grinding.

- Superficial repair to be performed.

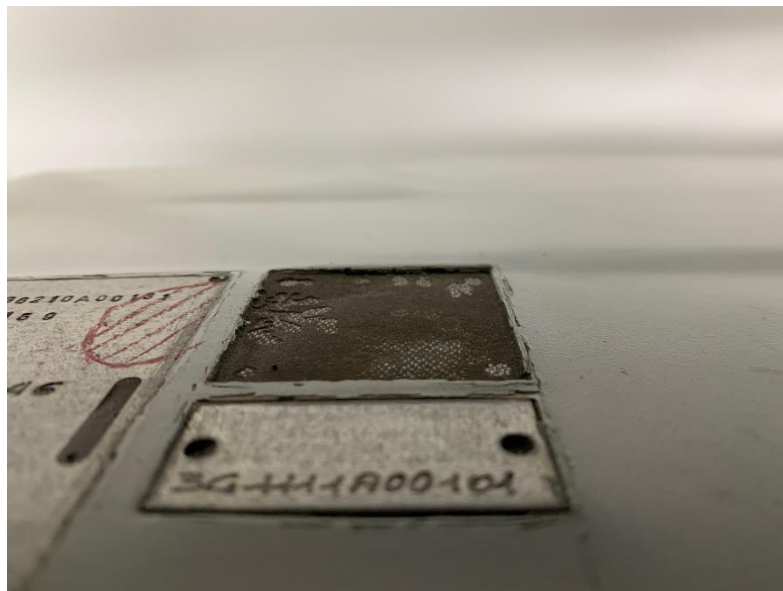
7. Data tag found missing.

- Data tag to be bonded.
