SKYWAYS TECHNICS	ASSESSMENT REPORT	SWT WO	003171	REV	00
		CUST PO	RMN-22-392	DATE	1-JUNE 2022

PART NUMBER	355A81-1030-100	DESCRIPTION	RADOME
SERIAL NUMBER	N/A	REMOVED FROM A/C REG	N/A
CUSTOMER	GALAXY AEROSPACE (M) SDN. BHD.

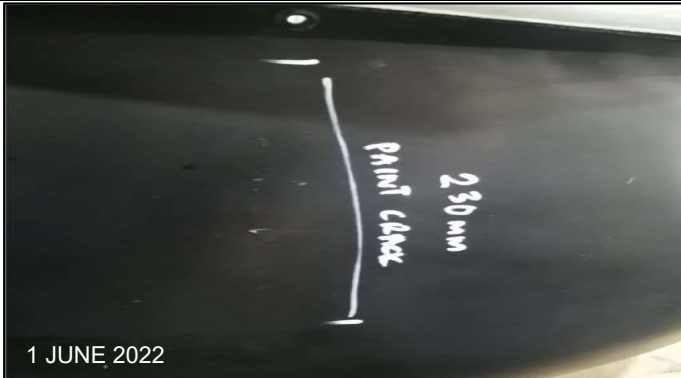
FIGURE 1

- Visual inspection carried out found paint crack on outer space with length 230 mm (See fig.1).
- Tap test carried out found delamination defect 80 mm x 50 mm (See fig. 2).

- Visual inspection carried out found paint crack on outer space with length 230 mm.

- Unit to be painted as per Standard Practices Manual 20-04-05-413.

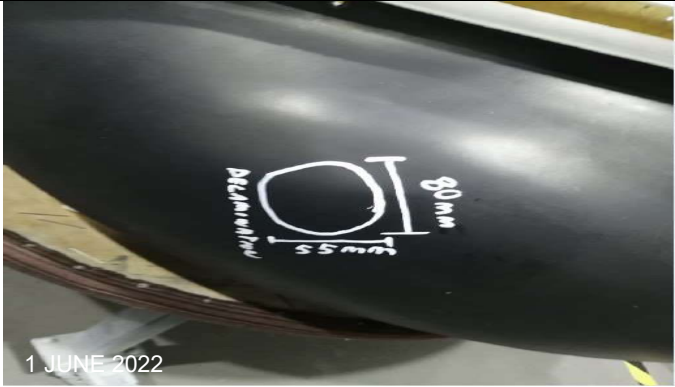
FIGURE 2

- Tap test carried out found delamination defect 80 mm x 50 mm.

- Inspect Radome as per MTC 20-03-01-101.
- Sand all around damaged areas as per MTC 20-03-06-409
- Prepare the surfaces before bonding the repair parts as per MTC 20-06-01-101
- Repair by removing damaged honeycomb core and replacing core as per MTC 20-03-06-418 and 20-03-07-101
- Install Vacuum Bag MTC 20-03-06-40
- Repair by removing damaged delamination (outer and inner) and replacing delamination as per MTC 20-03-06-418 and 20-03-07-101
- Install Vacuum Bag MTC 20-03-06-406
- Unit to be painted as per Standard Practices Manual 20-04-05-413.
- Total repair area size 80 mm x 50 mm = 40 sq cm or 6.20001 sq inch.

- Repair by removing damaged delamination (Outer and inner) and replacing delamination as per MTC 20-03-06-418 and 20-03-07-101.
