**Blade Repair Workshop Inspection Report**

<i>Customer:</i>	Galaxy Aerospace
<i>Part Number:</i>	<b>3G6210A00131</b>
<i>Serial Number:</i>	AW4236E
<i>TTSN:</i>	1917.15
<i>Date:</i>	2 April 2024

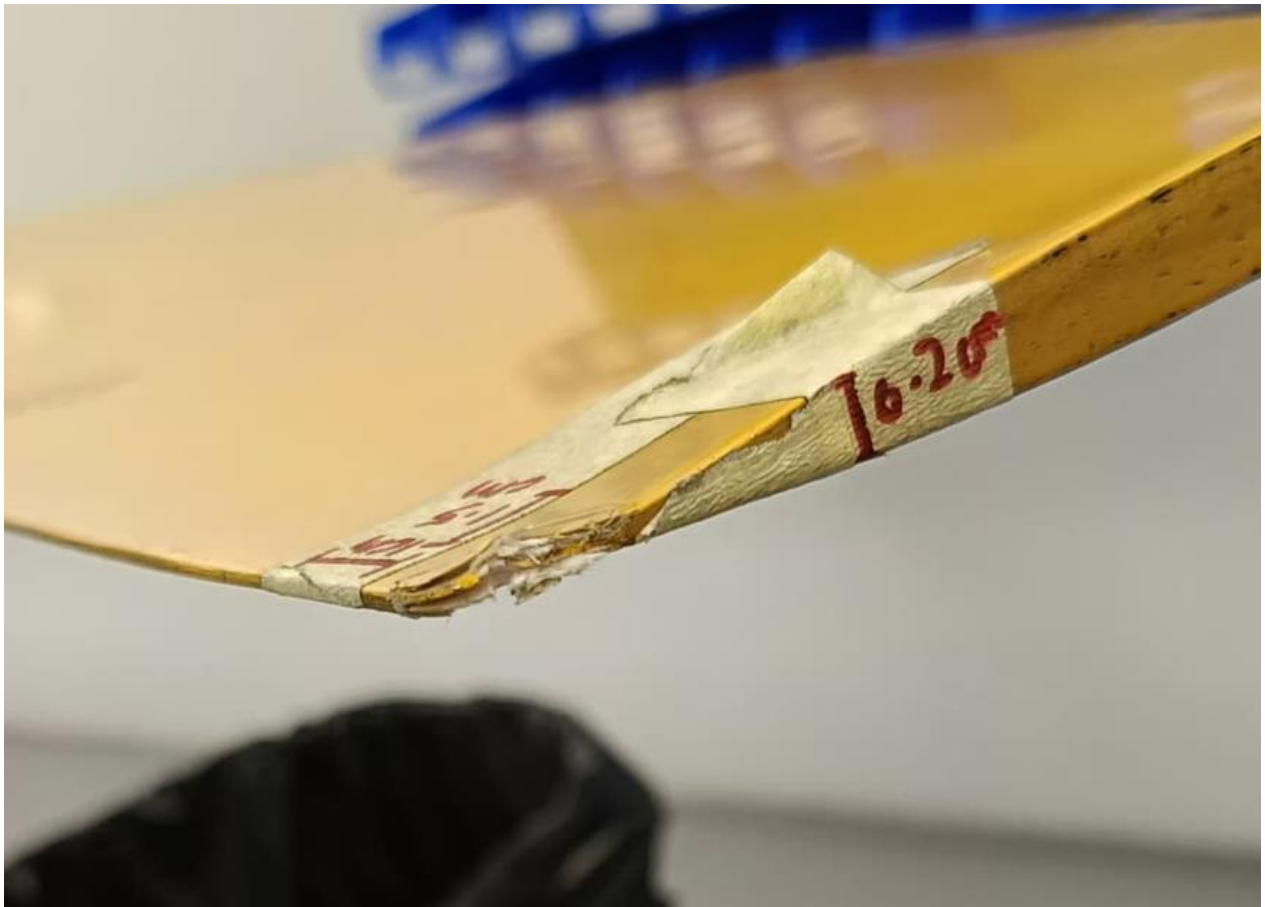
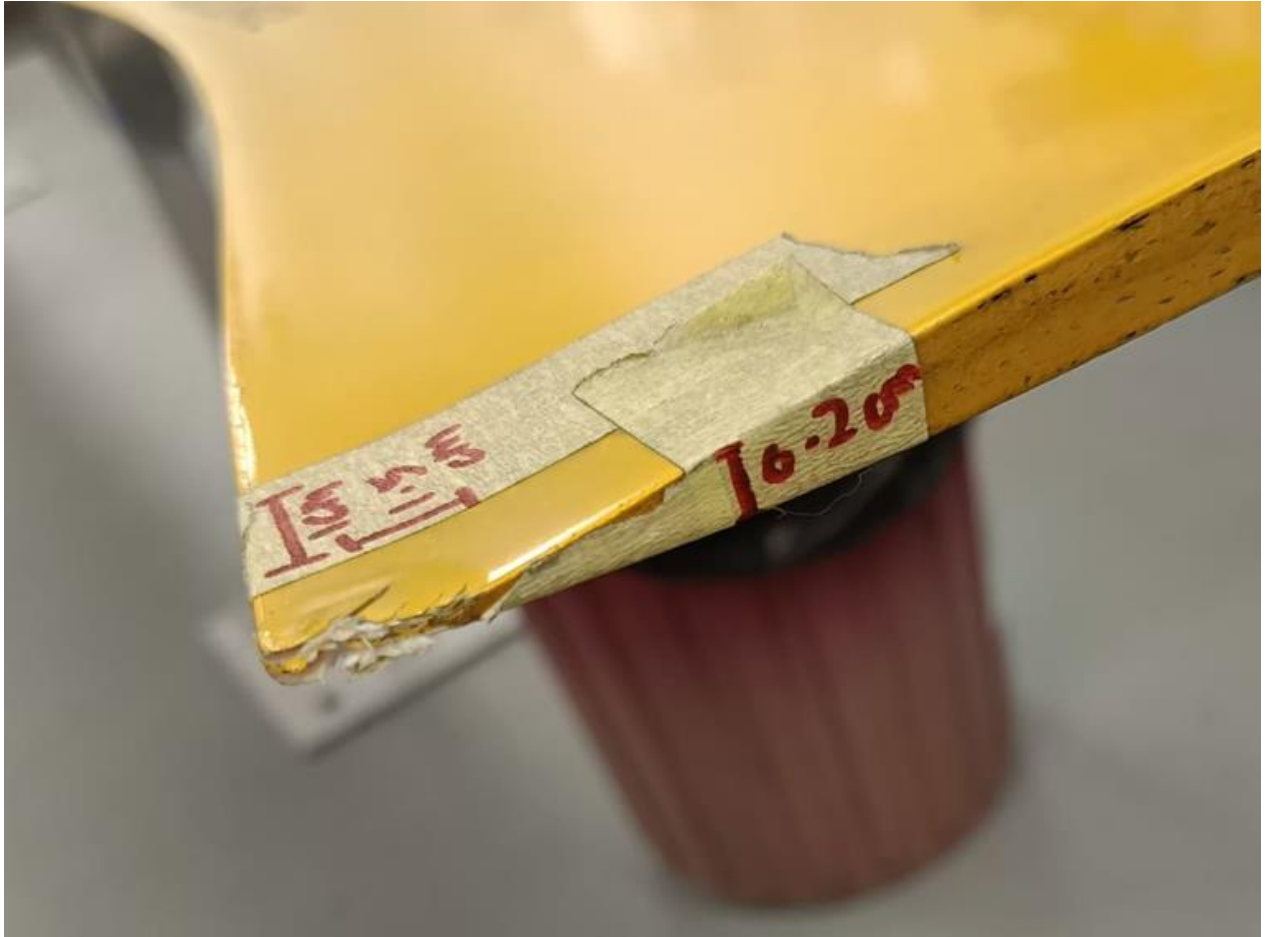
**Defect reported by customer:** Found deformed on tip

**Rectification required:-**

- ❖ *Tip Cap to be replaced*
- ❖ *Blade to body cover to be replaced in conjunction with tip cap replacement*

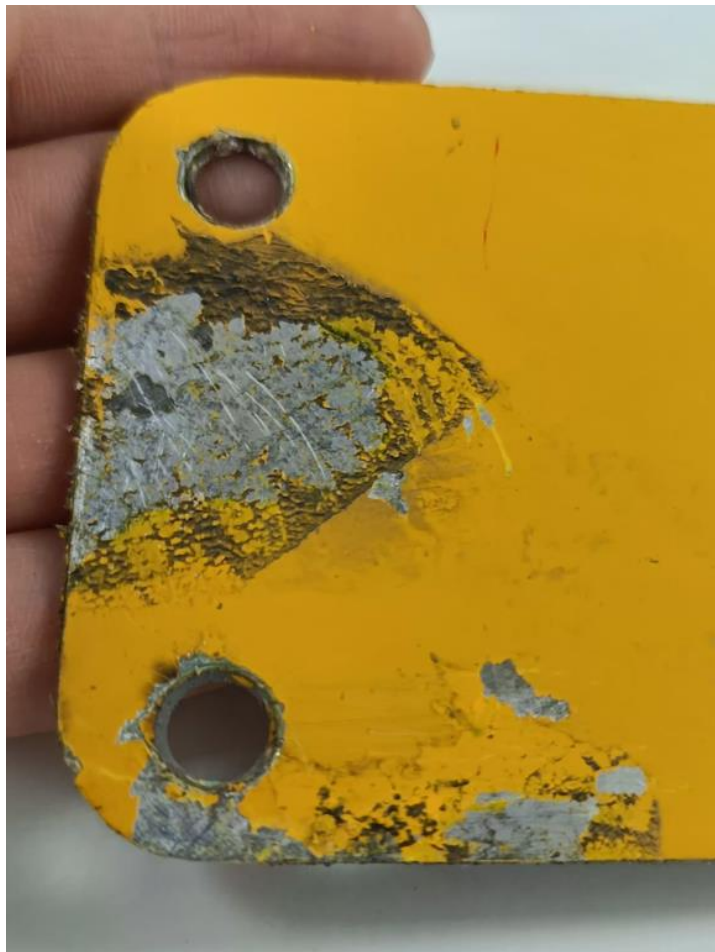
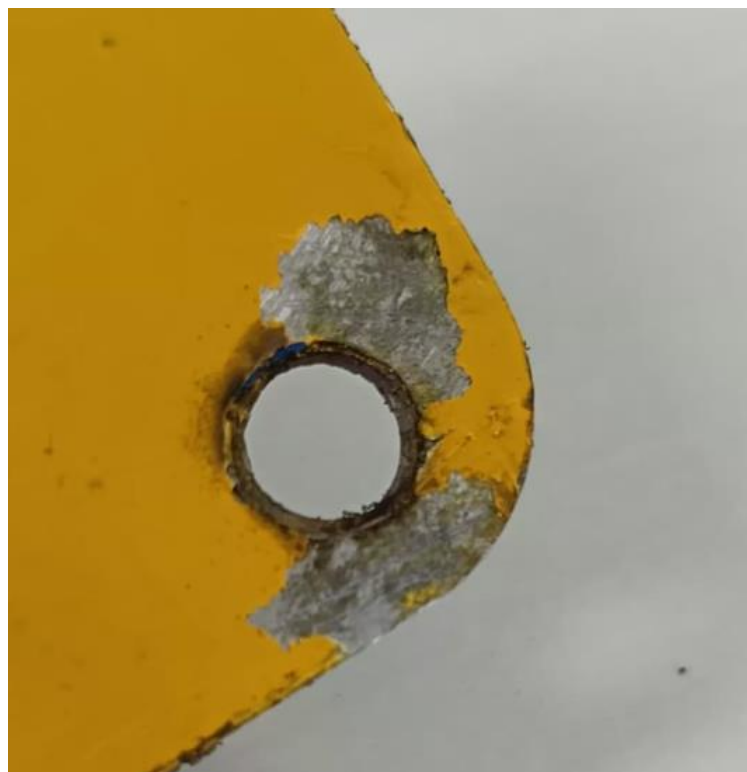
1. Tip weight pocket cover found heavily corroded

**Rectification required:** *Tip weight pocket cover to be replaced*

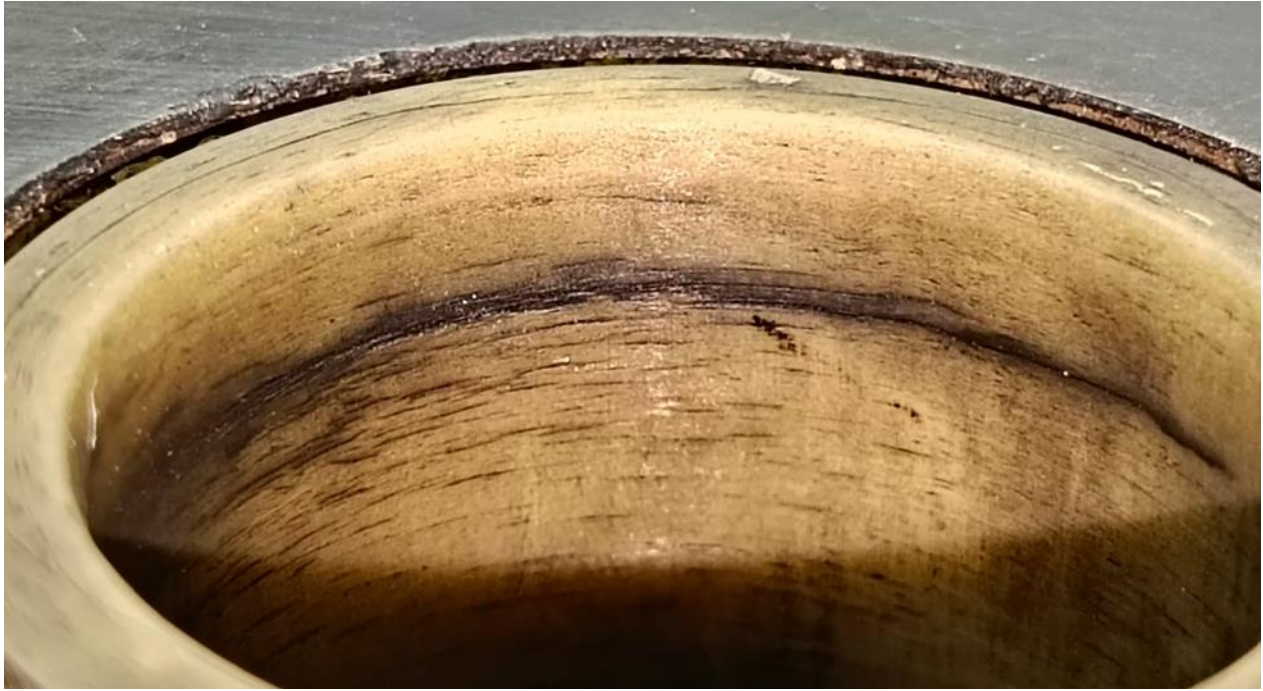
**FWD**

**2. Both root end bushings found crack**

**Rectification required: Both bushings to be replaced**

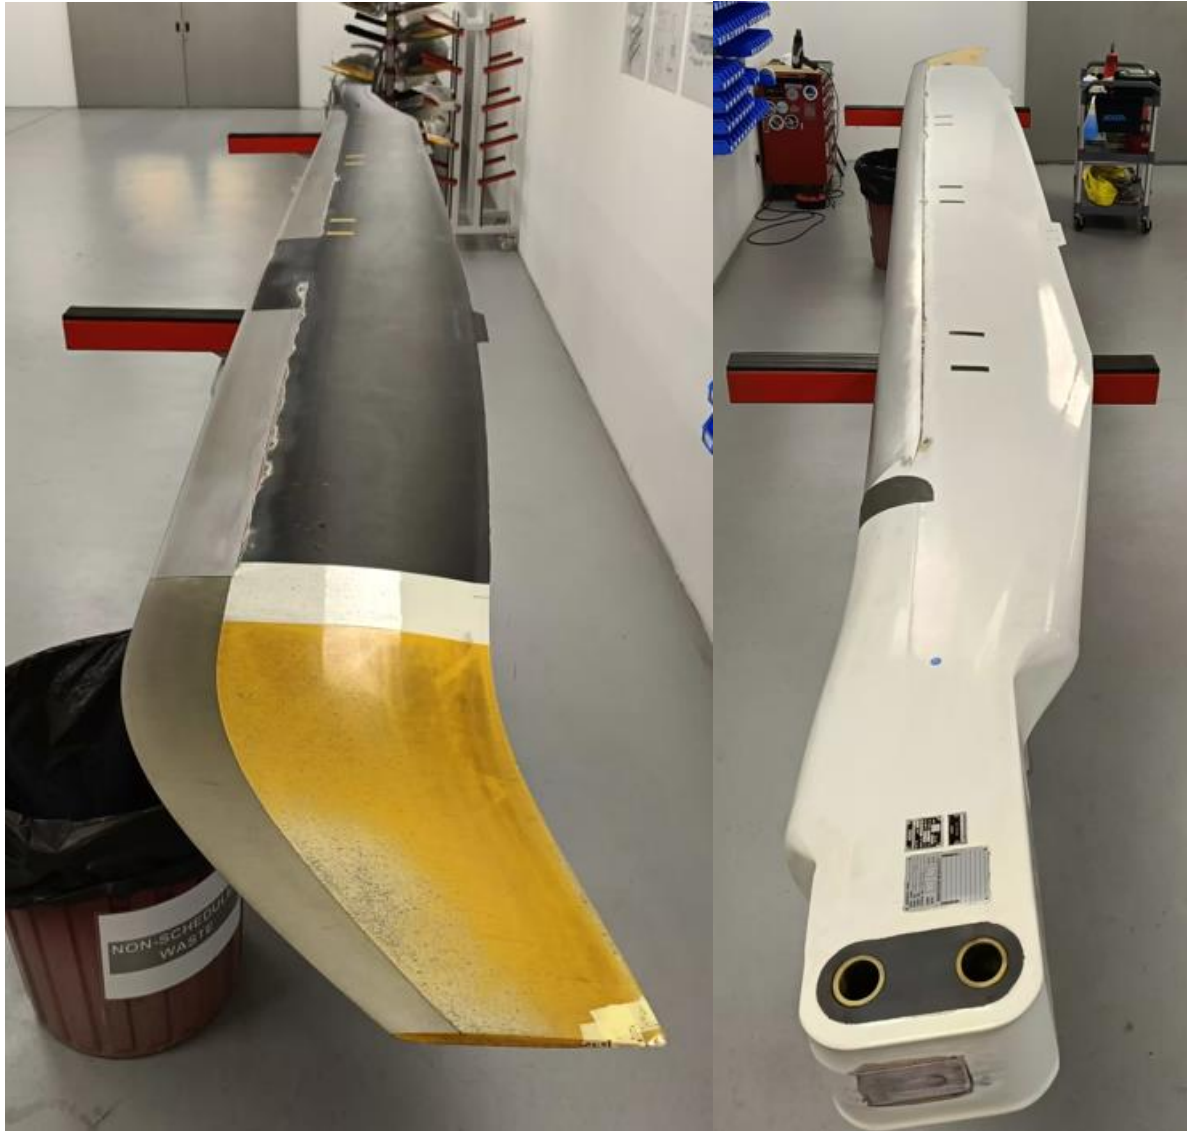
**4. Complete refinish to standard scheme required due to nature of repair**
