No.: STP-20-013 Date: 21-May-20

P/N	3G9560V00332 /3G9560V00432 /3G9560V00131 / 3G9560V00231	S/N	132 / 107 /247/240	TSN	As per log card	TSO	As per log card
(Costu	mer work order reference	PRJ-SS	-007264 /65&70	Work R	eference

Reason for removal: inspection

Scope of work Inspection

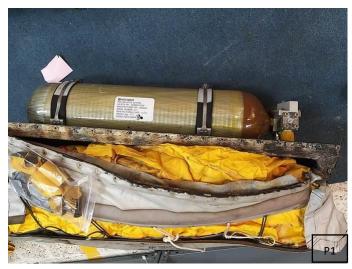
Floats assembly received in bad condition and assembly opened as per below photos 2.

P1 Aft float bag assembly received opened and sign of dirt's and water contamination

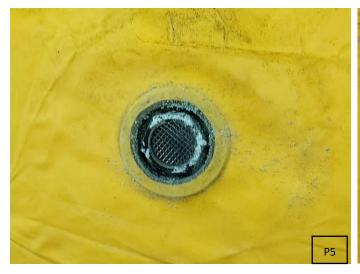
Float assembly part no	Float assembly serial no	Float bag part no	Float bag part serial no
3G9560V00231	240	3G9560V00651	1017

P5	Corrosion	
Р6	Seem welding debonding (inner and outer)

- 1. client to review helicopter wash procedure in order to eliminate water seepage inside the floats
- 2. client required not to open floats or life raft in field as its 3rd level activitie
- 3. MRO proceeding with replacement of defective items during the inspection

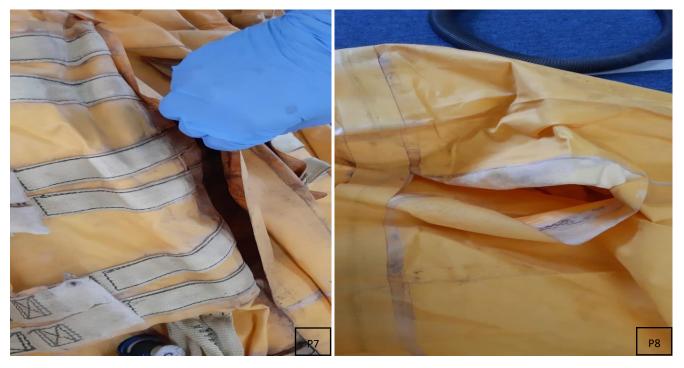
Float assembly part no	Float assembly serial no	Float bag part no	Float bag part serial no
3G9560V00131	247	3G9560V00651	1002

P7	Seem welding debonding (inner and outer)
Р8	Seem welding debonding (inner and outer)

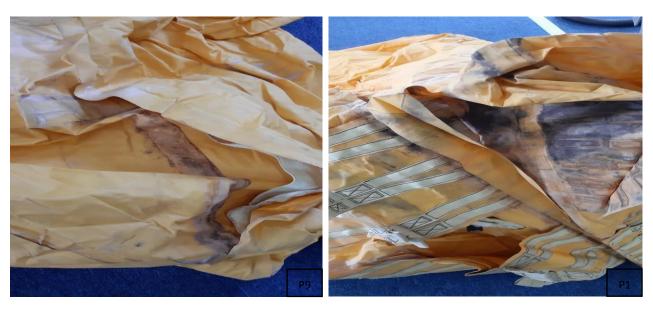
Р9	Seem welding debonding (inner and outer)
P10	Seem welding debonding (inner and outer) and dirt's due to water accumulation

Several seem welding de-ponding due to water accumulation same valves found corroded, client to review the helicopter wash procedure

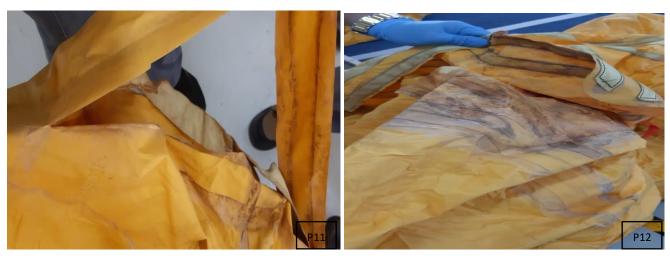
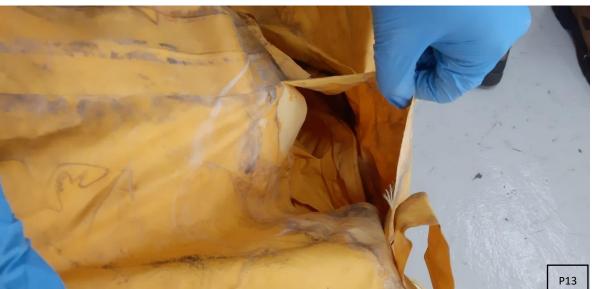
Float assembly part no	Float assembly serial no	Float bag part no	Float bag part serial
3G9560V00332	132	201655C	1035

P11	Seem welding debonding (inner and outer)		
P12			
P13	Seem welding debonding (inner and outer) and dirt's due to water accumulation

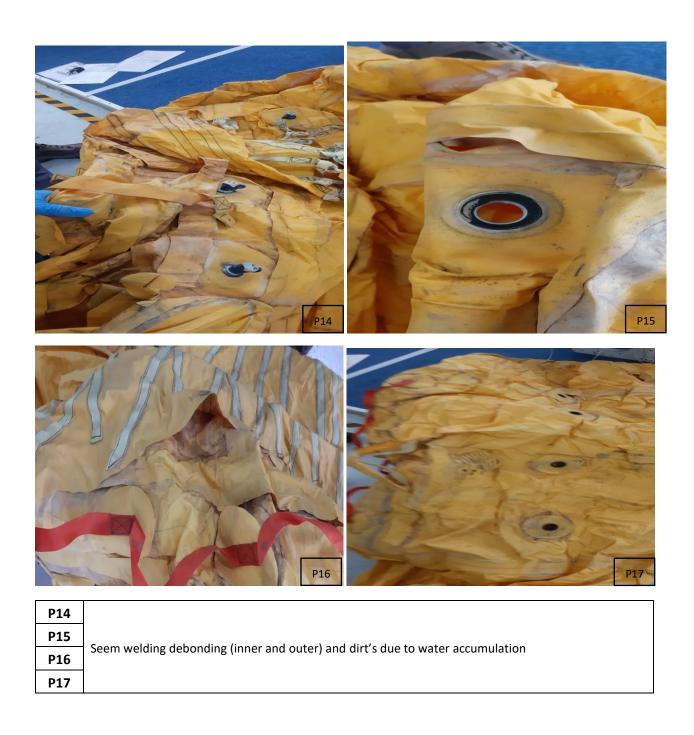
Float assembly part no	Float assembly serial no	Float bag part no	Float bag part serial
3G9560V00432	107	201655C	1023
