WORK REPORT

A/C REG	: N/A
PN	: 709-0160-48-101
SN	: P1532
Description	: A109 TR BLADE
TSN	: 957.32 hrs

LM/21/01

DESCRIPTION :	Tail Rotor Blade	RO NO :	AWM-21-081
PART NO :	709-0160-48-101	CUSTOMER :	Galaxy
SERIAL NO :	P1532	AIRCRAFT REG :	N/A

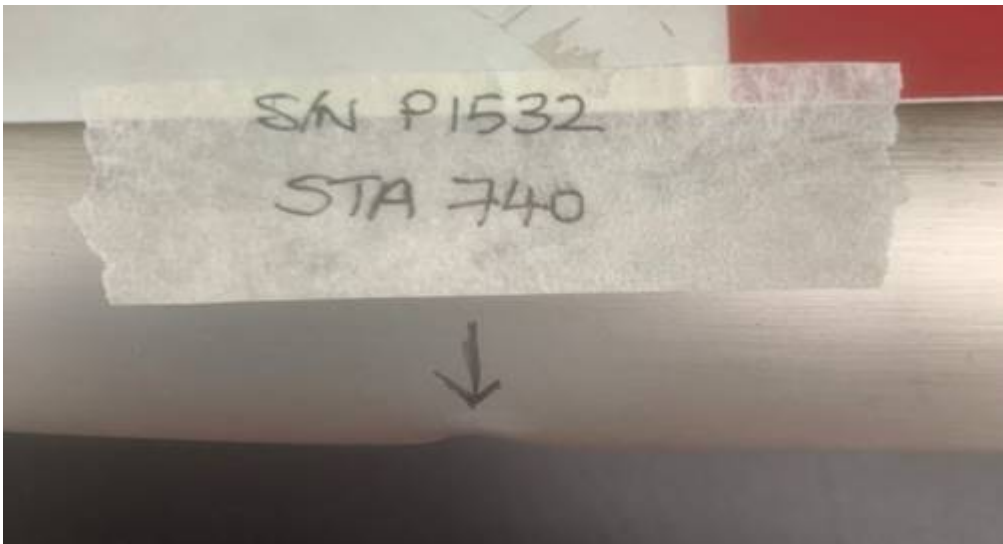
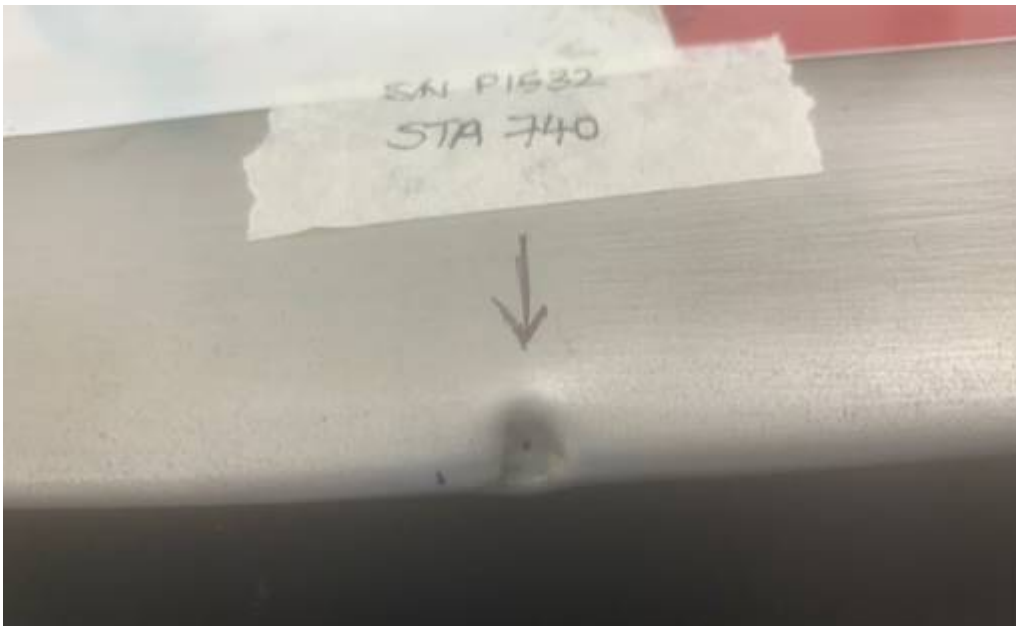
- Dent on Erosion shield

With respect to this case, the blade cannot be repaired nor erosion shield replacement can be performed. Therefore, the blade needs to be scrapped.

We received the subject TRB and found a sharp dent on the leading edge of the erosion shield @ STA 740 (see photos below). The depth of the dent is 2.87mm.

- Blade to be scrapped as per PSE-TQ-2021-39666

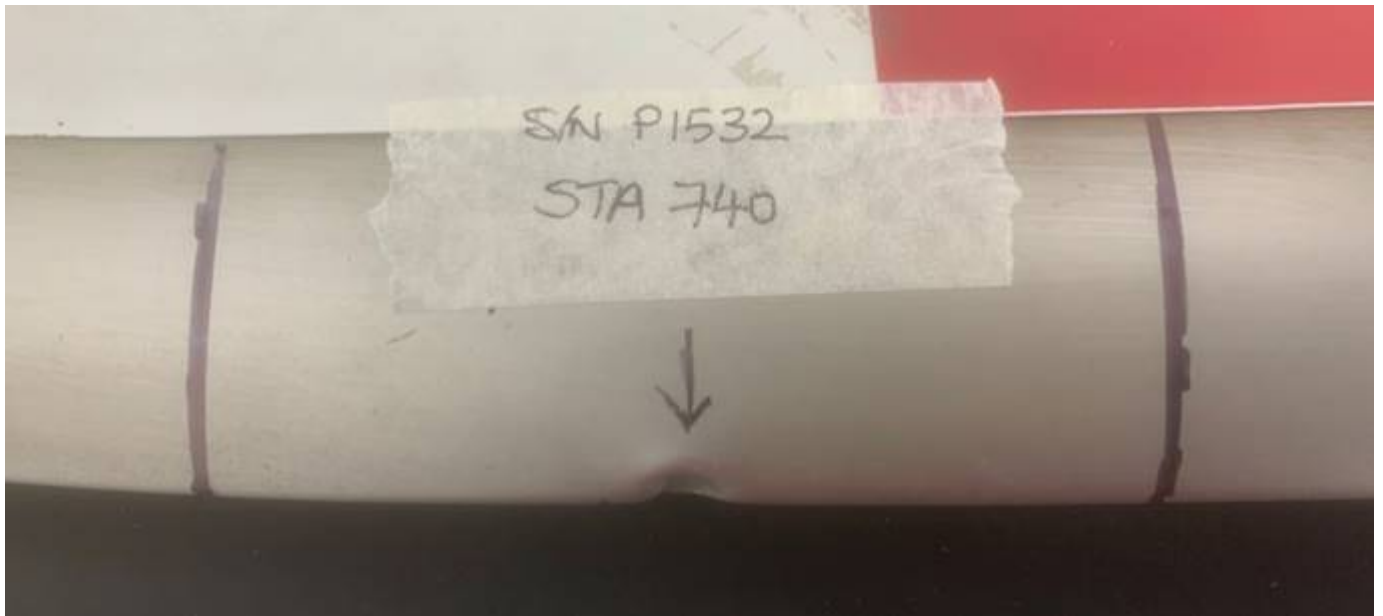
With reference to the A109S IETP DM 3C-A-64-11-01-00A-280A-C Step 10.2, sharp dents on the erosion shield are not permitted. We plan to trim and remove the marked area of the erosion shield as shown below to inspect whether the spar has been damaged as we believe that the blade can be sent back to Italy for an erosion shield replacement if the spar has not been damaged. Please advise if you have information to the contrary which would mean that our time is not wasted.
