RADIOGRAPHIC INSPECTION REPORT

Report No.: EASB/RT/2022-005

DELAMINATION INSPECTION

Po number :- BWS-0275
AIRCRAFT TYPE:- AW 109
REGISTRATION MARKING:- 9M-BOB
PART NUMBER :- 709-0103-01-109
SERIAL NUMBER :- J44994

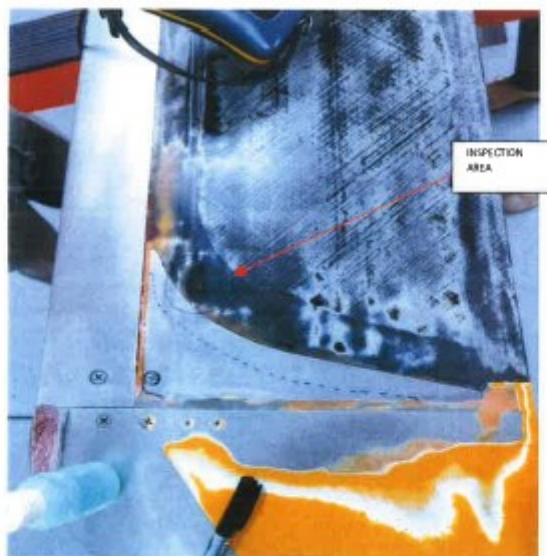
Figure 1

1. The test method using ultrasonic pulse echo.
2. Test on good area and defect area.

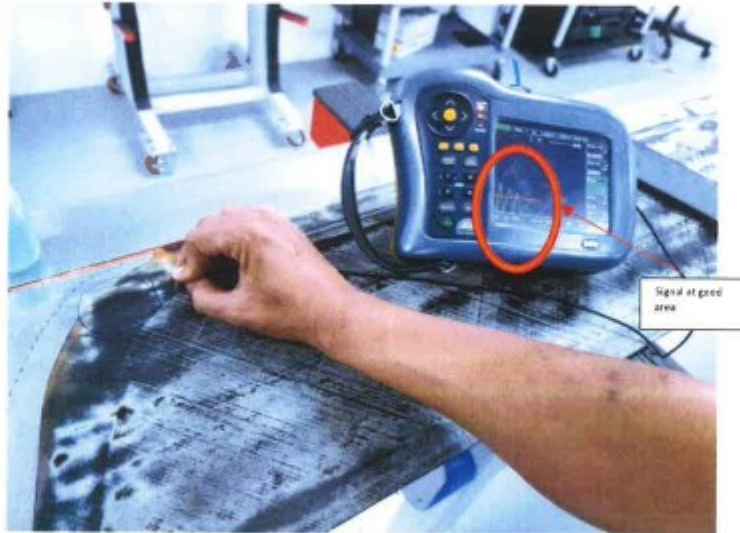
Tested signal at good area figure 2

1. Good area signal as per figure 2 at the circle area.

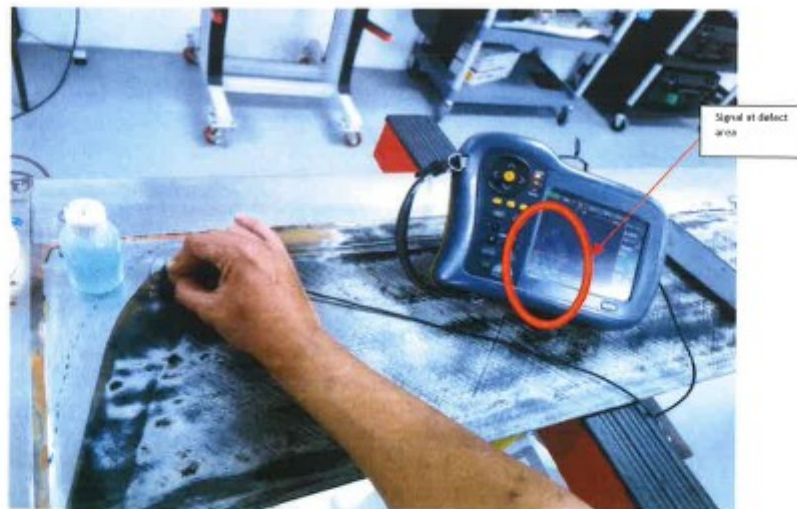
Figure 3 show drop in signal indicate delamination occur,

1. Defect signal as per figure 3 indicate drop in signal.

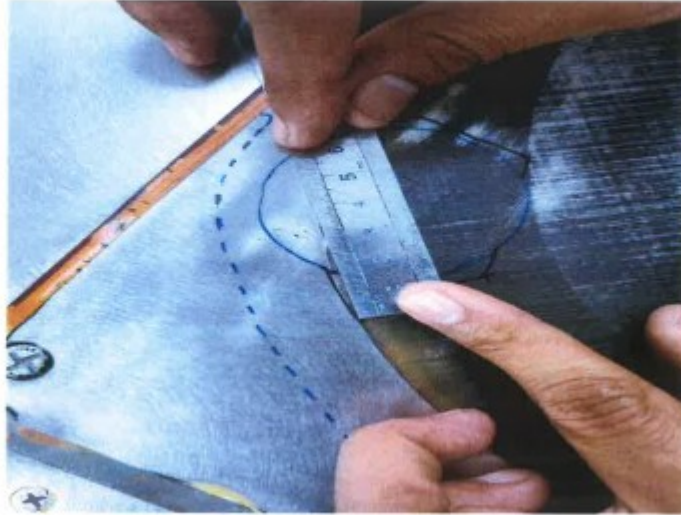
Extension area using pulse echo figure 4

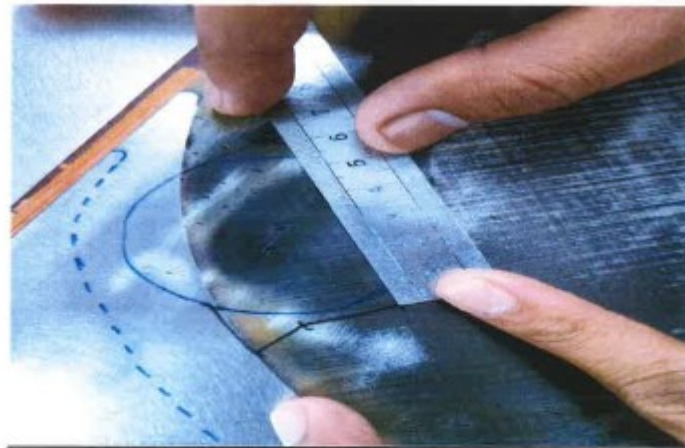
Extension area using pulse echo figure 5
