<b>ENGINEERING NOTICE</b>			
<b>TO</b>	All AMO Personnel	<b>ISSUE NO</b>	GAM/EN/01/22
<b>COMPLIANCE</b>	Immediate Effect	<b>ISSUE DATE</b>	17 <sup>th</sup> May 2022
<b>SUBJECT</b>	JBPM 9M-BOC Right Engine S/N: PCEKB0659 FOD

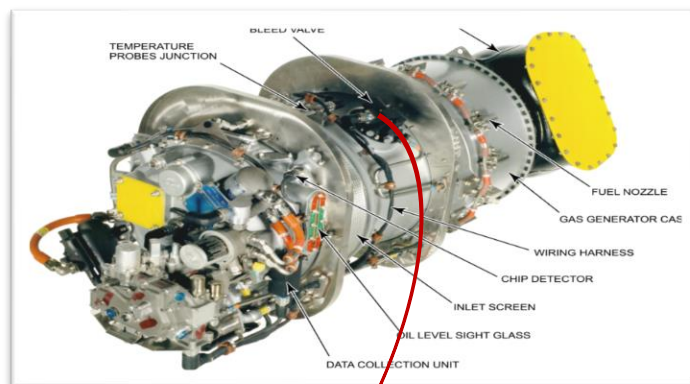
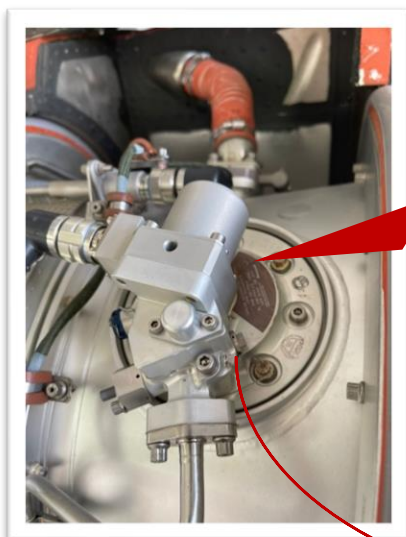
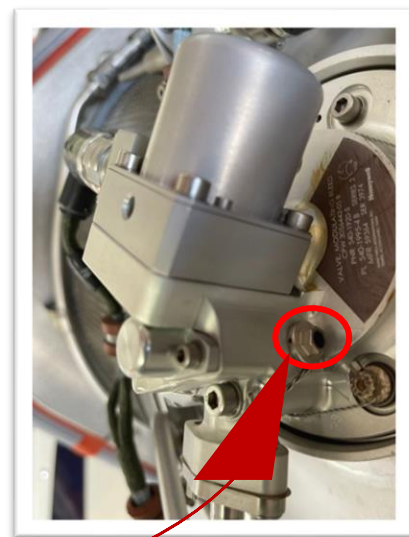
**Picture 1 – Bleed Valve FOD Location**

An incident was reported in Jabatan Bomba Penyelamat Malaysia (JBPM) AW139 Helicopter Registration No: **9M-BOC**. The Right engine PT6C-67C Serial Number: **PCEKB0659** encounter FOD ingestion during Engine Ground Run (EGR) at MIAT Hangar. The ingestion had caused the engine roughness operation during start up. Further investigation of the incident was carried out and found the Engine Bleed Valve was clogged with a Potter Wasp nest (refer picture 2).

1. During Airworthiness Inspection, Engineering team to ensure all opening ports, especially the Bleed Valve does not have any obstruction from FOD i.e. spider web, wasp nest etc.
2. To ensure that all standard practices to be practiced when aircraft are to be parked for a long term by referring to the latest AMP and EMM.

3. After the helicopter's long-term parking, the Bleed Valve is to be visually inspected for FOD, particularly in the indicated area during the de-preservation of the engine.
4. Pest control surrounding the hangar to be performed periodically to prevent insect from entering the hangar.
