ENGINEERING NOTICE			
TO	All AMO Personnel	ISSUE NO	GAM/EN/23/01
COMPLIANCE	Immediate Effect	ISSUE DATE	17 TH April 2023
SUBJECT	Misinterpretation Of Maintenance Manual

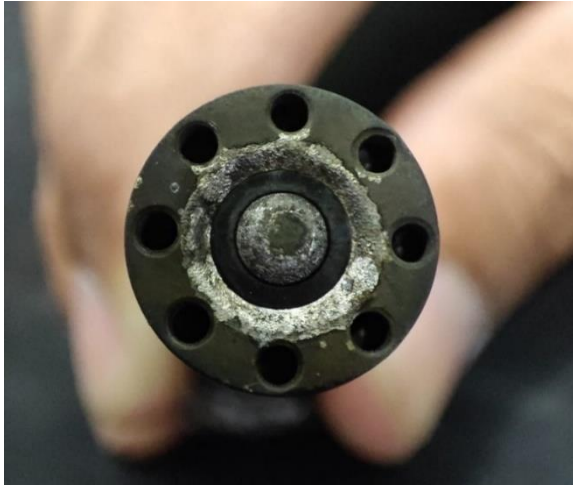
Figure 2

Spark Igniter (Firing End)

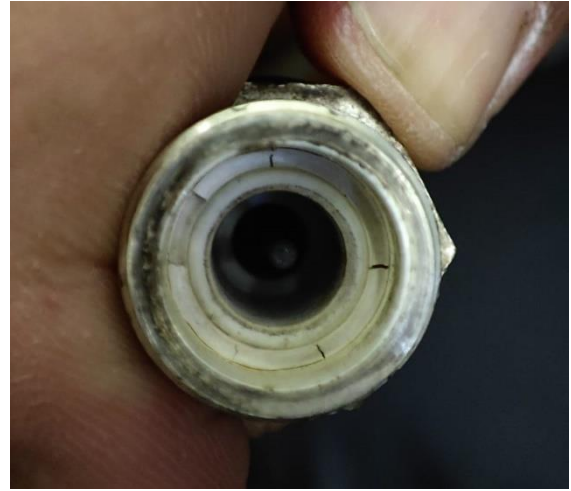
Spark Igniter (Cable End)

The rejection was based on the presumption that the ceramic at the cable end of the igniter was cracked, which wasn't the ceramic mentioned in the maintenance manual.

To avoid unjustified or unnecessary part replacement, the first rule is to confirm that the Maintenance Manual has been accurately interpreted.

Engineering personnel should formally consult the OEM or hold a small-group discussion with other engineers if they are unsure. Before deciding to reject any parts from service, the group should consult with an experienced LAE and the approved data for clarity. This is essential to make sure that the right decisions are made and that the relevant measures are taken because removing parts from service without the proper justification could lead to extra costs and safety risks, which could cause an aircraft to be grounded.
