Design Repair Approval S This form provides evidence of approve		ance with GAM/AE0	).P11	
Organisation:	DRAS Ref No: GAM004/DRAS	Issue No: 0	Page 1 of 15	
GalaxyAerospace				
AEO Reference: AEO 17/2018	Date: 17/07/2019			
Organisation operating H/C (Owner):	H/C Type: AS555	Ser. No: 5719 Reg. No.: M502-0	F/H F/C	
ROYAL MALAYSIAN NAVY (RMN)	H/C Component: NIL	I/C Component: Part No: NIL F/H		
Title: REPAIR - FUSELAGE AFT STR	RUCTURE LATERAL SH			
Damage/Repair Description: See Anne Repair Drawing No(s): NIL	ex 2 for Description of Da	amage and Annex 3	for Description of	
Repair Classification:	MAJOR / MINOF	२		
Reasons for Classification: See Annex 1 Reasons for Classification: See Annex 1 MOHD YUSSYUWARI MD YUSOP Date: 17/07/2019				
TCDS ref. & Regulations involved:	MSTC/16 & FAR 27 301 27 303 27 307 27 507			
Justification: Refer GAM004/CC and	I GAM004/SJR			
Fatigue Evaluation Document: NIL				
Other related substantiation (includes r	ef. to communication wi	th TC/STC, …): NIL

## Annex 2: Description of Damage

## Annex 3: Description of Repair

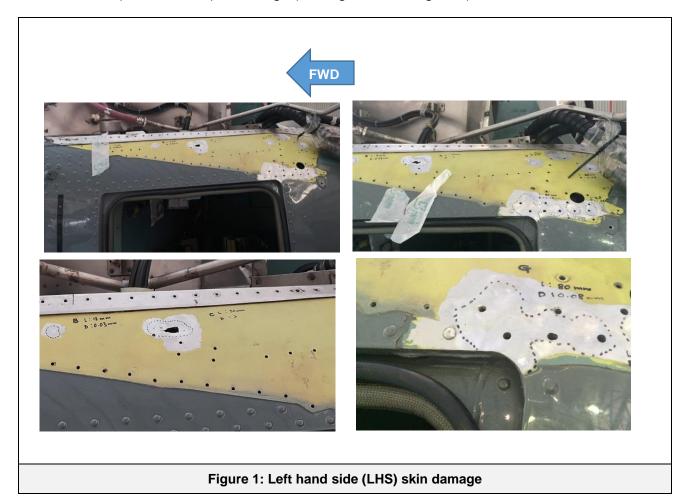
Corrosion beneath Rear structure stainless steel plates found during C inspection through which was conducted IAW *MET* 53-00-00-610- check - Corrosion under the stainless-steel Plate of the Rear Structure (with Removal) - Fuselage (see Figure 1 and Figure 2).
