Audit Report	
Report No.	IAR-2022/021
Area / Scope	PGU KK - PC6 & 208
Date of audit	30-31 Mar-01 Apr 2022

A	AUDIT DETAILS			
		Tick where applicable		
1.	Audit Type / Category	□ Scheduled □ Surveillance		Vendor Product Variation to approval
		Specify: Variation AMO Audit on PGU Kota Kinabalu for PC6 & Textron 208.

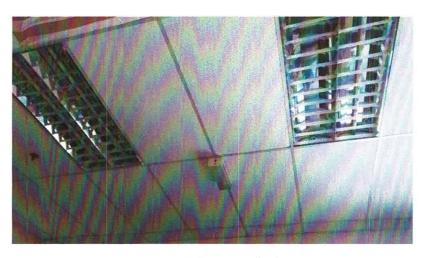
Figure 3: Lighting are broken.

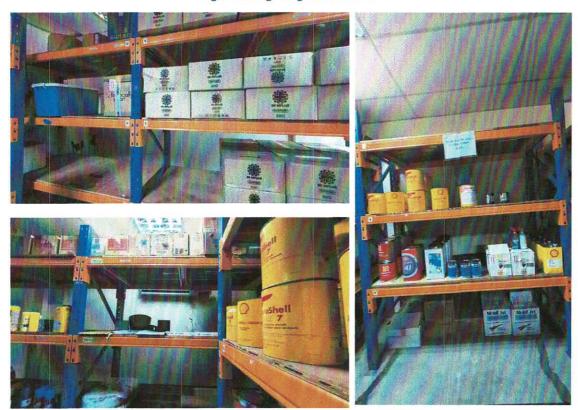
Figure 4: POL Storage Room

- a) A room for POL items found available at the hangar.
- b) The POL items were not controlled, and most of the POL items were discovered to be expired.
- c) The room found not suitably equipped to store POL items due to there no ventilation available.
- d) Items were stored together in the POL room such as sanitizer and spray paint can. Refer Figure 4.

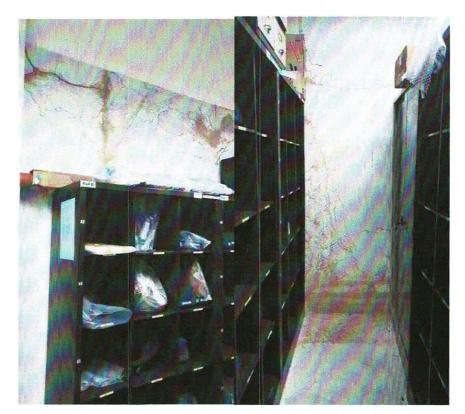
Figure 5: Holding Room Condition

- c) However, using of pigeon hole to store aircraft parts was not practical especially for bulky items where as during audit, those bulky items were found kept on the floor.
- d) Required to repaint as there was trace of termites on visible on wall. Refer Figure 5.
