CRISIS MANAGEMENT MINUTES OF MEETING – 08/21

Meeting Title:	Emergency Landing of RMPAOF AW139 aircraft.
Date of Meeting:	14 th June 2021
Time:	10:10 a.m. to 12:45 p.m.
Location:	Jade Training Room, GAM HQ
Chairperson:	Omar Bin Ahmad (Quality Assurance Manager - QAM)
Attendee:	<ol style="list-style-type: none"> 1. Ismail Bin Sulaiman (Chief Technical Operation Officer - CTOO) 2. Mohammad Nizam Bin Jaafar (Safety Manager - SM) 3. Ibrahim Hazly Bin Mohamad Yusof (Engineering in Charge – EIC) 4. Azillah Bin Matap (Maintenance Inspector / Supervisor – MI/S) 5. Zaty Nadhira Binti Mohamed Zuhari (Continuing Airworthiness Managing Manager – CAMM) 6. Mohamad Khair Bin Shaiful Alam (Quality Assurance Inspector – QAI)
Absent (with apologies)	<ol style="list-style-type: none"> 1. Shamsul Kamar Bin Samsudin (Accountable Manager – AM)

Meeting Objective
To carry out investigation and root cause analyses on the incident.

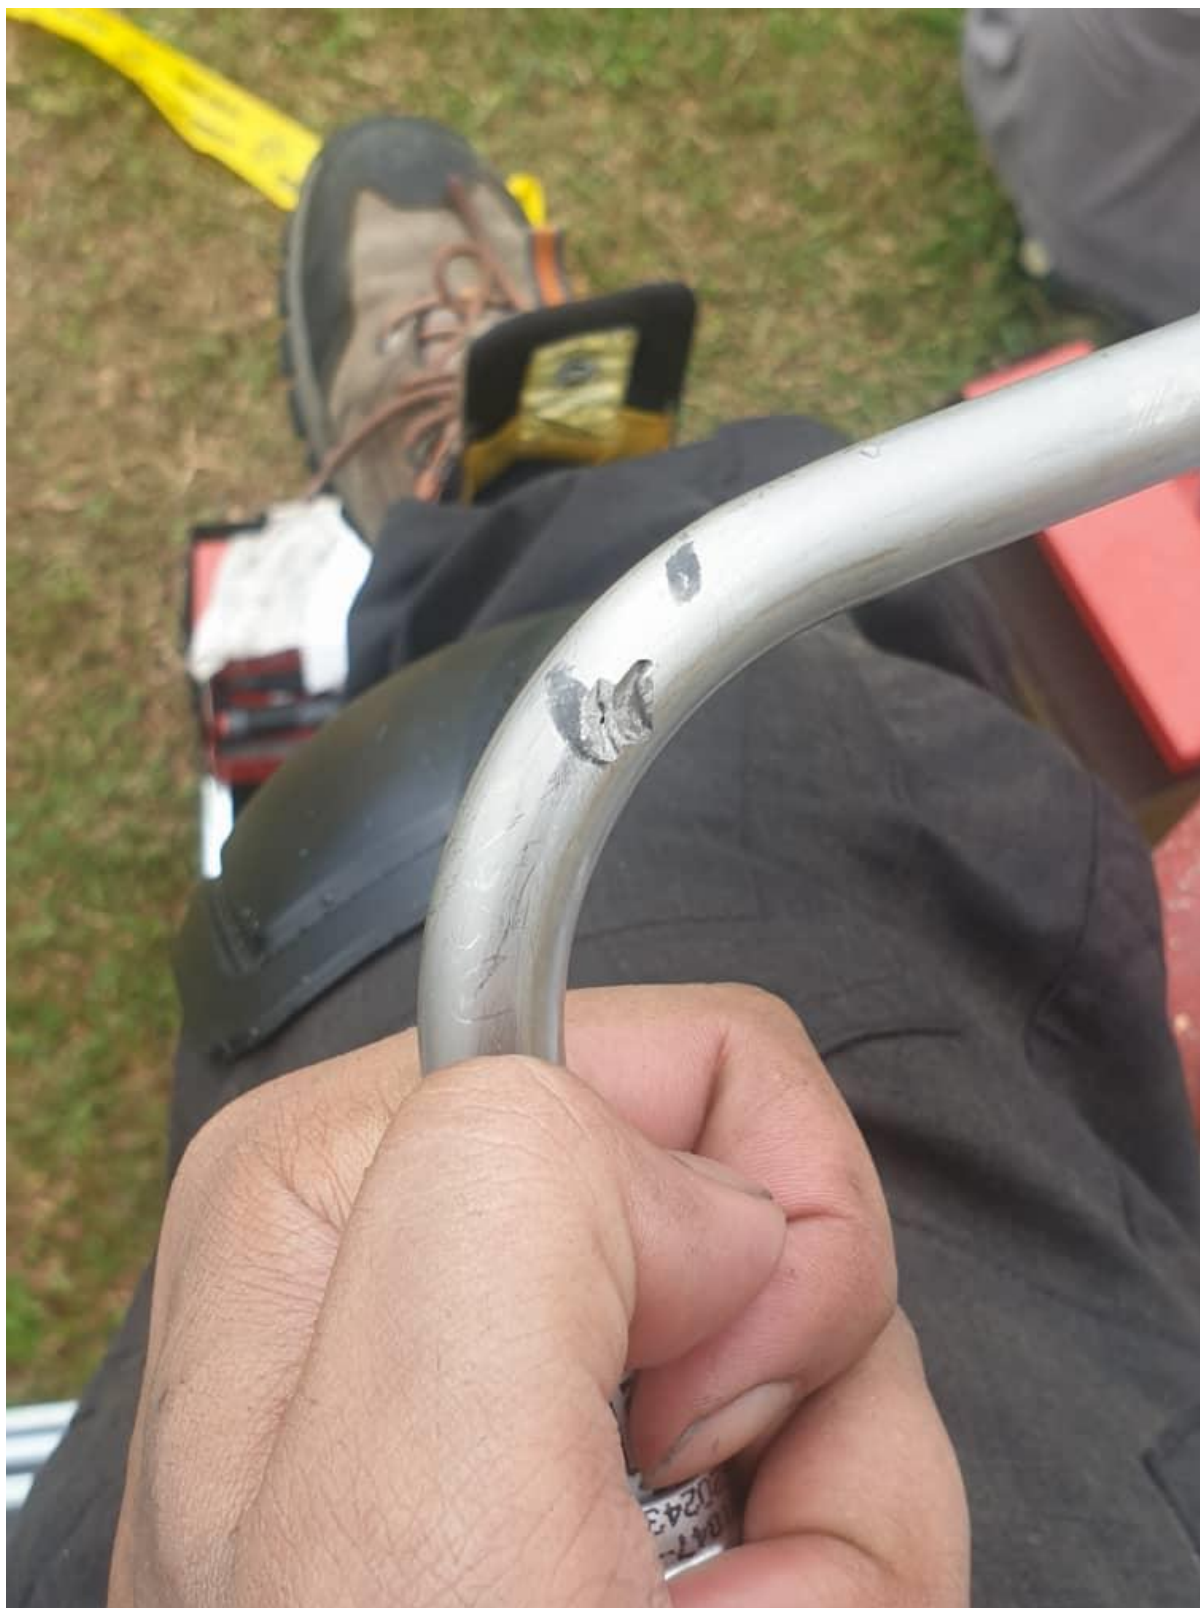
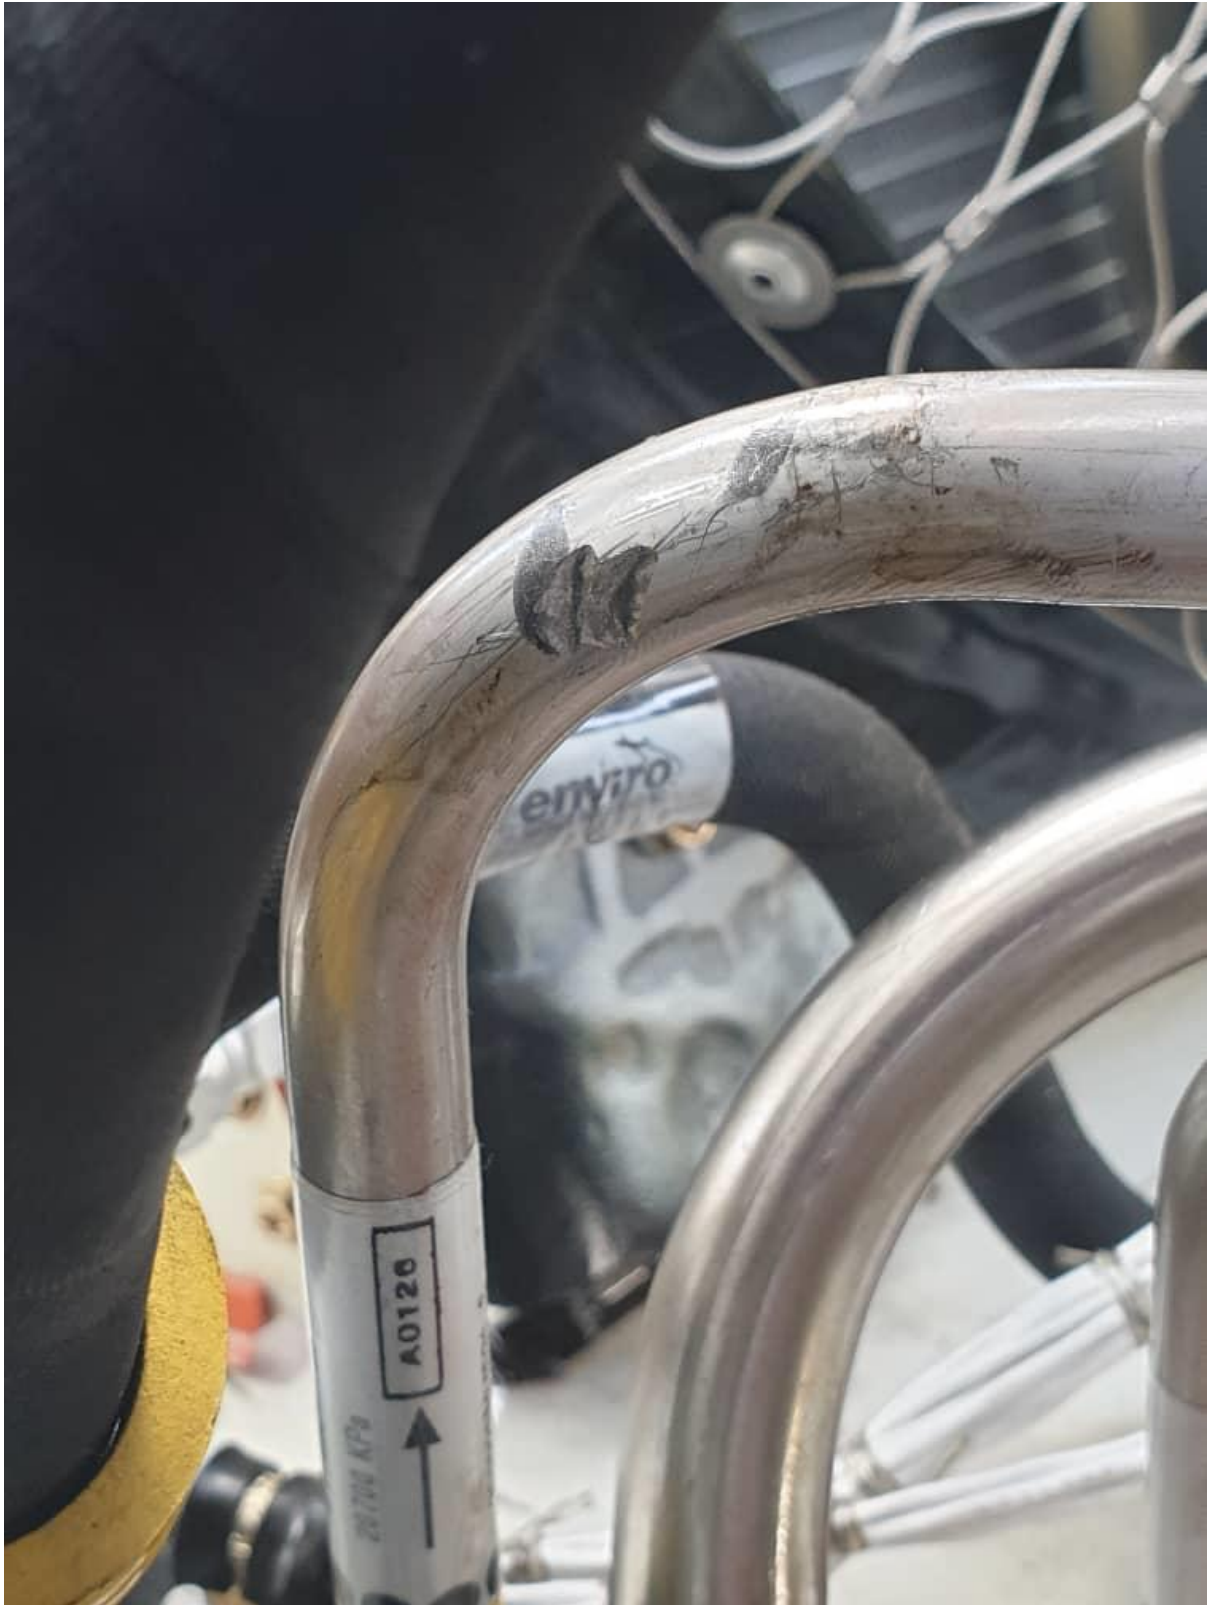
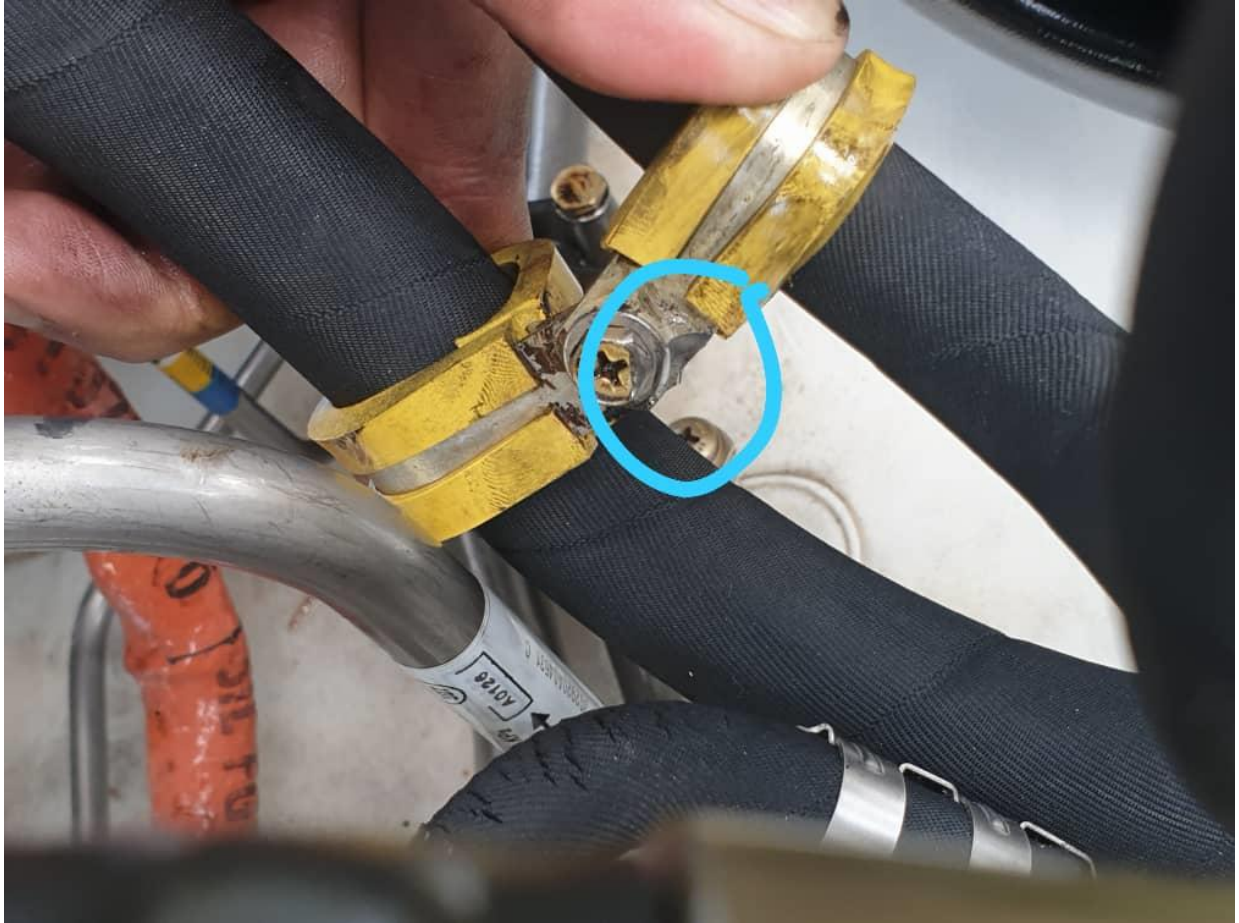
Attachment 1

3.0	<p>Investigation of Incident The aircraft was on operations Benteng, flight from Kapar to Tanjung Piandang and back to Subang airport. Upon reaching Pantai Remis approximately 5 to 6 NM from coastline on normal cruise, crew alert system appears caution message: utility hydraulic pressure low (HYD UTIL PRESS) illuminates and heard an abnormal noise suspected from MGB compartment. As a standard procedure crew opened quick reference handbook and followed all the action as stated. More cautions message appeared such as no. 2 hydraulic system pressure low (2 HYD OIL PRESS), no. 2 & no. 4 hydraulic pump failed (2 - 4 HYD PUMP), no. 2 hydraulic servo actuator in bypass (2 SERVO) and no. 2 hydraulic system fluid level low (2 HYD MIN). The abnormal noise was heard intermittently. Crew decided to land at Pantai Remis (SMK Dato' Idris Pangkalan Baru).</p> <p>Initial investigation indicated PCM No. 2 hydraulic quantity indicator stated zero level and maintenance personnel unable to determine the source of leaking. Aircraft was locked and cordoned on site while pilot and maintenance crew fly back to Subang base by 9M-PMD aircraft. On the same day, 5 Maintenance crew personnel (2 x LAE B1.3, 1 x B2 & 2 x Technician) was dispatch to site for aircraft recovery.</p> <p>After further troubleshooting, found out no. 4 hydraulic pump pressure line to PCM no. 2 found chaffing with air-conditioning hose clamp (Refer attachment 1).</p>

5.0	Topic	Discussion	Remarks
5.1	Aircraft Recovery	<ul style="list-style-type: none"> Dispatch 5 maintenance crew from base consist of 2 x LAE B1.3, 1 x B2, 2 x Technician. Affected area cleaned for detailed visual inspection. Visual inspection found damage on no. 4 hydraulic pump pressure line to PCM no. 2 chaffing with air-conditioning hose clamp. Replacement of damage pipeline. Replenished hydraulic fluid for EGR & troubleshooting. 	Awaiting EGR result

5.3	Permit to Fly	<ul style="list-style-type: none"> CAMM to ready for application on Permit to fly with condition to CAAM approval if necessary. 	-
5.4	Preventive Action	<ul style="list-style-type: none"> CAMO issue immediate instruction to inspect all AW139 fleet for chaffing on hose/pipeline. To verify the correct routing on air conditioning hose with another fleet. 	-
