**Our Ref. :** PSE/TQ/2021/31661 **Date:** 14 June 2021

**SUBJECT :** **AW139 S/N 31913 (TT 36,58 FH): Hydraulic System N° 2 Leakage**

**Subject:** Re: AW139 9M-PMF MSN 31913 - AIRCRAFT EMERGENCY LANDING DUE TO #2 HYDRAULIC SYSTEM LEAKING - CSR/2021/31660

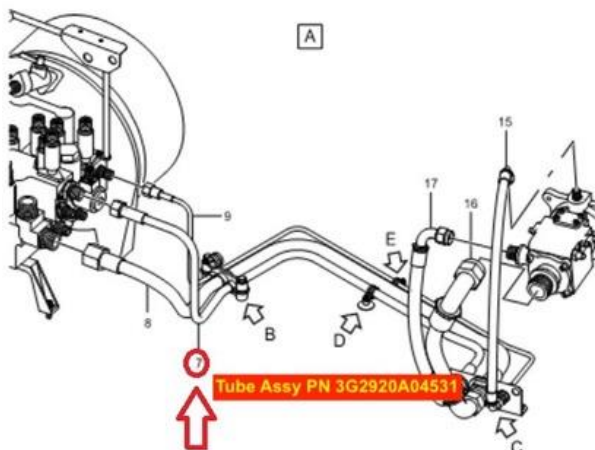
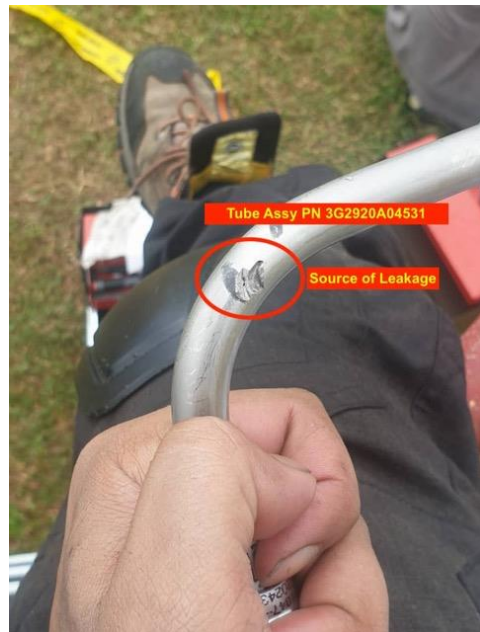
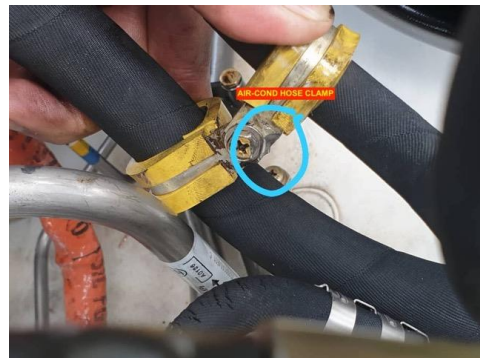
Maintenance carried out post-flight inspection and found that the source of leakage on #2 PCM is due to tube assy PN 3G2920A04531 found chaffing with air-conditioning hose clamp.

- Tube assy P/N 3G2920A04531 is replaced (refer to the applicable steps of AMP 39-A-20-40-00-00A-010A-A Standard practices - Hydraulic system - General data);
- The procedure detailed in Annex B is performed with no discrepancy;
- General visual inspection on upper deck area to detect possible presence of leakage is successfully performed. In case of findings, contact LH Service Engineering to receive proper corrective actions.

Replaced the tube assy PN 3G2920A04531 on #2 PCM.
