Directorate General Technical Airworthiness

AUDIT FINDINGS (2 of 5)

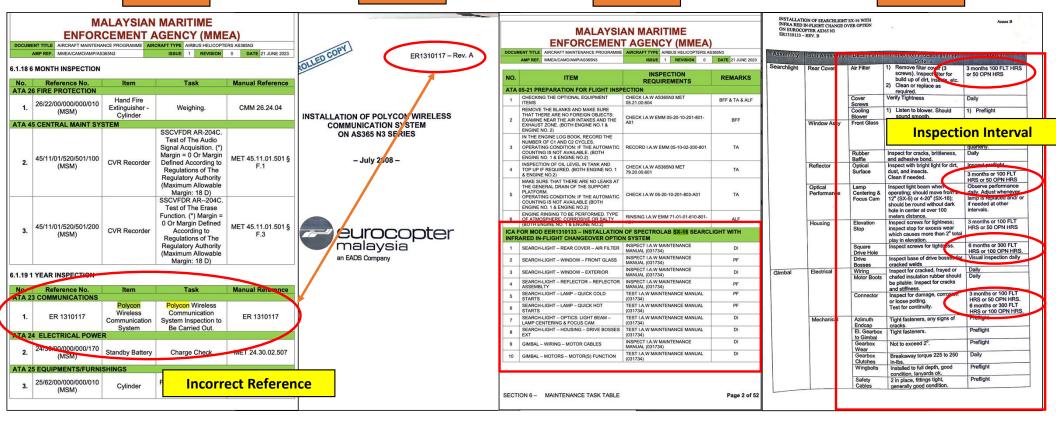
**REF #4**

b. There is requirement for inspection with several interval following the installation of the Searchlight SX-16 on the aircraft, as per Ref#3. However, according to Ref#4, the interval details for all maintenance activities have not been included in the AMP.		
	Thus, contrary with M.A.302(e).
