TECHNICAL INSTRUCTION COMPLIANCE	TIC REF NO	TIC-EC155-21-0053
		DATE ISSUE	21 JUL 2021

PUBLICATION TITLE	EASA - EC155B AIRWORTHINESS DIRECTIVES		
	ATA 65 - TAIL ROTOR -DOUBLE BEARING - INSPECTION/REPLACEMENT		
REV NO	EASA AD NO. 2021-0170, NEW ISSUE	REV. DATE	19 JULY 2021
APPLICABLE TO	<input checked="" type="checkbox"/> AC TYPE:	<input checked="" type="checkbox"/> AC S/N:	<input type="checkbox"/> ENG. TYPE:
	EC155	6583	
	<input type="checkbox"/> PROPELLER TYPE:	<input type="checkbox"/> PROPELLER S/N:	<input type="checkbox"/> APU TYPE:
	<input type="checkbox"/> COMPONENT:	<input type="checkbox"/> EQUIPMENT:	
DISTRIBUTIONS	<input checked="" type="checkbox"/> OPERATOR	<input checked="" type="checkbox"/> AMO	<input checked="" type="checkbox"/> CAMO
	<input type="checkbox"/> QUALITY	<input type="checkbox"/> OTHER:

AD No.: 2021-0170

ATA 65 – Tail Rotor – Double Bearing – Inspection / Replacement

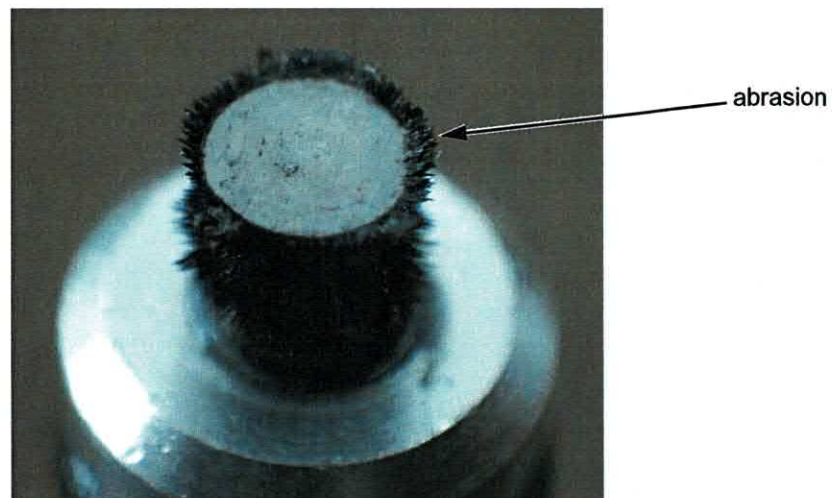
IN THE FLOW CHART, THE ABRASION PARTICLES (CLASS g AS PER MTC) MUST BE TAKEN INTO ACCOUNT IN ADDITION TO THE PARTICLE TYPES USUALLY TAKEN INTO ACCOUNT.

Figure 1: Example of abrasion on the chip detector

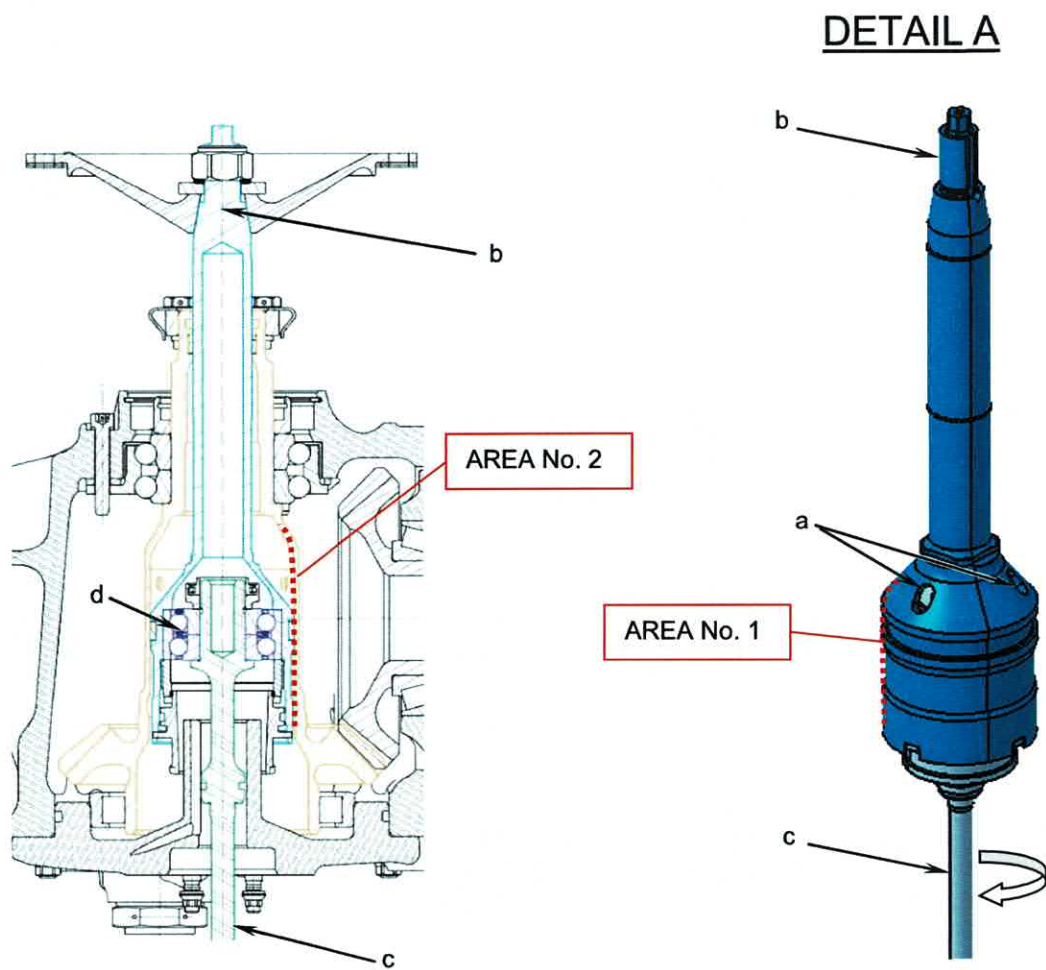
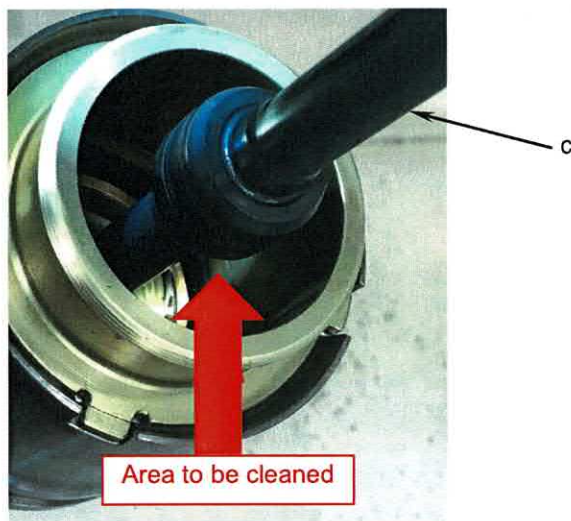
DETAIL B

Figure 2 (Washing of the double bearing)
