From:	<u>flight ops</u>
To:	Ismail Sulaiman (GAM/CTOO)
Cc:	<u>Shamsul Kamar Samsudin; hasnan@galaxyaerospace.my; emri@galaxyaerospace.my; azlizan; Admin</u> Department
Subject:	AW139 REGN 9M-YTL SN 41358 FUEL TANK CAP LANYARD
Subject.	AWISS REGN SMETTE SN 41550 TOLE TANK CAP LANTARD
Date:	Sunday, 28 November, 2021 9:33:13 PM

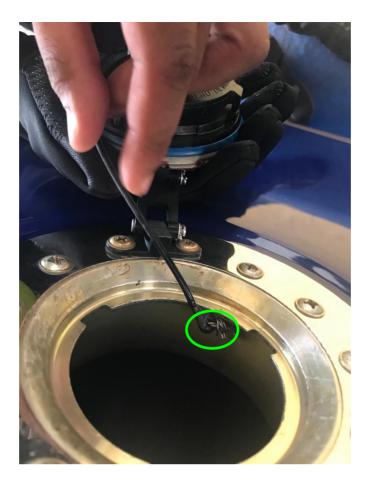
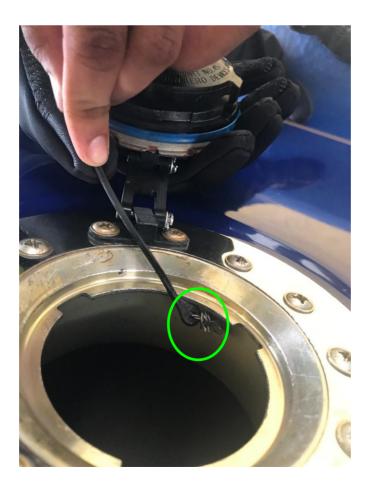
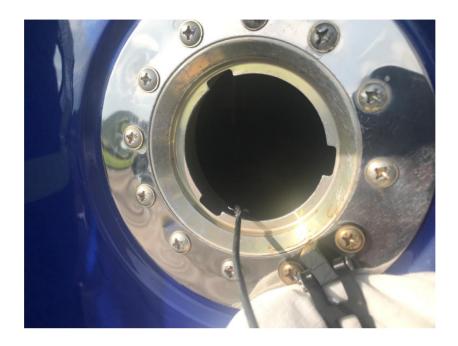
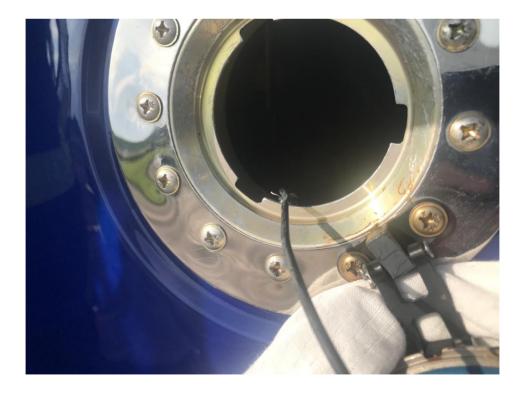
With reference to the above, we regret to have not received any defect, replacement or rectification report of **Fuel tank cap lanyard** on 9M-YTL. Today, during refuelling we noticed an unusual lanyard attached to the fuel cap with abnormal wirelock at the inner end.

Please investigate. We look forward to receiving your report and remedial action soonest.
