# **DEFECT REPORT**

## **LIGHTNING STRIKE ON AIRCRAFT**

| <b>Aircraft Type:</b> | BEEHCRAFT B300 (SUPER KING AIR 350) |
| <b>Aircraft Registration:</b> | 9M-PTB |

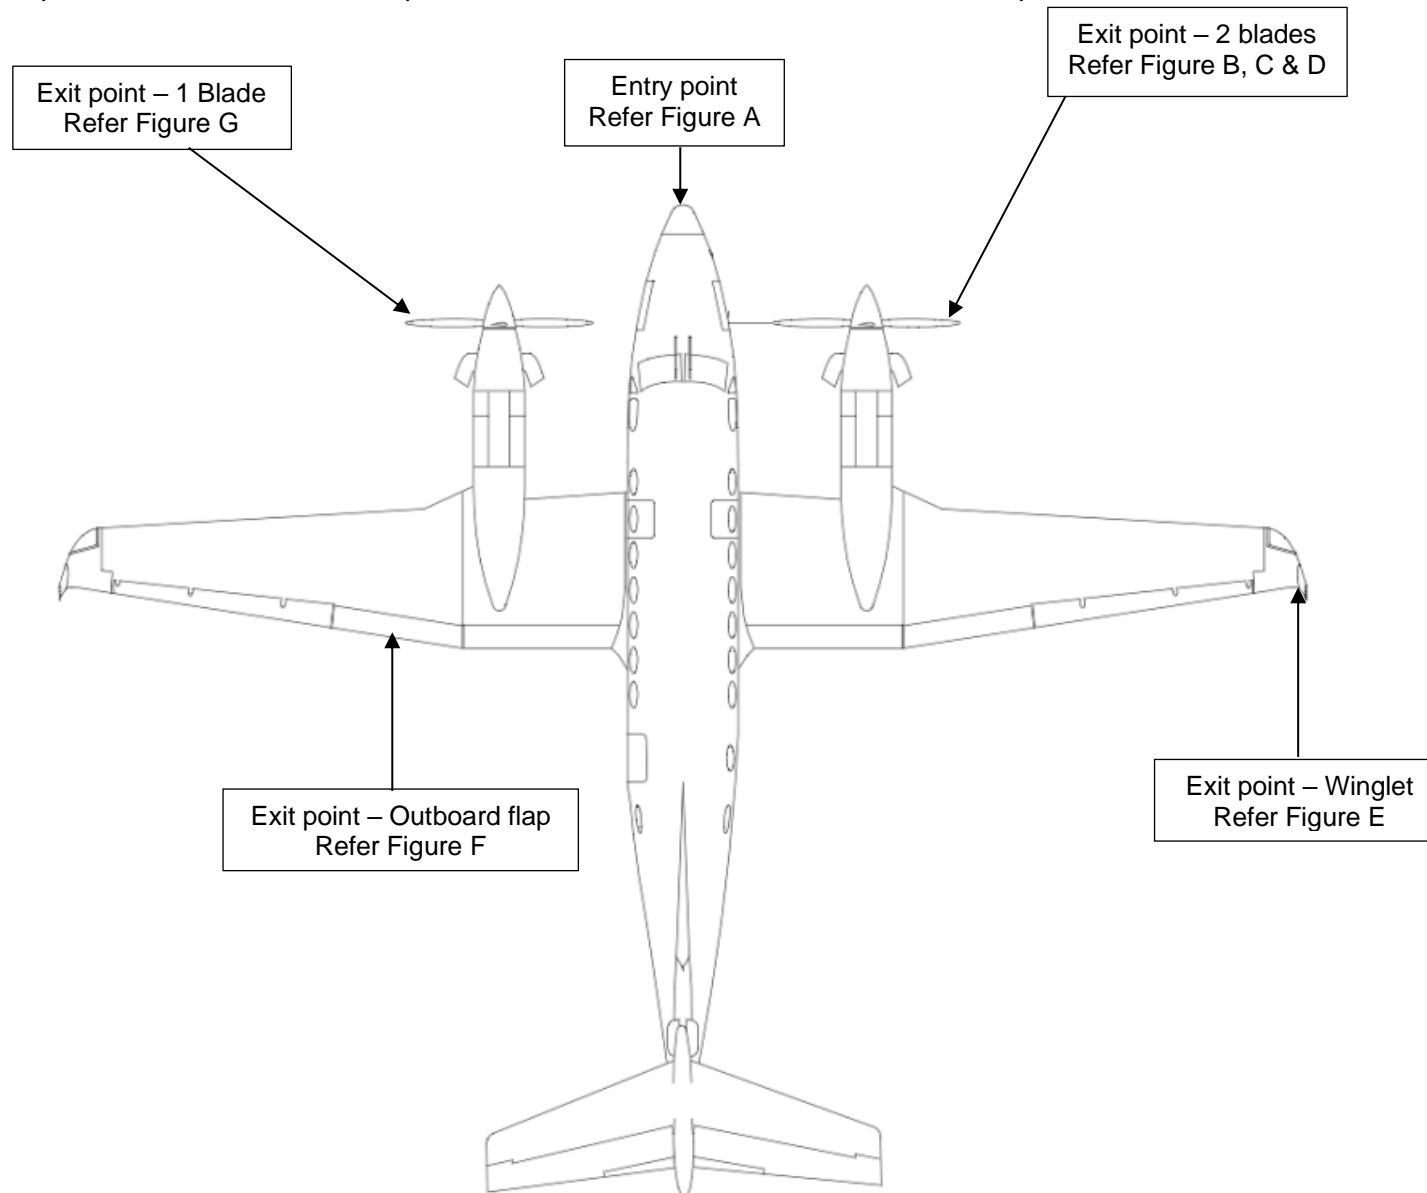
1. Based on the visual inspection, the aircraft was suspected to be struck on the nose radome. Refer picture below:

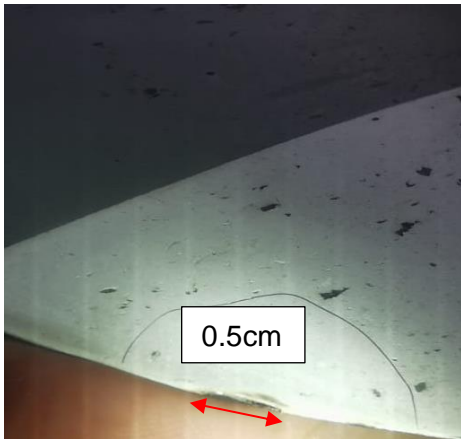
Figure B: Propeller blade

| NO. | COMPONENT | INSPECTION / CHECK | RESULT | REMARKS |
|---|---|--|---|--|
| 1. | PROPELLER | <ul style="list-style-type: none"> <li>• Inspect the propeller blades</li> <li>• Removed the propeller.</li> </ul> | <ul style="list-style-type: none"> <li>• Found <b>one pit</b> on the LH side and <b>three pits</b> on RH side propeller blade.</li> <li>• Propeller LH and RH side are <b>removed for overhaul.</b></li> <li>• Propeller governor are <b>removed for overhaul.</b></li> </ul> | <ul style="list-style-type: none"> <li>• Whenever the propeller has been struck by lightning, the propeller governor must be replaced or overhauled.</li> <li>• Refer to Woodward Service Bulletin 33574 or subsequent revision.</li> <li>• Textron recommend the propeller to be <b>SENT OUT</b> to manufacturer for overhaul as mention in AMM.</li> </ul> |

| NO. | COMPONENT | REMARKS |
|---|---|---|
| 1. | PROPELLER | <ul style="list-style-type: none"> <li>• Propeller to be inspect or replaced utilizing the Hartzell Standard practices manual 202A.</li> </ul> |

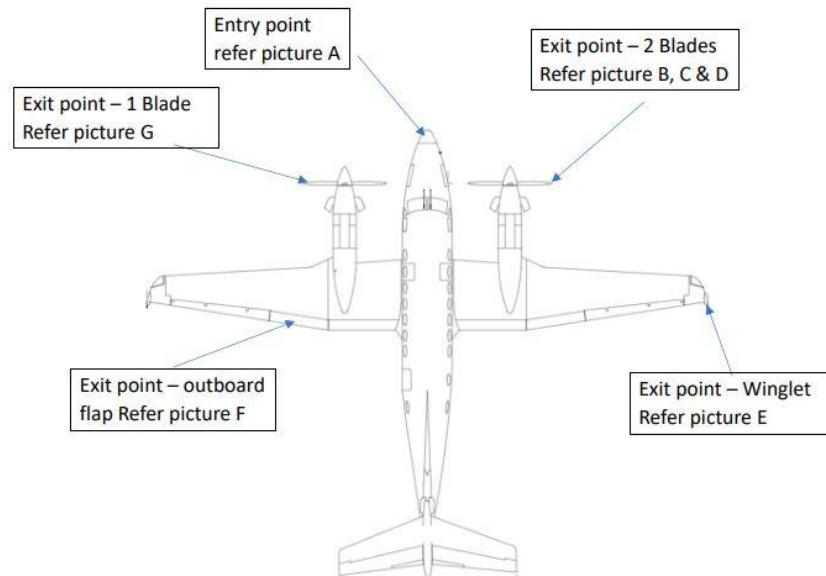
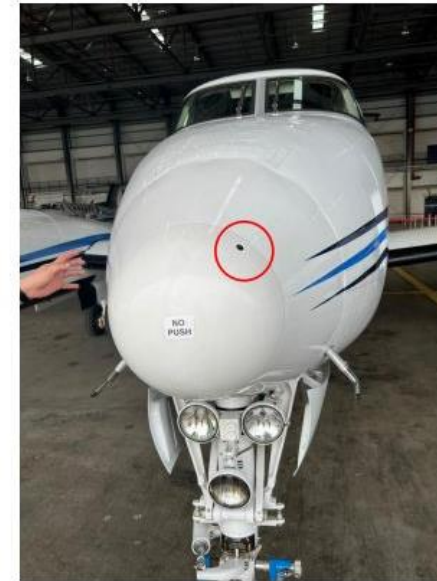
PICTURE A – ENTRY POINT

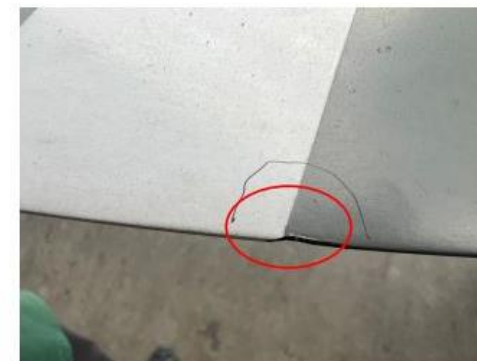
PICTURE B – EXIT POINT

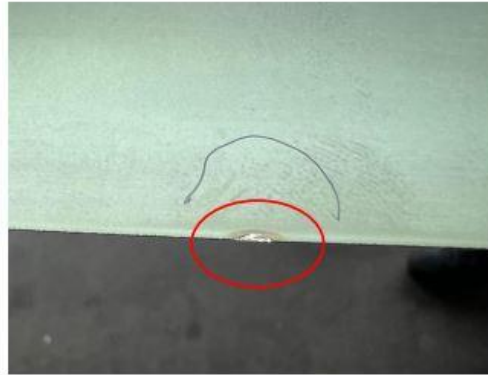
PICTURE C – EXIT POINT

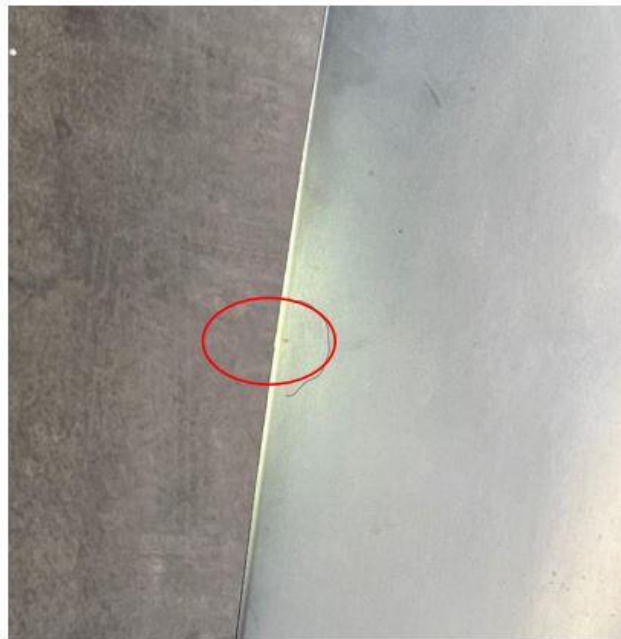
PICTURE D – EXIT POINT

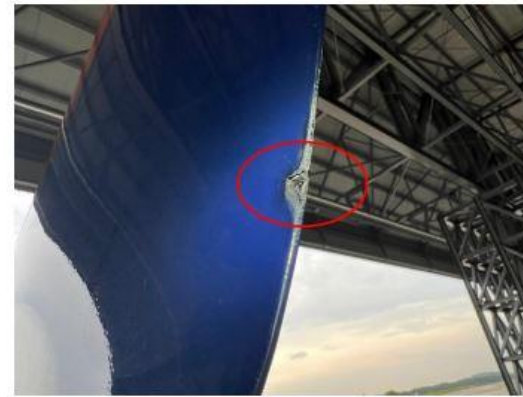
PICTURE E – EXIT POINT

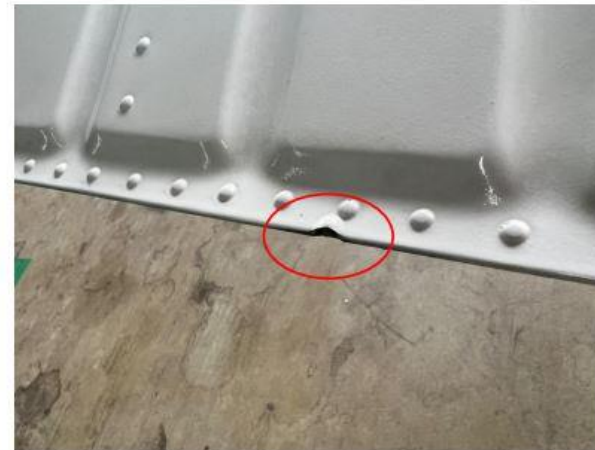
PICTURE F – EXIT POINT

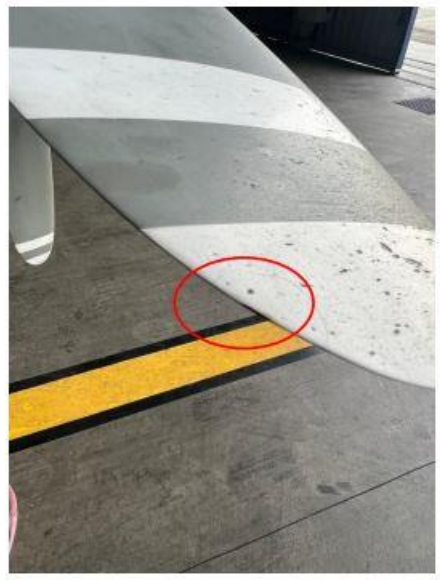
PICTURE G – EXIT POINT
