**DETAILS OF ACCIDENT/INCIDENT/OCCURRENCE/ISDR**

Aircraft type	:	<b>AW139</b>
Aircraft Registration	:	<b>9M-BOD</b>
Aircraft MSN	:	<b>31291</b>
A/F Hours	:	<b>2306:00</b>

- 1. Occurrence:** Pilot reported, an aircraft AW139 with registration 9M-BOD (SN: 31291) experienced Hoist Cable Cut Cartridge Exploded during Hoist Cut System ARM TEST on ground.

**ACCIDENT/INCIDENT/OCCURRENCE/  
ISDR REPORT**

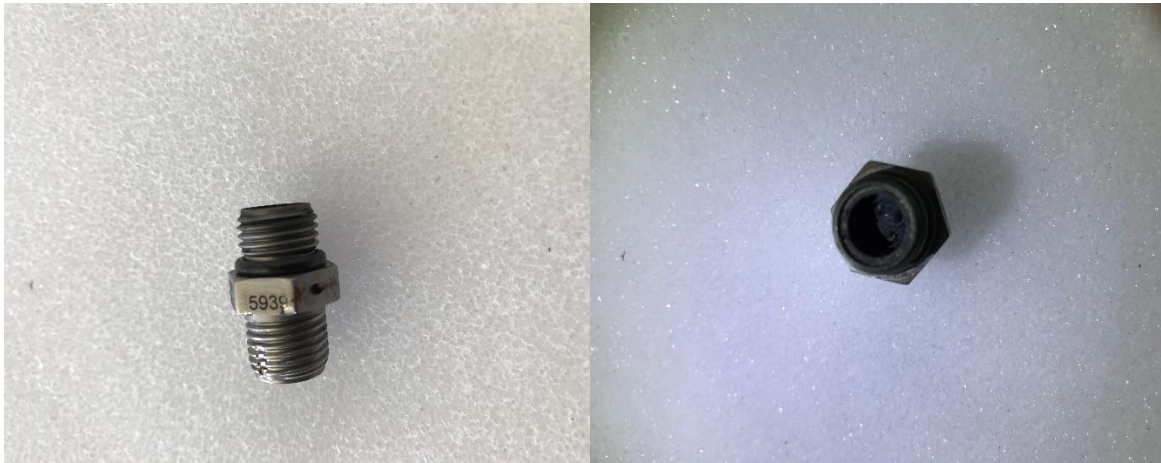
1. From the investigation and troubleshoot process, we have confirmed that the cartridge is activated due to electrical shortage between Hoist Guard Connector and Cable Cut connection at Terminal Block TB120 which causing the voltage is present at the connector cartridge. The aircraft was in airworthy and satisfactory condition except for the hoist.
2. The affected Hoist Assembly was removed from the aircraft
3. The aircraft will not be fitted with any Hoist Assembly until that Terminal Block is replace and wiring check need to be performed in order to confirm Hoist System Serviceability.
4. Items involved and need to be replaced:
  - a. Cable Assembly, P/N: 43225-298
  - b. Cable Cutter Assembly, P/N: 42315-75-1
  - c. Cartridge, P/N: 42315-281
  - d. Packing, P/N: M28778-5
  - e. Connector Receptacle (Terminal Block TB120), P/N: 30-271-01WPN

**FIGURE 3 – CARTRIDGE EXPLODED**

1. Wiring check shall be carried out prior to installation of Hoist Assembly in the future
