DETAILS OF ACCIDENT/INCIDENT/OCCURRENCE/ISDR	
Date	: 15-3-2021
Time	: 1800 HRS
Place	: JBPM MIRI HANGAR

AIRCRAFT INFORMATION	
Aircraft type	: AW139
Aircraft Registration	: 9M-BOD
Aircraft MSN	: 31291
A/F Hours	: 2683:21

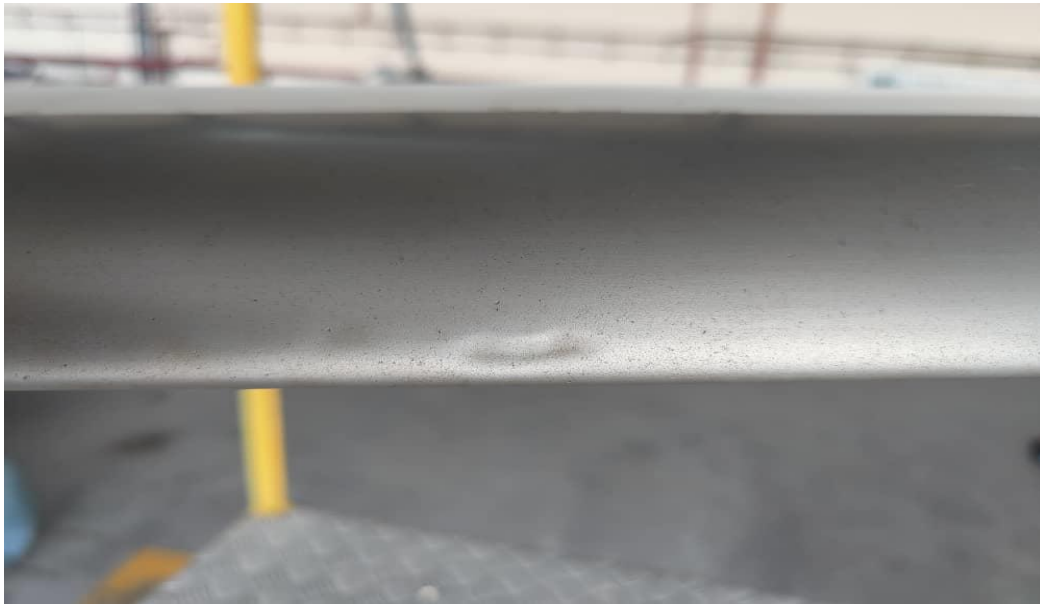
DESCRIPTION OF EVENTS
<p>INTRODUCTION:</p> <ol style="list-style-type: none"> Occurrence: LAE reported, an aircraft AW139 with registration 9M-BOD (SN: 31291) experienced Main Rotor Blade (WHITE) dented on leading edge abrasion strip. Observation before and during incident: The aircraft was flown from Renggit, Johor Bharu to Miri, Sarawak. The aircraft departed from Subang Base on 20-Feb-21 and arrived at Miri on 21-Feb-21. Once landed, the aircraft was parked inside the JBPM Hangar, Miri Base. LAE involved was performing blade cleaning when he found one of the blades dented due to FOD. Observation post incident: Detail inspection was performed on the affected blade to evaluate the area of damages. The details inspection extended to others blade and aircraft fuselage. NIL additional damage found. <p>OBSERVATION:</p> <ol style="list-style-type: none"> A preliminary check was carried out by our LAE, confirmed the dented was cause by FOD. Further investigation needs to be carried out to confirm area of damages.

FIGURE 1 – BLADE DENTED

1. Further investigation was carried out as per AW139 AMP 39-A-62-11-01-00A-31AA-B, Main Rotor Blade Detailed Inspection
2. Dented was measured, found damage within limitation.
 - a) Dented Area – 0.7 cm² (limit, 1.0 cm²)
 - b) Depth – 0.4 mm (limit, 0.7 mm)
 - c) No area debonded found
3. Repetitive inspection shall be carried out on Daily Inspection to monitor the damaged.

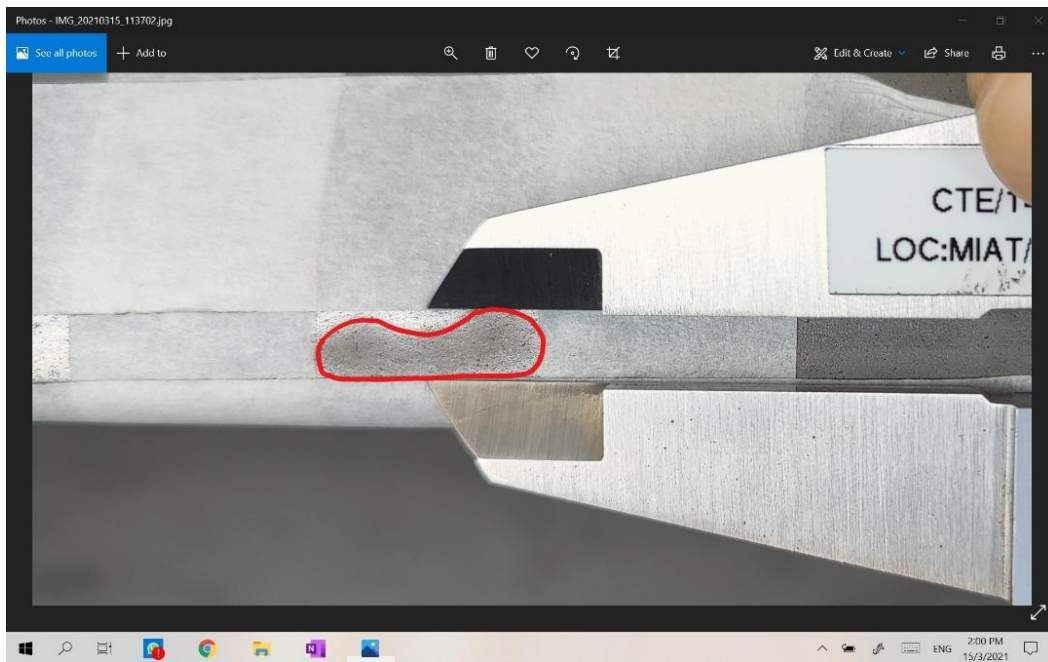
FIGURE 2 – EXACT AREA OF DENTED
