## BOLLETTINO TECNICO

N° **139-467**

**TAIL ROTOR DRIVE LINE (TRDL) BEARING SUPPORT BRACKET**

## B.T. 139-467 Rev. A

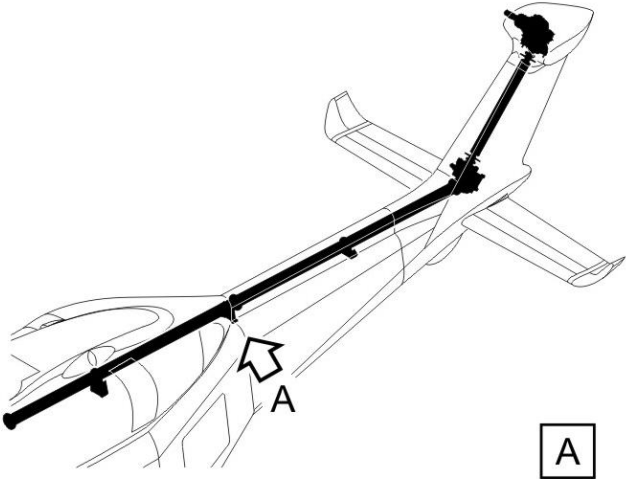
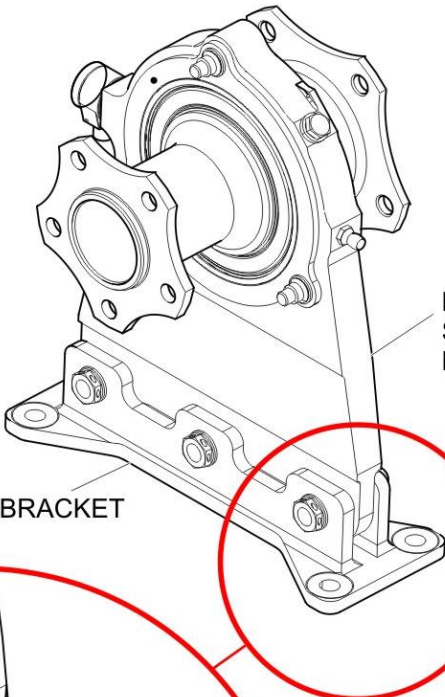
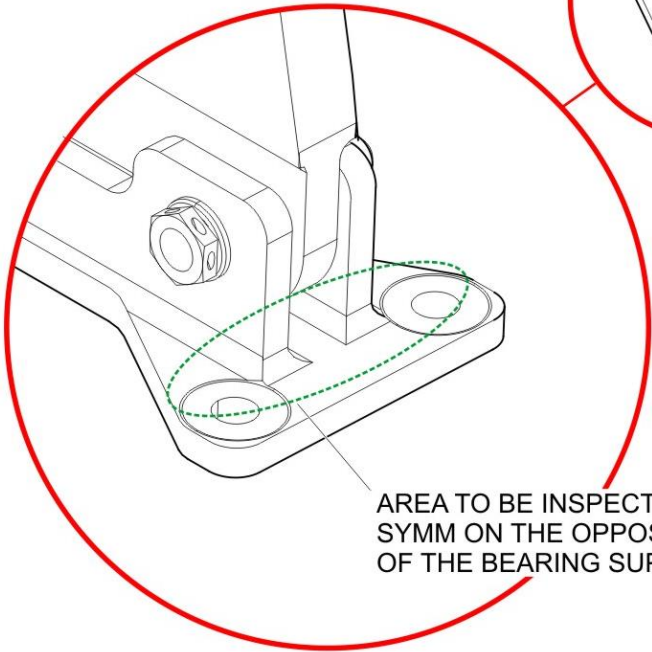
Figure 1

Cases of cracks in the bearing support have been reported in service.

- 3.3 Perform the visual inspection for cracks of the bearing support bracket according to figure 1, using a magnifying glass and a strong light.
4. If you do not find any crack, go to step 5, otherwise do as follows:

AREA TO BE INSPECTED  
SYMM ON THE OPPOSITE SIDE  
OF THE BEARING SUPPORT BRACKET

- 4.1 Replace the bearing support bracket. Refer to AMP DM n° 39-B-65-11-11-

- 4.2 Return the defective bearing support bracket to LHD. Contact Product Support Engineering ([CSE.AW139.AW@leonardocompany.com](mailto:CSE.AW139.AW@leonardocompany.com)) for the appropriate instruction to return defective components.
5. Install access panel 310AL. Refer to AMP, see DM n° 39-A-06-41-00-00A-010A-A.
6. Remove the platform from the right side of the fuselage.
7. Return the helicopter to flight configuration and record for compliance with part I of this Bollettino Tecnico on the helicopter logbook.

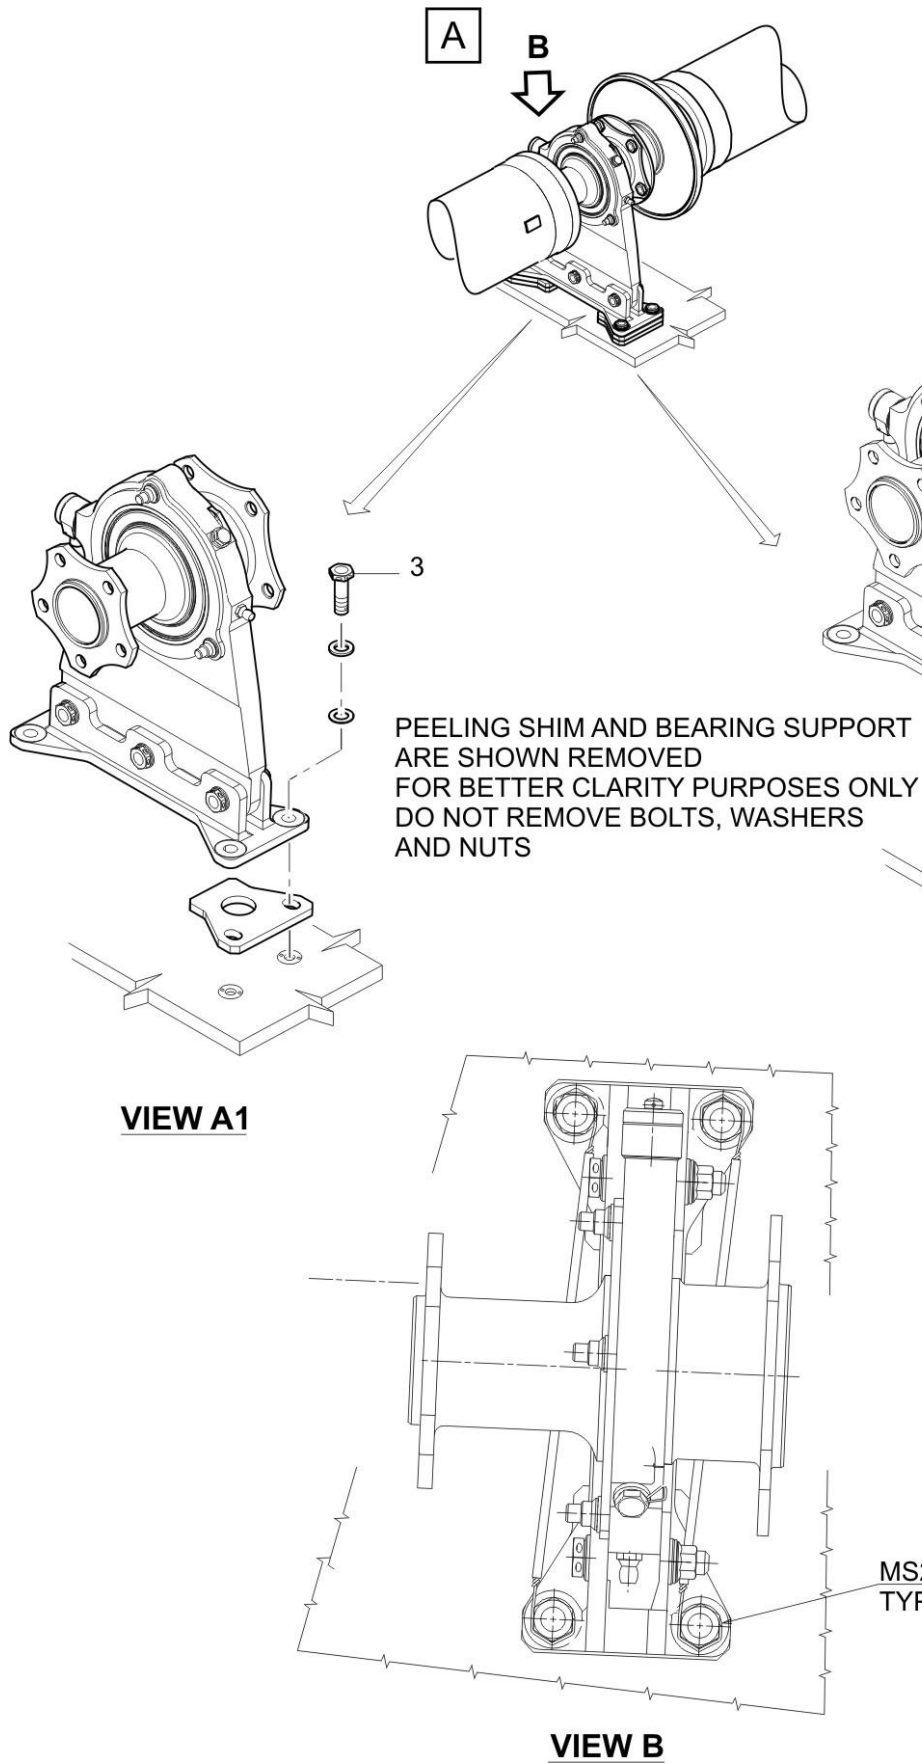
Figure 2

2. With reference to figure 2 view A2, check the torque of the four nuts (1) that fix the bearing support bracket as follows:
  - 2.1 Open access panel 183AL or 184AR and remove access panel 190AL to get access to the work area.

- 2.6 Check the torque of the four nuts. Make sure that the torque value is between 6.78 and 9.60 Nm (60.00 thru 85.00 lbf in).
  - 2.7 Report any under-torque / over-torque cases to LHD; contact Product Support Engineering ([CSE.AW139.AW@leonardocompany.com](mailto:CSE.AW139.AW@leonardocompany.com)). Safety the four nuts with four new cotter pins P/N MS24665-136.

- NOTE**
- Record the lockwire installation scheme before performing following step 3.5.
- 3.5 Remove the lockwire from the four bolts (3).
  - 3.6 Check the torque of the four bolts. Make sure that the torque value is between 6.78 and 9.60 Nm (60.00 thru 85.00 lbf in).

- 3.8 Safety the four bolts with lockwire P/N MS20995C32 according to figure 2 view B.
  - 3.9 Seal the bolts using Proseal 890A or Proseal 700.
  - 3.10 Apply corrosion protection compound MIL-PRF-16173 grade 1 on the exposed/not sealed parts of the bolt heads and washers where applicable, ensuring to cover their surface completely with an homogenous and gap free layer. Make sure to guarantee 2 mm overlap over the mating surfaces.
