## SERVICE BULLETIN

## № 139-601

**DATE:** December 21, 2021 **REV.:** A - May 11, 2022

## ATA 33 - INSPECTION AND REINFORCEMENT OF SEARCHLIGHT SUPPORT

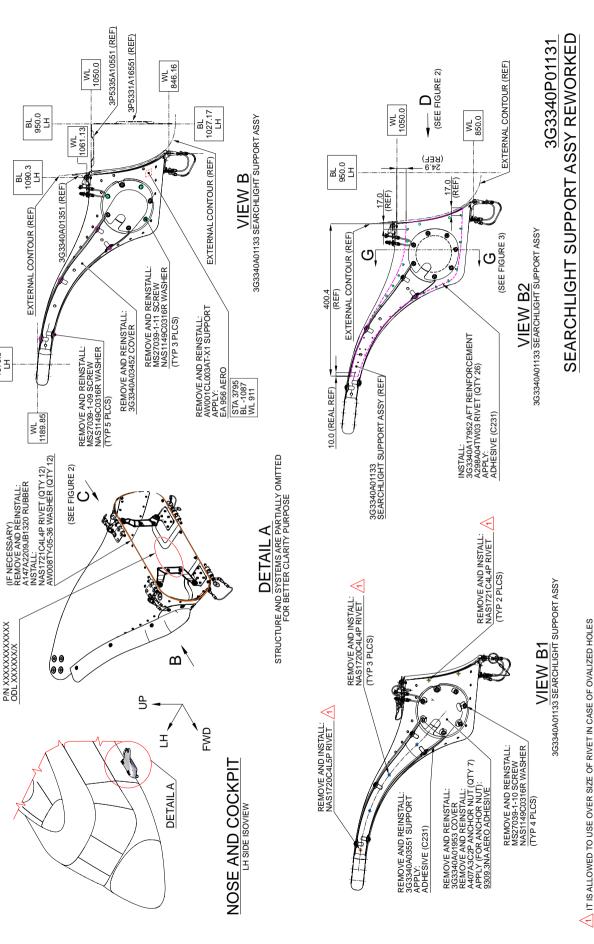
The "Ordine di Lavoro" is marked inside the support searchlight assy (refer to Figure 1 Detail A).

4. With reference to Figure 1 Detail A, check the "Ordine di Lavoro" marked inside the support searchlight assy.

- 5. Perform a visual inspection of the searchlight support assy and check for any crack or damage in the FWD area of the support.
- In case of finding, record for compliance with Part I of this Service Bulletin on the helicopter logbook and immediately skip to Part II of this Service Bulletin. Otherwise, perform following Step 7.

- 4. With reference to Figures 1 and 2, gain access to the area affected by the installation and perform searchlight support assy rework P/N 3G3340P01131 as described in the following procedure:
  - 4.1 With reference to Figure 1 View B, remove and retain for later reuse the cover P/N 3G3340A03452, n°5 screws P/N MS27039-1-09, n°3 screws P/N MS27039-1-11 and n°8 washers P/N NAS1149C0316R from the searchlight support assy.
  - With reference to Figure 1 View B1, remove and retain for later reuse the cover
     P/N 3G3340A01953, n°4 screws P/N MS27039-1-10 and n°4 washers
     P/N NAS1149C0316R from the searchlight support assy.
  - 4.3 With reference to Figure 1 View B, remove and discard support P/N AW001CL003AT-X1 from the searchlight support assy.
  - 4.4 With reference to Figure 1 View B1, remove n°7 anchor nut P/N A407A3C2P from the searchlight support assy.

4.5 With reference to Figure 1 Detail A, remove the rubber P/N A147A2209JB1320.

4.6 With reference to Figure 1 View B1, remove and retain for later reuse the support P/N 3G3340A03551 and remove and discard the rivet P/N NAS1720C4L5P, n°3 rivets P/N NAS1720C4L4P and n°2 rivets P/N NAS1721C4L4P from the searchlight support assy.

- 4.11 With reference to Figure 1 View B2 and in accordance with dimension shown, install the AFT reinforcement P/N 3G3340A17952 on the searchlight support assy by means of adhesive (C231).
- 4.12 With reference to Figure 1 View B2, fix the AFT reinforcement P/N 3G3340A17952 on the searchlight support assy by means of n°26 rivets P/N A298A04TW03.

- 4.19 With reference to Figure 1 View B1, fix the support P/N 3G3340A03551 on the searchlight support assy by means of the rivet P/N NAS1720C4L5P and n°3 rivets P/N NAS1720C4L4P.
- 4.20 With reference to Figure 1 View B1, install n°7 anchor nuts P/N A407A3C2P on the searchlight support assy by means of adhesive EA 9309.3NA AERO.
- 4.21 With reference to Figure 1 View B1, install the cover P/N 3G3340A01953 previously removed on the searchlight support assy by means of n°4 screws P/N MS27039-1-10 and n°4 washers P/N NAS1149C0316R previously removed.
- 4.22 With reference to Figure 1 View B, install support P/N AW001CL003AT-X1 on the searchlight support assy by means of adhesive EA 956 AERO.

4.23 With reference to Figure 1 Detail A, install rubber P/N A147A2209JB1320 on the searchlight support assy by means of adhesive EC1357, n°12 washers P/N AW008TY-05-36, n°12 rivets P/N NAS1721C4L4P.

- 4.24 With reference to Figure 1 View B, install the cover P/N 3G3340A03452 previously removed on the searchlight support assy by means of n°5 screws P/N MS27039-1-09, n°3 screws P/N MS27039-1-11 and n°8 washers P/N NAS1149C0316R previously removed.
- 4.25 With reference to Figure 1 Detail A, remark the reworked searchlight support assy as P/N 3G3340P01131 by means of an indelible pen.
- 5. If necessary, in accordance with AMP DM 39-L-33-49-04-00A-720A-K, install the power conditioning interface unit on the searchlight support assy.
