SERVICE BULLETIN

N° 139-661

ATA 24 – OVERHEAD PANEL INSPECTION

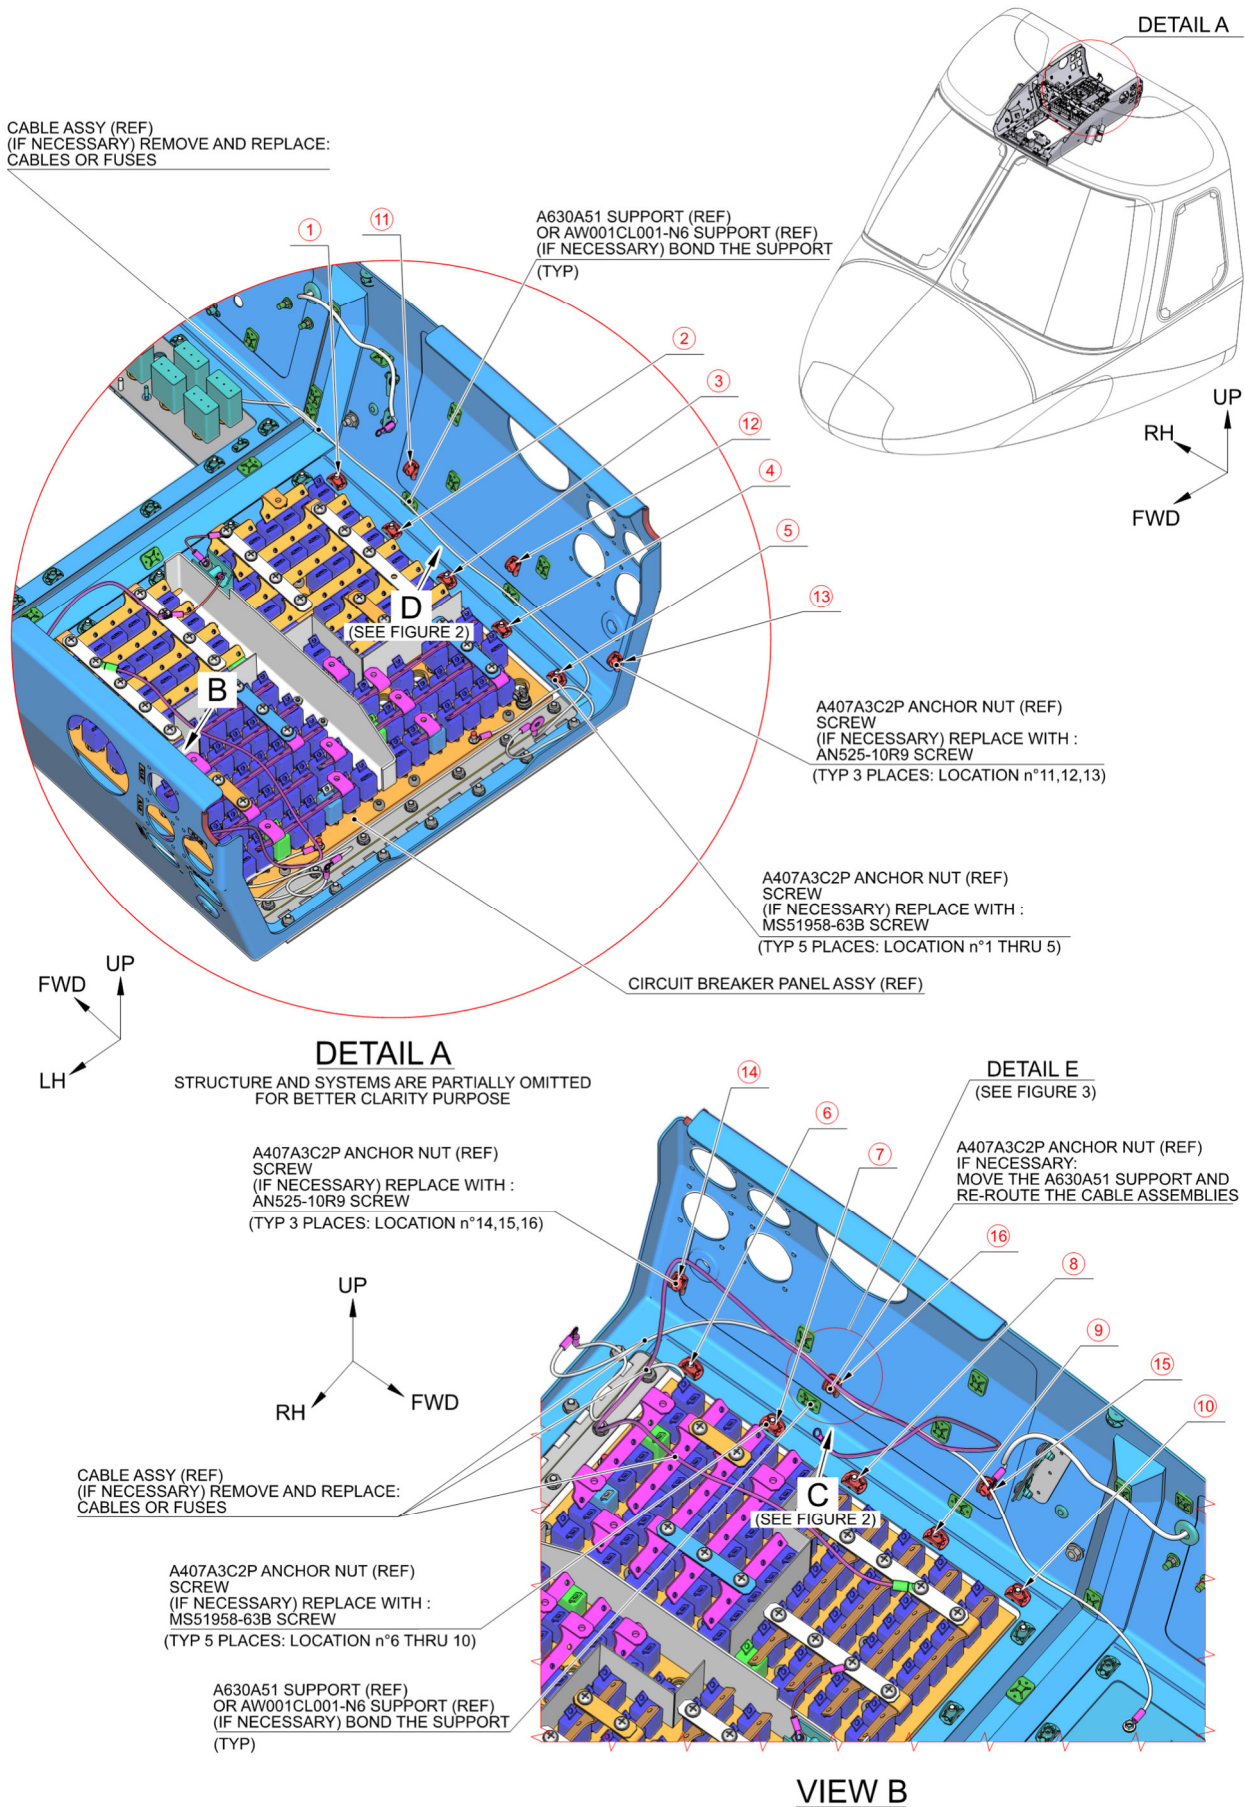
This Service Bulletin is issued in order to prescribe an inspection of the overhead panel cable harnesses, anchor nuts, screws and supports, to locate potential chafing conditions.

- 2.3 With reference to Figure 1 Detail A and View B, check the length of the screws (removed in the previous step 2.1) at the indicated locations from n°11 thru n°16, if applicable:
 - 2.3.1 Make sure that each screw is long 15.06 mm or less.

- 2.3.2 If the length is not less than 15.06 mm replace each affected screw with a new one P/N AN525-10R9.
- 2.4 With reference to Figure 1 Detail A and View B, remove the screws at the indicated locations from n°1 thru n°10 and check their length:
 - 2.4.1 Make sure that each screw is long 12.7 mm or less.

- 2.4.2 If the length is not less than 12.7 mm replace each affected screw with a new one P/N MS51958-63B.
- 2.5 With reference to Figure 1 Detail A and View B, re-install n°6 screws, if applicable, in their respective anchor nuts P/N A407A3C2P at the indicated locations from n°11 thru n°16 without the lining panels previously removed at step 2.1
- 2.6 With reference to Figure 1 Detail A and View B, re-install n°10 screws in their respective anchor nuts P/N A407A3C2P at the indicated locations from n°1 thru n°10, keeping the circuit breaker panel assy open.
- 2.7 With reference to Figure 1 Detail A and View B, check for chafing damage of the cable harness and ensure that clearance exists between the cable harness and the anchor nuts P/N A407A3C2P and/or the screws at the indicated locations from n°1 thru n°16.

- 2.8 With reference to Figure 1 Detail A and View B, remove and replace the damaged cables or fuses.
- 2.9 With reference to Figure 1 View B and to Figure 3 Detail E, measure at the indicated location n°16, on the LH side, the clearance between the anchor nut P/N A407A3C2P and the cable harnesses including a check of the mutual position.

Perform the following step 2.10 if the clearance is NOT at least 10.0 mm and/or if the cable harnesses is installed BELOW the anchor nut.

- 2.10 With reference to Figure 1 View B, move the existing support P/N A630A51 or P/N AW001CL001-N6, as applicable, and re-route the cable harnesses in order to respect the clearance of at least 10.0 mm and guarantee the installation ABOVE the anchor nut.
- 2.11 With reference to Figure 1 Detail A and View B, check that all the supports P/N A630A51 and P/N AW001CL001-N6, as applicable, on the LH and RH side are soundly bonded to the panel with no evidences of detachment or delamination.

- 2.13 With reference to Figure 1 Detail A and View B, to Figure 2 View C and View D, apply n°2 layers of the white tape P/N AW005ME04T05305 on n°10 anchor nuts P/N A407A3C2P (n°5 on the LH side and n°5 on the RH side).
- 2.14 With reference to Figure 1 Detail A and View B, to Figure 2 View C and View D, apply n°2 layers of the white tape P/N AW005ME04T05305 on each of the n°6

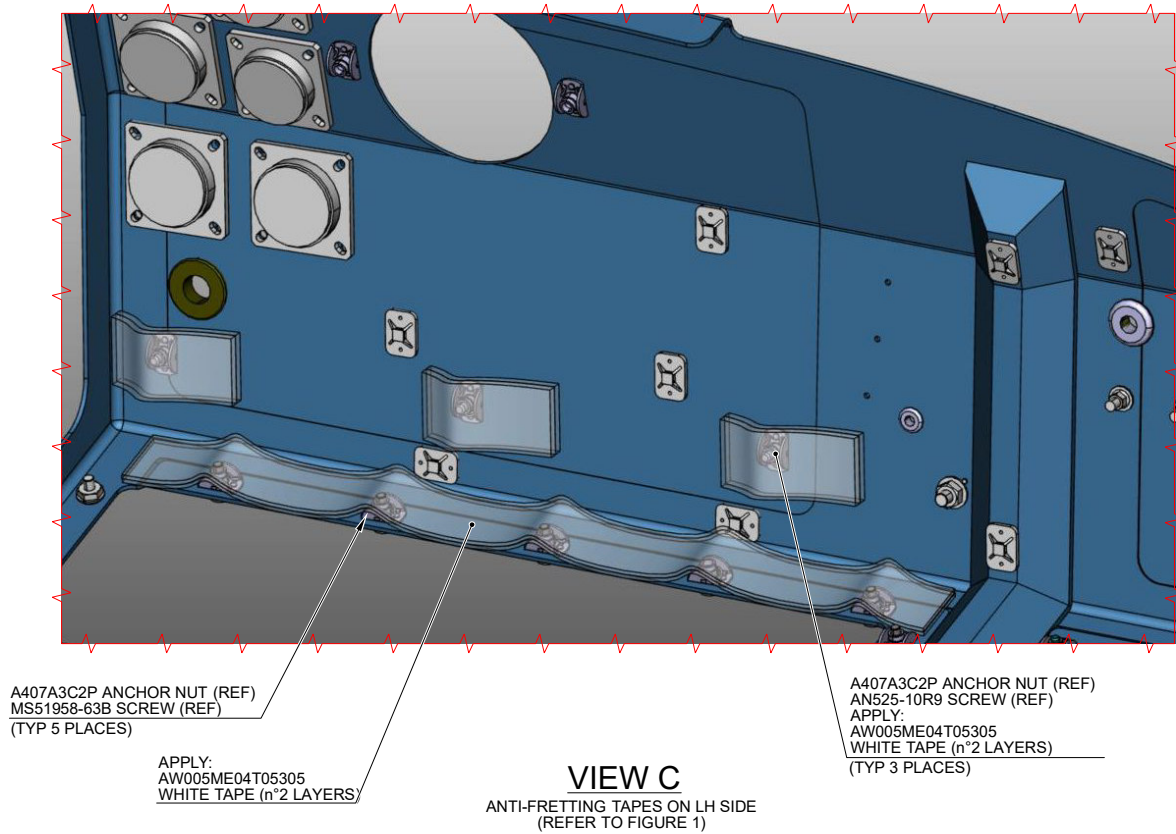
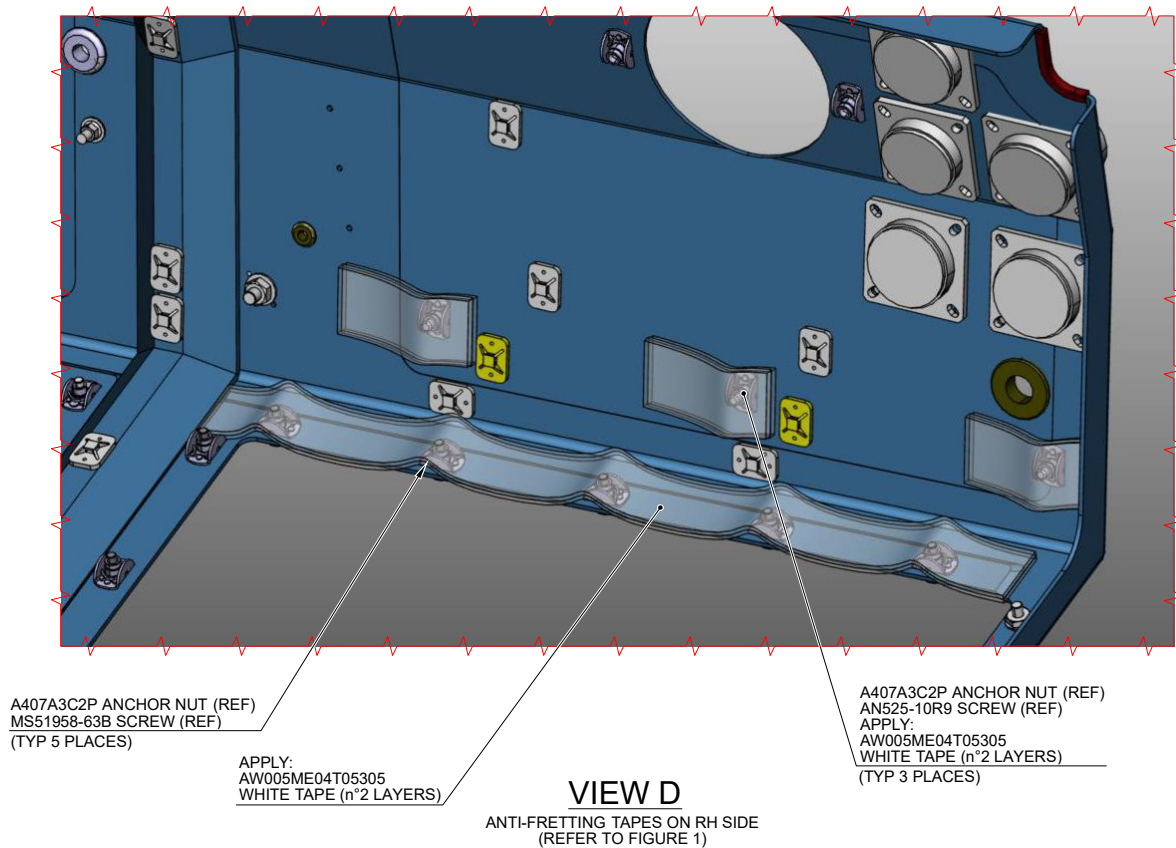
- 2.3 With reference to Figure 1 Detail A and View B, to Figure 2 View C and View D, check for the condition of the n°2 layers of the white tape P/N AW005ME04T05305 on n°10 anchor nuts P/N A407A3C2P (n°5 on the LH side and n°5 on the RH side).

- 2.4 With reference Figure 2 View C, remove n°2 layers of the white tape from the anchor nuts and apply in the same position n°2 new layers of the white tape P/N AW005ME04T05305.

- 2.5 With reference to Figure 2 View D, repeat step 2.4 for the RH side.
- 2.6 With reference to Figure 1 Detail A and View B, to Figure 2 View C and View D, check for the condition of the n°2 layers of the white tape P/N AW005ME04T05305 on each of the n°6 anchor nuts P/N A407A3C2P (n°3 on the LH side and n°3 on the RH side).
