SERVICE BULLETIN

№ 139-661

DATE:	February 4, 2021			
REV. :	A - February 18, 2021

ATA 24 – OVERHEAD PANEL INSPECTION

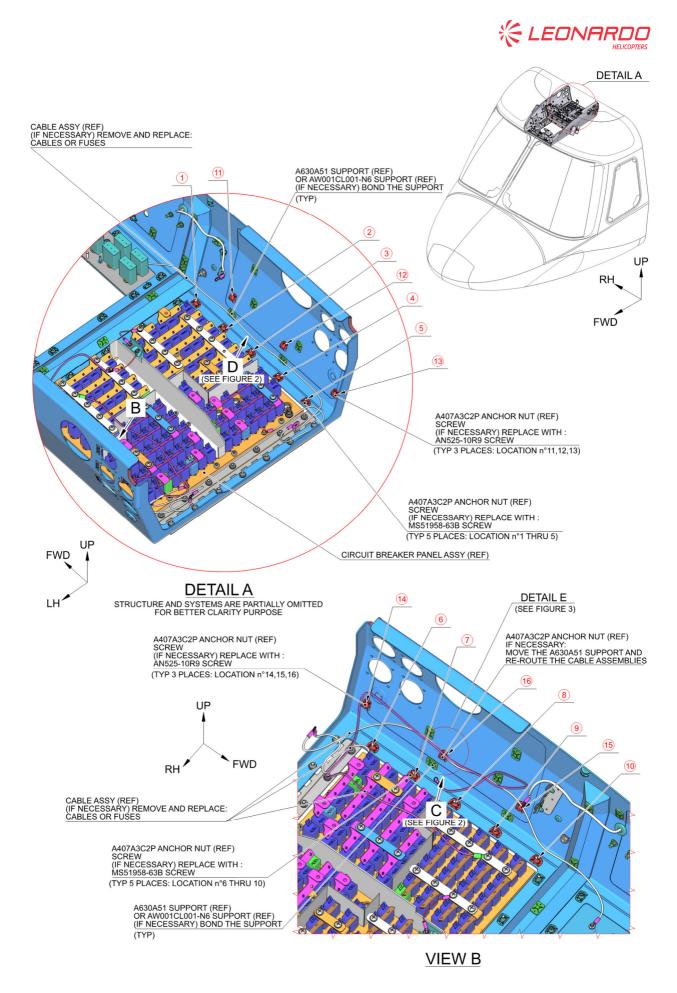
This Service Bulletin is issued in order to prescribe an inspection of the overhead panel cable harnesses, anchor nuts, screws and supports, to locate potential chafing conditions.

- 2.3.2.2 With reference to Table 3, if less than 2 screw thread pitches remain visible, install one grip more than the identified screw.
- 2.3.2.3 With reference to Table 3, if more than 4 screw thread pitches remain visible, install one grip less than the identified screw.
- 2.3.2.4 Repeat the visual check and the steps 2.3.2.2 and 2.3.2.3 until the correct screw P/N is identified from Table 3 and the screw thread pitches visible from the anchor nut are 2, 3 or 4.
- 2.3.2.5 If no screws from Table 3 satisfy the requirement of step 2.3.2.4 contact the Product Support Engineering (engineering.support.lhd@leonardocompany.com).
- 2.4 With reference to Figure 1 Detail A and View B, check for chafing damage of the cable harness and ensure that clearance exists between the cable harness and the anchor nuts P/N A407A3C2P and/or the screws at the indicated locations from n°1 thru n°16.

2.5 With reference to Figure 1 Detail A and View B, reroute or remove and replace the damaged cables or fuses.

- 2.7 In accordance with the applicable steps of AMP DM 39-A-20-10-19-00A-920A-A and with reference to Figure 1 View B, move the existing support P/N A630A51 or P/N AW001CL001-N6, as applicable, and re-route the cable harnesses in order to respect the clearance of at least 10.0 mm and guarantee the installation ABOVE the anchor nut.
- 2.8 With reference to Figure 1 Detail A and View B, check that all the supports P/N A630A51 and P/N AW001CL001-N6, as applicable, on the LH and RH side are soundly bonded to the panel with no evidences of detachment or delamination.

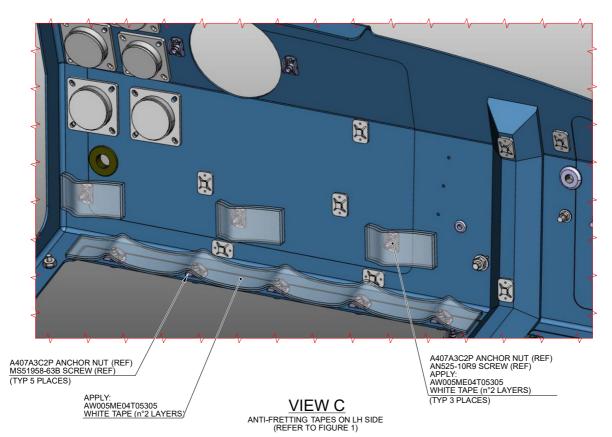
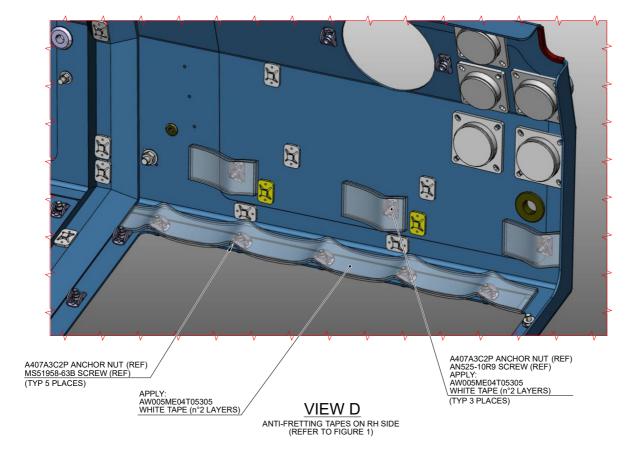
Moreover, this SB prescribes the application of a white protective tape on the anchor nuts in order to avoid chafing with the cable harnesses.

- 2.11 With reference to Figure 1 Detail A and View B, to Figure 2 View C and View D, apply n°2 layers of the white tape P/N AW005ME04T05305 (or equivalent P/N listed in consumable list) on n°10 anchor nuts P/N A407A3C2P (n°5 on the LH side and n°5 on the RH side).

- 2.12 With reference to Figure 1 Detail A and View B, to Figure 2 View C and View D, apply n°2 layers of the white tape P/N AW005ME04T05305 (or equivalent P/N listed in consumable list) on each of the n°6 anchor nuts P/N A407A3C2P (n°3 on the LH side and n°3 on the RH side).

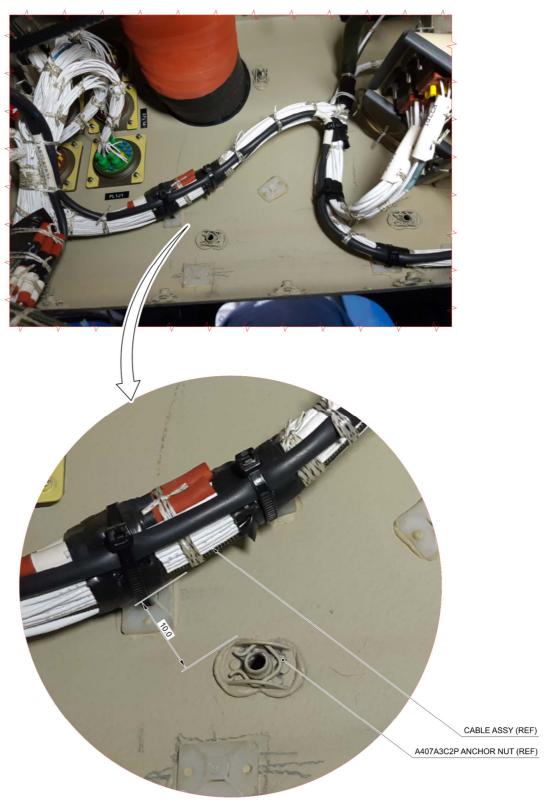
2.6 With reference to Figure 1 View B and to Figure 3 Detail E, measure at the indicated location n°16, on the LH side, the clearance between the anchor nut P/N A407A3C2P and the cable harnesses including a check of the mutual position.

Perform the following step 2.7 if the clearance is NOT at least 10.0 mm and/or if the cable harnesses is installed BELOW the anchor nut.

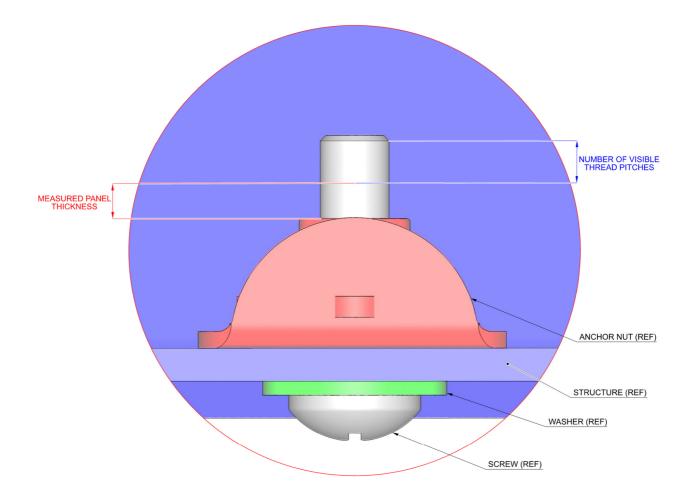
- 2.2.3 Visually check that the number of thread pitches remained visible out of the anchor nut is between 2 and 4 after having subtracted the panel thickness value previously measured (refer to Figure 5).
- 2.2.4 If, when subtracted the panel thickness, less than 2 or more than 4 screw thread pitches remain visible, change the screw according to the following procedure:

- 2.2.4.2 With reference to Figure 4, Table 2, if less than 2 screw thread pitches more than the panel thickness previously measured remain visible, install one grip more than the identified screw.
- 2.2.4.3 With reference to Table 2, if more than 4 screw thread pitches more than the panel thickness previously measured remain visible, install one grip less than the identified screw.
- 2.2.4.4 Repeat steps 2.2.4.2 and 2.2.4.3 until the correct screw P/N is identified from Table 2 and the screw thread pitches visible from the anchor nut are 2, 3 or 4 more than the panel thickness previously measured.
- 2.2.4.5 If no screws from Table 2 satisfy the requirement of step 2.2.4.4 contact the Product Support Engineering (engineering.support.lhd@leonardocompany.com).

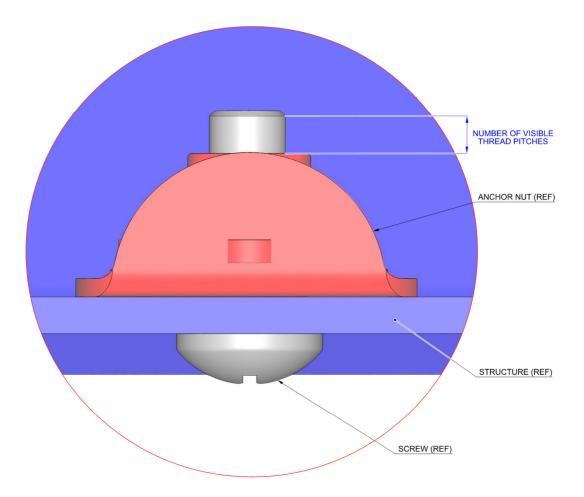
- 2.3 With reference to Figure 1 detail A and View B, check the screws length at the indicated locations from n°11 thru n°16, if applicable, according to the following procedure:
 - 2.3.1 Visually check that the number of thread pitches remained visible out of the anchor nut is between 2 and 4 (refer to Figure 6).
