SEL-79-05

OIL - O-RING INSPECTION AND INSTALLATION FOR OIL PRESSURE TRANSDUCER

SERVICE LETTER

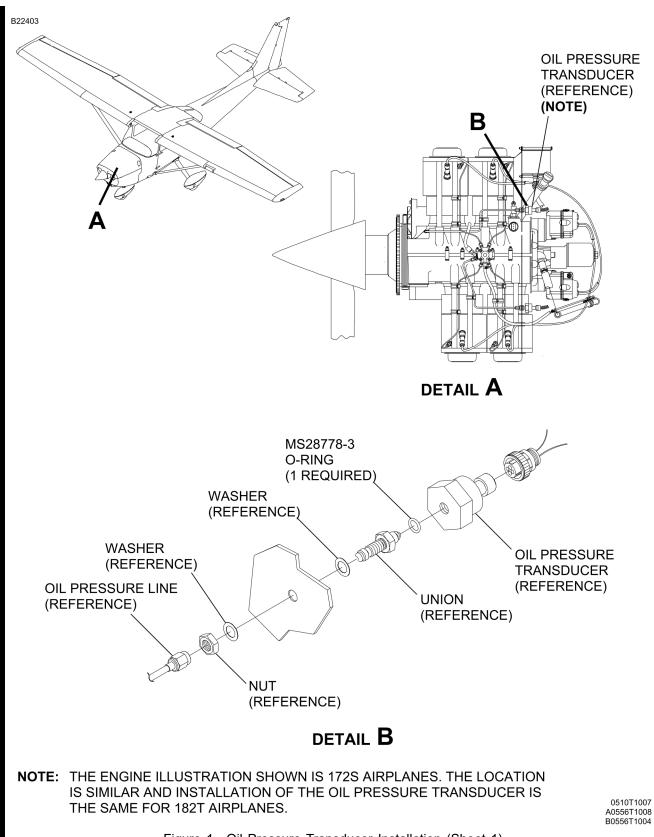
The oil pressure transducer may have been installed without O-ring, which may cause oil leak in engine.

- 4. Inspect the oil pressure transducer for the MS28778-3 O-Ring. (Refer to the applicable Maintenance Manual, Chapter 79, Oil Pressure Indicators Maintenance Practices.)

- A. If MS28778-3 O-Ring is present, remove and discard the MS28778-3 O-Ring from the oil pressure transducer.
 - (1) Install a new MS28778-3 O-Ring to the oil pressure transducer.

- B. If MS28778-3 O-Ring is not present, Install a new MS28778-3 O-Ring to the oil pressure transducer. (Refer to the applicable Maintenance Manual, Chapter 79, Oil Pressure Indicators - Maintenance Practices.)
