# MANDATORY

# SERVICE BULLETIN

DATE: September 20, 2024 Service Bulletin No. 660  
Engineering Aspects are  
FAA Approved

SUBJECT: Reprint of Slick/Champion Aerospace Service Bulletin SB1-24A

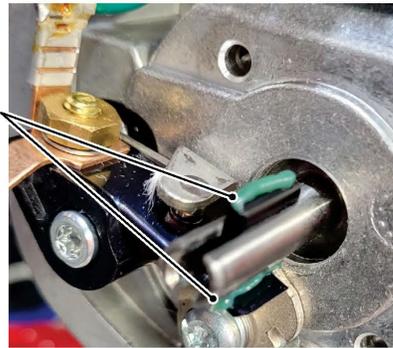
Figure 2 Proper cam grease application

Apply a bead of cam grease to both cam lobes

- (a) For Category 1 magnetos per this service bulletin, disassemble the magneto and inspect the cam for cam grease. If no cam grease is present, apply cam grease M1827 or equivalent (Fig. 2), per the latest revision of F-1100 Master Service Manual.
- (b) For Category 2 magnetos per this service bulletin, disassemble the magneto and inspect the cam for cam grease and wear conditions. If no cam grease is present, and cam shows signs of wear, replace the contact breaker points assembly and the cam, per the latest revision of F-1100 Master Service Manual is required.
