PRATT & WHITNEY CANADA
SERVICE BULLETIN

P&WC S.B. No. 13531

TURBOPROP ENGINE
IGNITION CABLE ASSEMBLY - INSPECTION/REPLACEMENT OF

PT6A-52, PT6A-60A, PT6A-60AG, PT6A-61, PT6A-62, PT6A-65B, PT6A-65R, PT6A-65AG,
PT6A-65AR

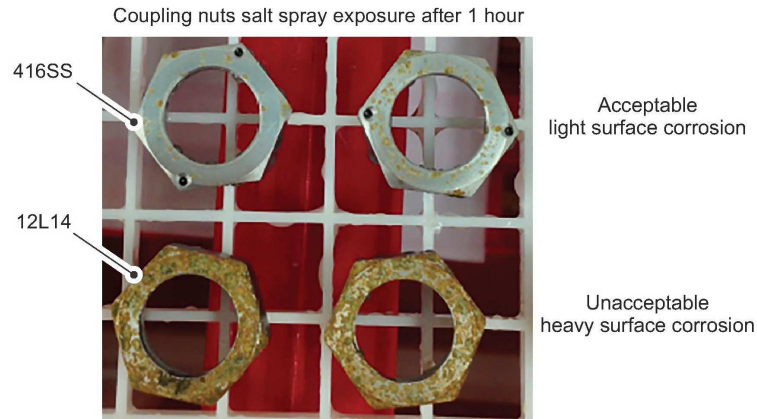
FIGURE 1

- (1) Evidence:
(a) Visual signs of corrosion on a small lot of ignition cable coupling nuts. Refer to Fig. 1.

Salt spray exposure
(Sheet 1)

- (2) Problem/Condition:
- (a) The coupling nuts were made from improper material using 12L14 bar stock instead of 416 stainless steel (ss).
- (3) Solution:
- (a) Replace only the ignition cable with the correct date code, identified in Para. 1.A.(1), with a new ignition cable during normal routine replacement and/or visual inspection of the igniter plugs.

- (1) Replace the existing ignition cable model with a new cable model manufactured with the 416 ss coupling nuts, as listed in Para. 1.C.(3), Solution.

- (2) Inspect the ignition cable and look for evidence of severe corrosion on the igniter-end coupling nuts as shown in Fig. 1. If severe corrosion is identified, check the exciter-end collar for the correct date code shown in Fig. 2. If the date code is one that is in the range of the codes listed in Para.1.A. (1), return the ignition cable to the manufacturer for replacement.
- (3) Install ignition cable listed under New P/N in Para.2.(C)., in accordance with the P&WC maintenance manual instructions (Ref. 74-20, IGNITER AND IGNITION CABLE - MAINTENANCE PRACTICES).
