WO No : 18255-1/7	ACFT REGN : 9M-PEC	SHEET NO: 1 of 1
DATE OPEN : 27/12/18	ACFT TYPE : BELL 429	
RAISED BY : HAZWAN	A/F HOURS : 1794.3

50 Hour Main Rotor Yoke Assembly.
(Refer to 429-MPI, Chapter 4 Table 2)

ALERT SERVICE BULLETIN

SUBJECT: MAIN ROTOR PITCH LINK ROD END BEARING INSPECTION, INTRODUCTION OF.

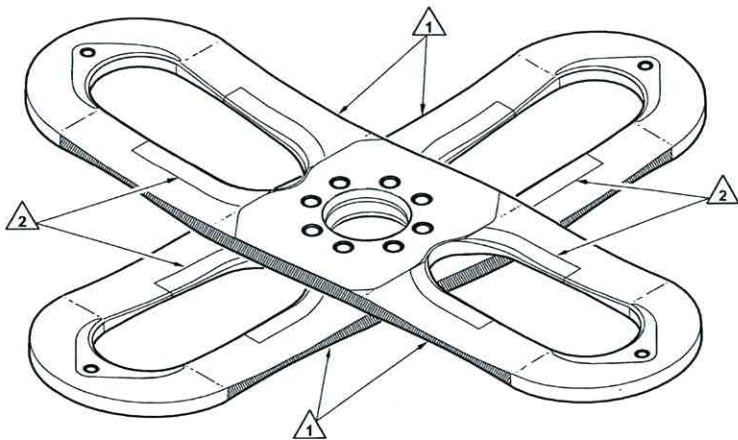
50 HOUR MAIN ROTOR YOKE ASSEMBLY INSPECTION CARRIED
OUT AS PER 429-MPI CHAPTER 04-00-00 , TABLE 2
FIGURE 1. FOUND SATISFACTORY

1. Do a general visual inspection for cracks on all leading and trailing edges of the main rotor yokes in cross-hatched areas.
2. Do a general visual inspection of polyurethane protective tape for cracking, looseness, tearing, or peeling away from the main rotor yoke surfaces.
3. Refer to BHT-429-CMM, Chapter 62 for damage limits.

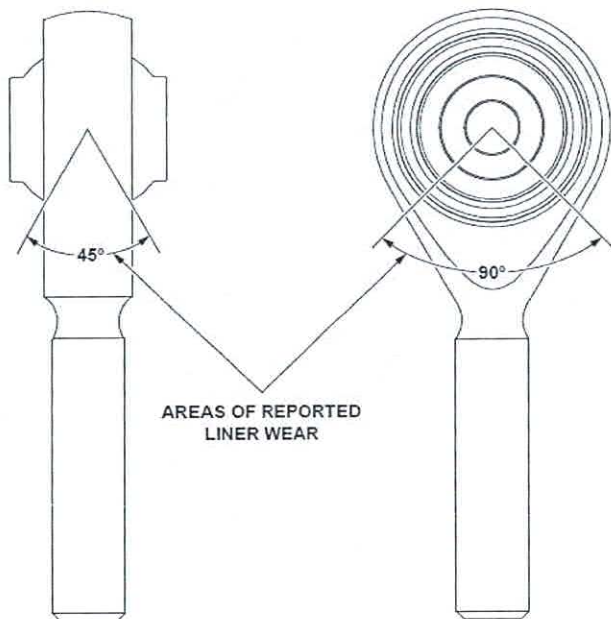
Figure 1 - Upper Pitch Link Rod End

1. Disconnect all the lower pitch link rod ends from the swashplate outer ring (BHT-429-MM-1 Chapter 62).
2. Inspect both the upper and lower pitch link rod ends for axial and radial bearing play. Roll the bearings through multiple angles during inspection, paying particular attention to potential wear at locations shown in Figure 1.

3. If abnormal wear or bearing play is detected, remove the affected pitch link assembly and perform a dimensional check of both axial and radial bearing play (BHT-429-MM-1, Chapter 62). Axial and radial bearing play shall be measured at whichever angle results in the maximum play, paying particular attention to the angles that mimic the installation configuration.

4. Replace any bearing which exceeds the allowable limits (BHT-429-MM-1, Chapter 62).
5. Re-connect or reinstall the rotor pitch link assemblies (BHT-429-MM-1, Chapter 62).

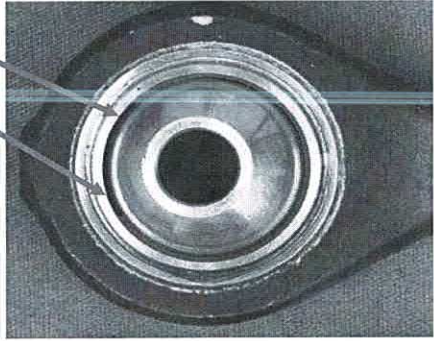
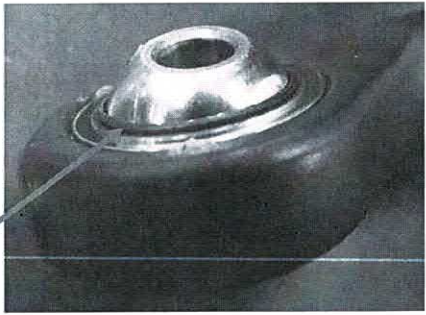
Figure 1 – Tail Rotor Pitch Link Bearing Liner

Bell Helicopter has received reports of tail rotor pitch link assemblies 429-012-112-101/-103 with bearings 429-312-107-103 worn beyond the published limits and bearing liner failures. Tail rotor pitch link assemblies 429-012-112-101/-103 were required to be modified per Alert Service Bulletin (ASB) 429-15-26 by March 7, 2016.

4. Perform a dimensional check of both axial and radial play (BHT-429-MM-1, Chapter 67). With a 10X magnifying glass, visually inspect the bearing liner condition for cracks or deterioration of the liner or if the liner extrudes out of the plane (Figure 1).

Missing Liner

Bearing Liner Extruding

- a. Replace any bearing that exceeds the allowable limits and/or if cracks or deterioration of the bearing liner are noted.
 - i. Perform **Part II** of this ASB or replace the affected tail rotor pitch link assembly with an acceptable part.

- ii. If **Part II** has already been accomplished on the affected tail rotor pitch link assembly, replace the bearing per the instructions in the 429 Maintenance Manual (BHT-429-MM-1, Chapter 67) or replace the tail rotor pitch link assembly with an acceptable part.

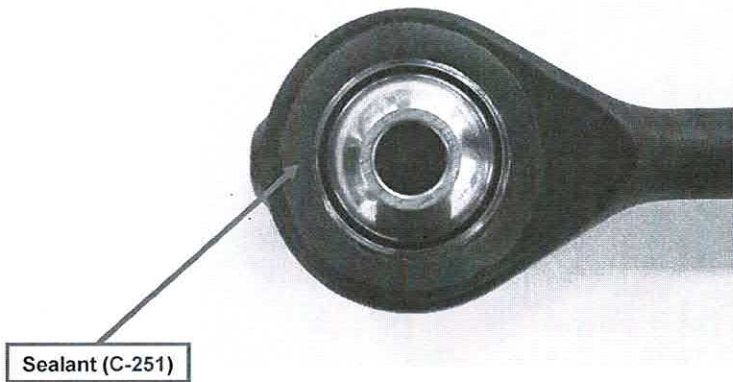
Figure 2 – Example of Sealant (C-251) Installation

5. Inspect the tail rotor pitch link assembly sealant (C-251) for condition.
 - a. Make sure there are no pin holes or voids present in the sealant.
 - b. The thickness of the sealant should not exceed 0.025 inch (0.64 mm), should extend over the roll staked lip by a minimum of 0.030 inch (0.76 mm), and remain clear of the bearing ball.

3. Install the new bearing 429-312-107-103 (BHT-429-MM-1, Chapter 67).
4. Clean the affected area with isopropyl alcohol (C-285). Apply corrosion preventative sealant (C-251) to the bearing roll stake lip and the pitch link (Figure 2).
 - a. Make sure there are no pin holes or voids present in the sealant.
 - b. The thickness of the sealant should not exceed 0.025 inch (0.64 mm), should extend over the roll staked lip by a minimum of 0.030 inch (0.76 mm), and remain clear of the bearing ball.
5. Reidentify the tail rotor pitch link assembly with a white permanent fine point marker, or equivalent, as follows:

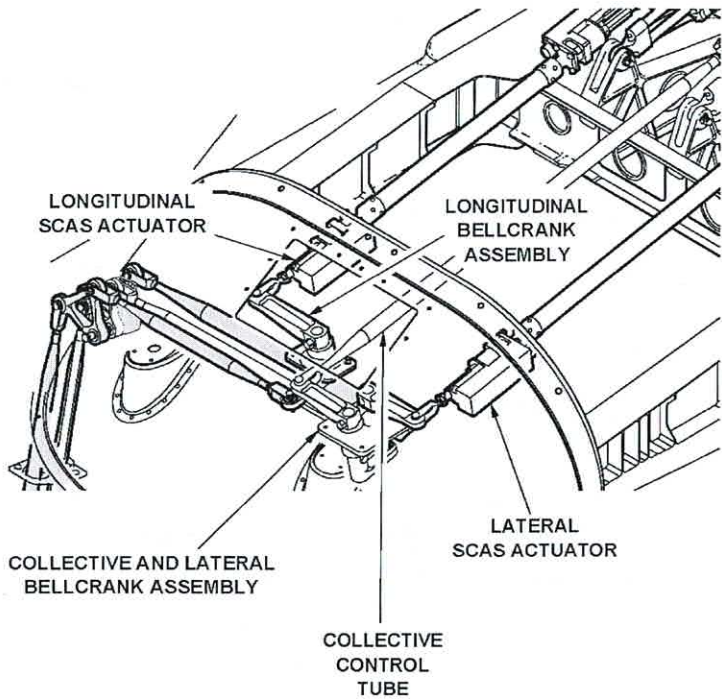
Figure 1 - Bellcrank Assemblies

Bell Helicopter has received reports concerning flight control systems that have intermittent restrictions. ASB 429-14-13 was published to address helicopters which did not have air conditioning drainage modifications incorporated. The latest report involved a helicopter which did not have the air conditioning kit installed. Further investigation has determined that static and in-flight precipitation can pool at the forward portion of the roof structure providing a source of contamination for the roof mounted collective and cyclic bellcrank pivot bearings. **Part I** of this bulletin introduces a freedom of rotation check of the roof mounted collective and cyclic bellcrank pivot bearings, and a freedom of rotation check for the collective and cyclic bellcrank arm end bearings. **Part II** of this bulletin repeats **Part I** every 6 months.

3. Slowly move the cyclic stick fore/aft and laterally, and the collective stick up/down from stop to stop. If any roughness is detected in the flight control system, remove and replace the six MS27646-41 pivot bearings (Item 1, Figure 2) in the collective/lateral 429-001-523-101/-103, and longitudinal bellcrank 429-001-532-101/-103 (BHT-429-MM-1, Chapter 67).
4. Should discrepant pivot bearings be found that require replacement, contact Product Support Engineering to report findings.

If binding is detected in any MS27643-4 arm end bearings, all three arm bearings must be replaced per the BHT-ALL-SPM. If tooling and facilities are not available, the arms may be sent through Bell Helicopter CPR for bearing replacement. Alternatively, arm assemblies may be purchased through spares.

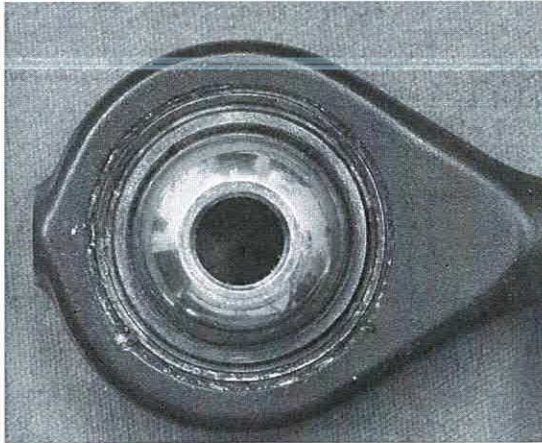
Figure 1 - Pitch Link Corrosion

Bell Helicopter has received reports of corrosion on tail rotor pitch links present between the roll staked lip of the 429-312-107-103 bearing and the beveled edge of the 429-012-112-101/-103 tail rotor pitch link. **Part I** of this bulletin introduces an inspection for corrosion and the application of sealant. **Part II** of this bulletin introduces

3. Use 10X magnification to inspect all eight tail rotor pitch link bearing bores for corrosion evident by the presence of aluminum oxide extruding from between the roll staked lip of the bearing outer race and the pitch link bearing bore (Figure 1). If corrosion is found, replace the affected pitch link.

4. If no corrosion is found in the previous step, clean the area thoroughly with isopropyl alcohol (C-285) and inspect using 10X magnification. If corrosion is found, replace the affected pitch link.

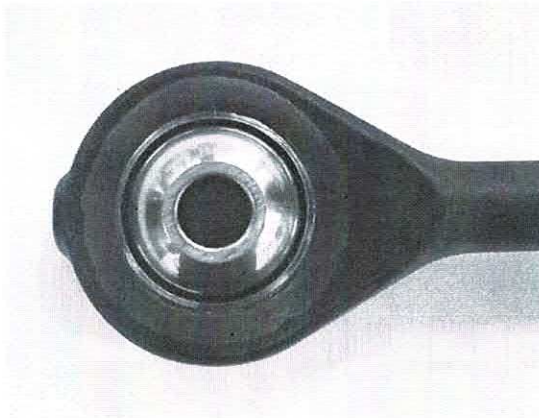
Figure 2 - Sealant Application

1. Inspect the tail rotor pitch links for condition of applied sealant. If sealant is damaged, reapply as per **Part I** of this bulletin.
2. Make an entry in the helicopter logbook indicating compliance with **Part II** of this Alert Service Bulletin.

5. If no corrosion is found in the previous step, remove any traces of torque stripe and clean the affected area with isopropyl alcohol (C-285). Apply corrosion preventative sealant (C-251) MIL-PRF-81733 to the bearing roll stake lip and the pitch link (Figure 2). Make sure that there are no pin holes or voids in the sealant. The thickness of the sealant should not exceed 0.025 inch (0.64 mm), should extend

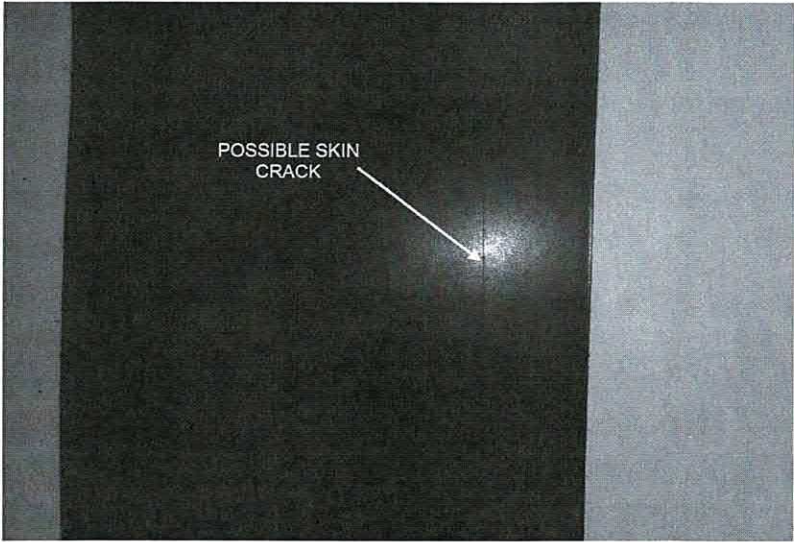
Figure 1 - Possible Skin Crack Indication

Bell Helicopter has received two reports of tail rotor blade skin cracks. As such this defect will become evident as a chordwise paint crack. Applicability of this bulletin to any spare part shall be determined prior to its installation on an affected helicopter.

1. Prepare the helicopter for maintenance.
2. Carry out a general visual inspection of all four tail rotor blade inboard and outboard skins for evidence of chordwise paint cracks.
3. Should a paint crack be detected in a tail rotor blade skin, please contact Product Support Engineering for further instructions.
4. Make an entry in the helicopter logbook and the Historical Service Record (HSR) indicating compliance with this Alert Service Bulletin.
