WORK ORDER

A/C Reg	9M-LKE
A/C S/N	8297
A/C Type	AS350 B3 e

Modification Title: **Repair of LH Cargo Compartment Door**

SUBJECT: Repair of LH Cargo Compartment Door

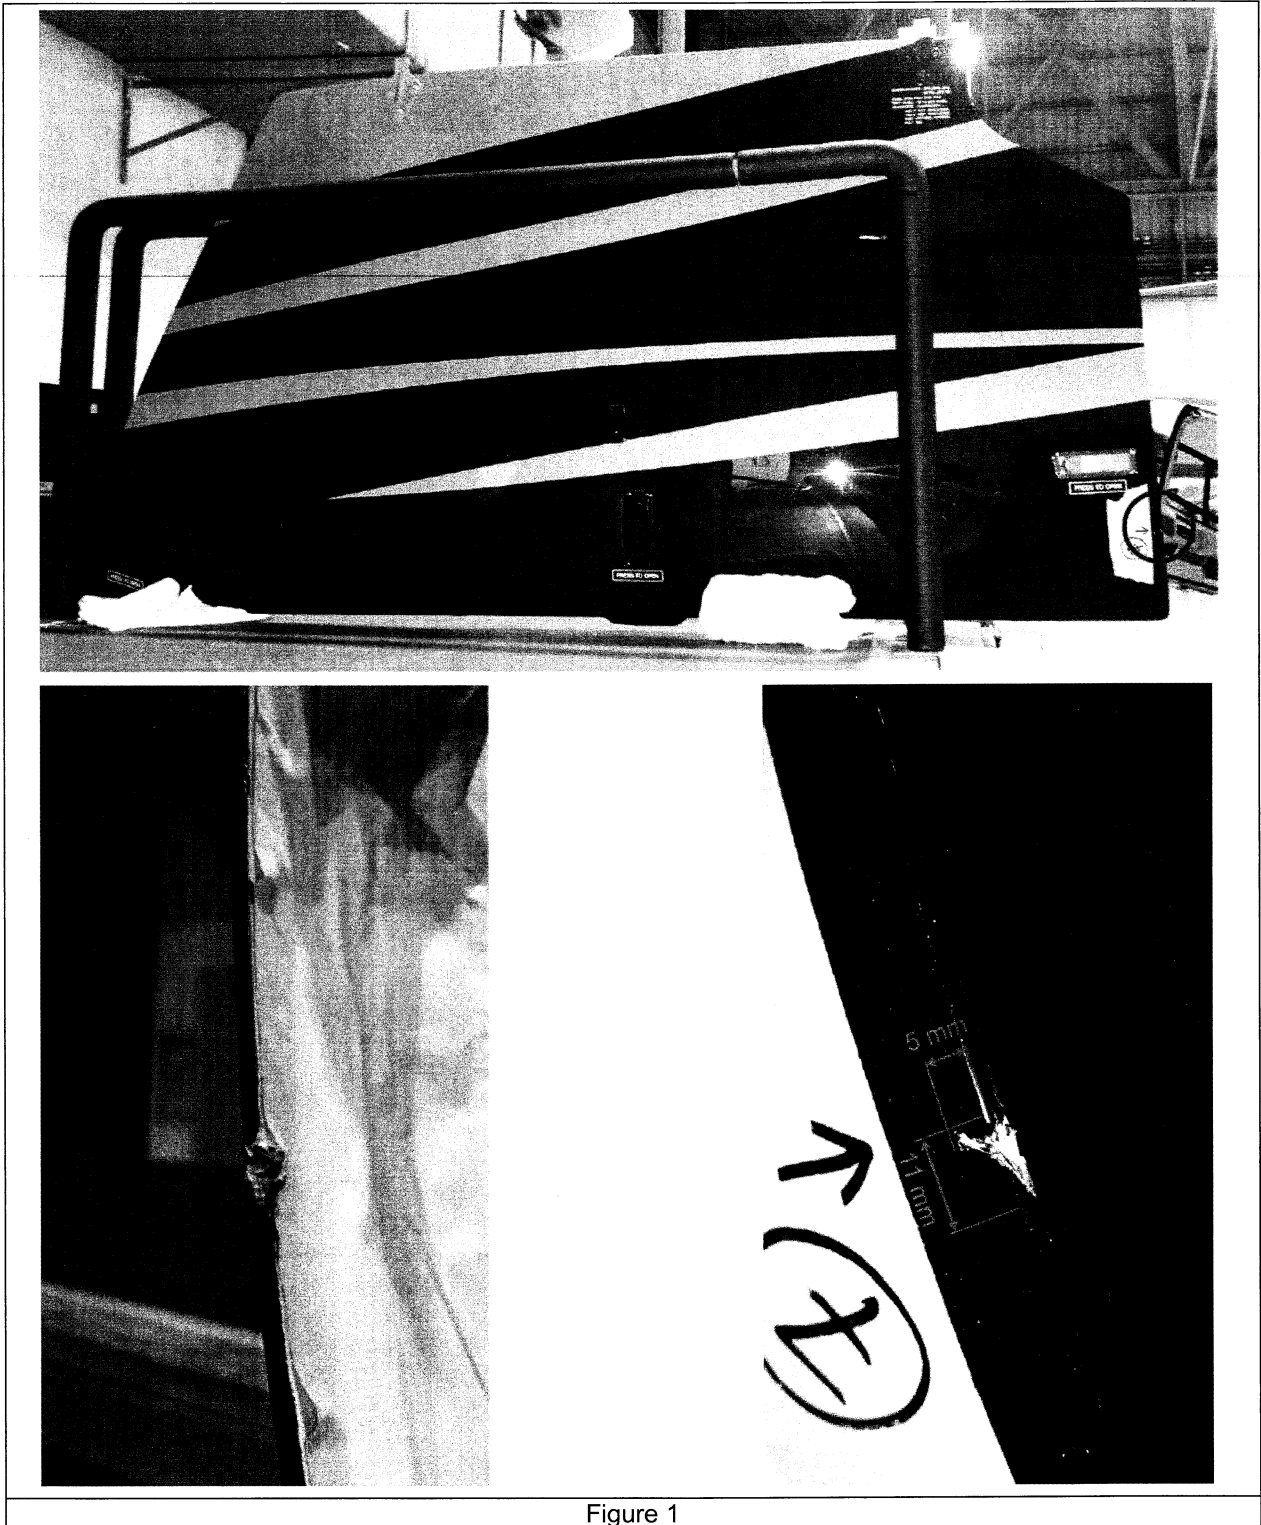
Annex 2: Description of Damage

Operator reported that the Door INST, Cargo Compartment, LH has a perforation at the aft lower end.

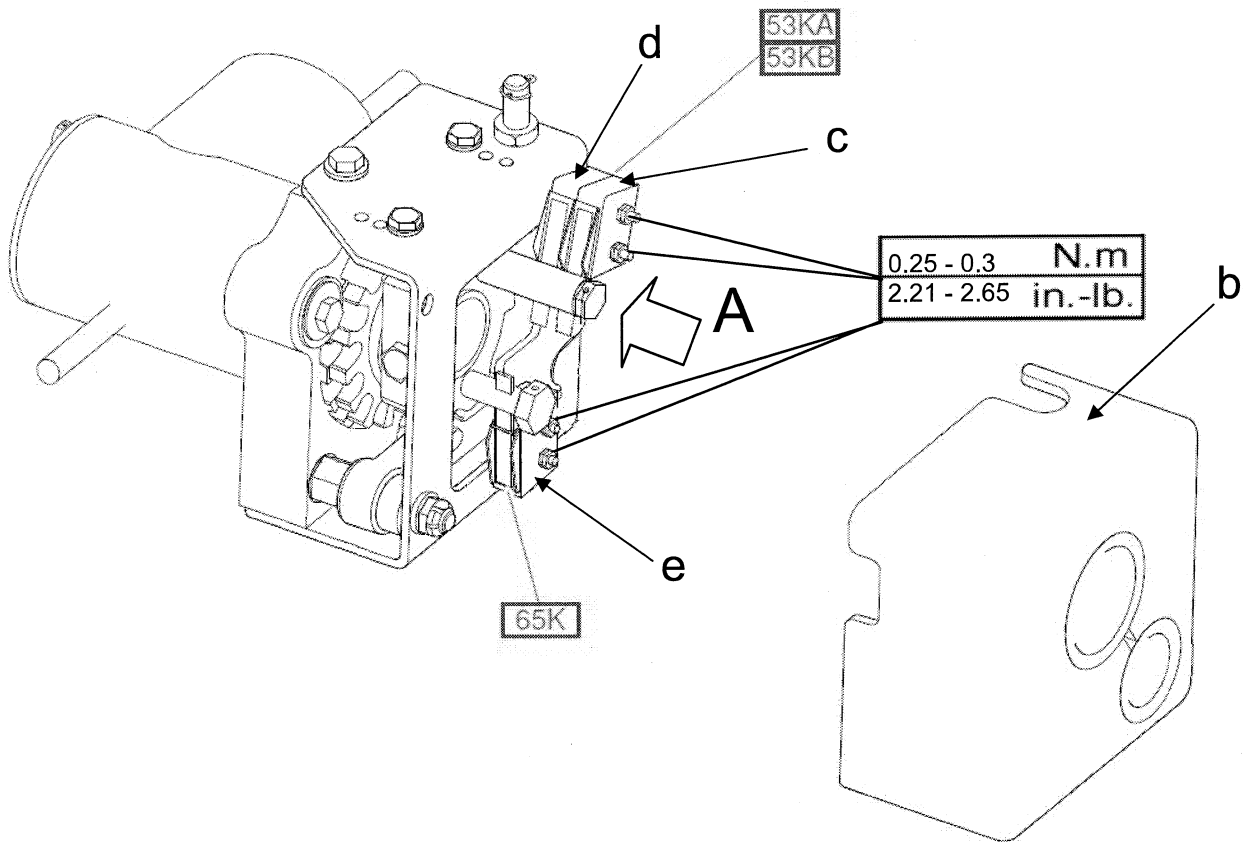
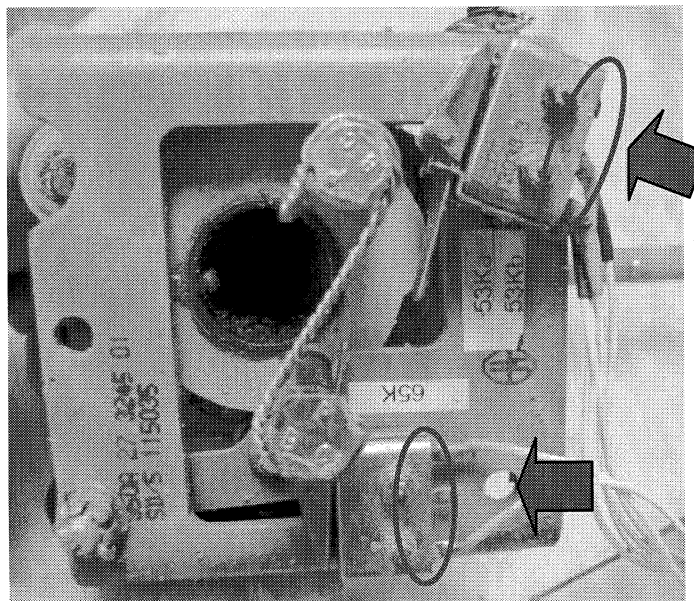
Figure 1

- Inspect the wiring side of microswitches (c), (d) and (e) in order to ensure that there are no marks, residues, corrosion or flaky varnish (DETAIL A - Figure 1).
- If there are marks, residues, corrosion or flaky varnish, comply with paragraph 3.B.2.
- If there are no marks, residues, corrosion or flaky varnish, comply with paragraph 3.B.3.

- Disconnect the electrical connector 87DELTAP1 (a).
- Loosen and mechanically remove the microswitch(es) concerned as per AMM Task 76-12-04, 4-1.
- For each microswitch, note the position of the wires on the terminals.
- Remove and discard the sheath.
- Remove any varnish present.
- Unsolder the wires.
- Clean the wire side as per MTC Work Card 20.04.03.401 or 20.04.03.103.
