[Docket No. FAA-2020-0883; Project Identifier 2019-CE-034-AD; Amendment 39-21460; AD 2021-05-17]

Airworthiness Directives; Rockwell Collins, Inc. Flight Display System Application

ACTION: Final rule.

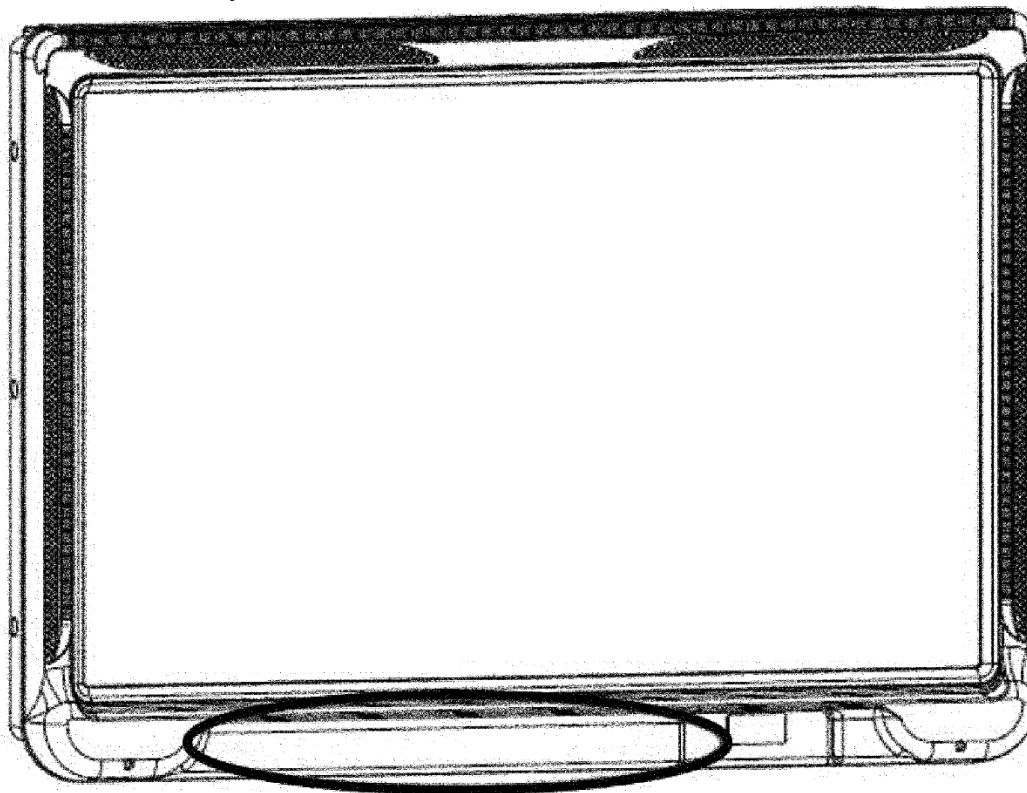
Figure 1 to paragraph (g)(1)(iii); placard location on bezel

(iii) Install the placard on the bottom of each aircraft primary flight display bezel in the area depicted in figure 1 to paragraph (g)(1)(iii) of this AD.

- (1) Within 30 days after July 23, 2019 (the effective date of AD 2019-12-09), do the following:
 - (i) Revise the airplane flight manual (AFM) or AFM supplement (AFMS) by adding the following text to the Limitations section: For TCAS II installations, during flight, do not operate TCAS in the "TA/RA" mode; TCAS may only be operated in "TA Only" mode.
 - (ii) Fabricate a placard for each aircraft primary flight display, using at least 1/8 inch letters, with the following text: TCAS Flight Ops—TA Only mode (TA/RA mode prohibited).

(4) The airplane flight manual revision and placards required by paragraph (g)(1) of this AD may be removed after completing the software upgrade required by paragraph (g)(3) of this AD.
