Airworthiness Directive

AD No.: 2021-0044

ATA 24 – Electrical Power – Overhead Panel – Inspection

ATA 24 – OVERHEAD PANEL INSPECTION

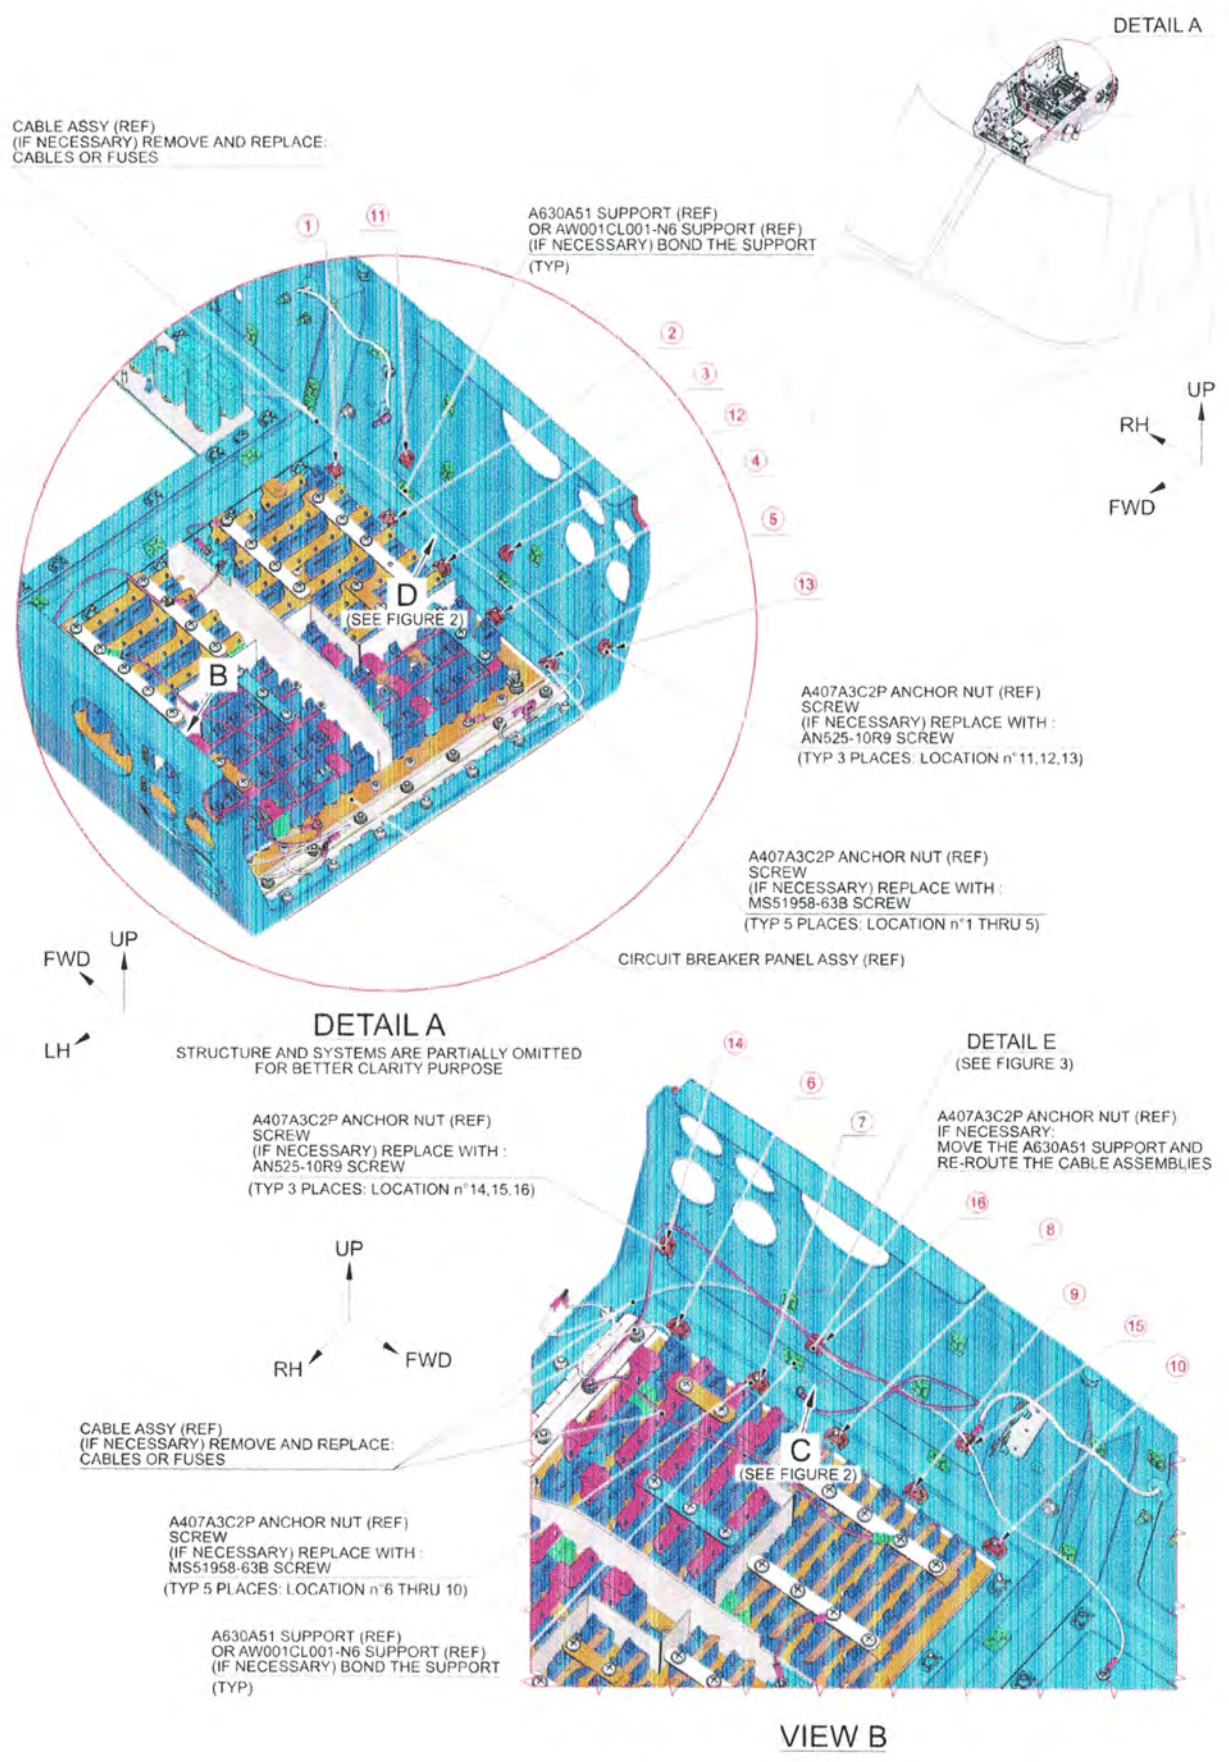
- 2.3 With reference to Figure 1 Detail A and View B, check the length of the screws (removed in the previous step 2.1) at the indicated locations from n°11 thru n°16, if applicable:
 - 2.3.1 Make sure that each screw is long 15.06 mm or less.

- 2.3.2 If the length is not less than 15.06 mm replace each affected screw with a new one P/N AN525-10R9.
- 2.4 With reference to Figure 1 Detail A and View B, remove the screws at the indicated locations from n°1 thru n°10 and check their length:
 - 2.4.1 Make sure that each screw is long 12.7 mm or less.

- 2.4.2 If the length is not less than 12.7 mm replace each affected screw with a new one P/N MS51958-63B.
- 2.5 With reference to Figure 1 Detail A and View B, re-install n°6 screws, if applicable, in their respective anchor nuts P/N A407A3C2P at the indicated locations from n°11 thru n°16 without the lining panels previously removed at step 2.1
- 2.6 With reference to Figure 1 Detail A and View B, re-install n°10 screws in their respective anchor nuts P/N A407A3C2P at the indicated locations from n°1 thru n°10, keeping the circuit breaker panel assy open.
- 2.7 With reference to Figure 1 Detail A and View B, check for chafing damage of the cable harness and ensure that clearance exists between the cable harness and the anchor nuts P/N A407A3C2P and/or the screws at the indicated locations from n°1 thru n°16.

- 2.8 With reference to Figure 1 Detail A and View B, remove and replace the damaged cables or fuses.
- 2.9 With reference to Figure 1 View B and to Figure 3 Detail E, measure at the indicated location n°16, on the LH side, the clearance between the anchor nut P/N A407A3C2P and the cable harnesses including a check of the mutual position.

- 2.10 With reference to Figure 1 View B, move the existing support P/N A630A51 or P/N AW001CL001-N6, as applicable, and re-route the cable harnesses in order to respect the clearance of at least 10.0 mm and guarantee the installation ABOVE the anchor nut.
- 2.11 With reference to Figure 1 Detail A and View B, check that all the supports P/N A630A51 and P/N AW001CL001-N6, as applicable, on the LH and RH side are soundly bonded to the panel with no evidences of detachment or delamination.

- 2.12.2 With reference to Figure 1 Detail A and View B, carefully remove the bonded plastic support P/N A630A51 and/or P/N AW001CL001-N6 with an applicable plastic spatula. Make sure that you do not cause damage to the structure during this operation.
- 2.12.3 Rub the seat of the plastic support on the structure with the Abrasive pad (C015) to remove the unwanted sealant.

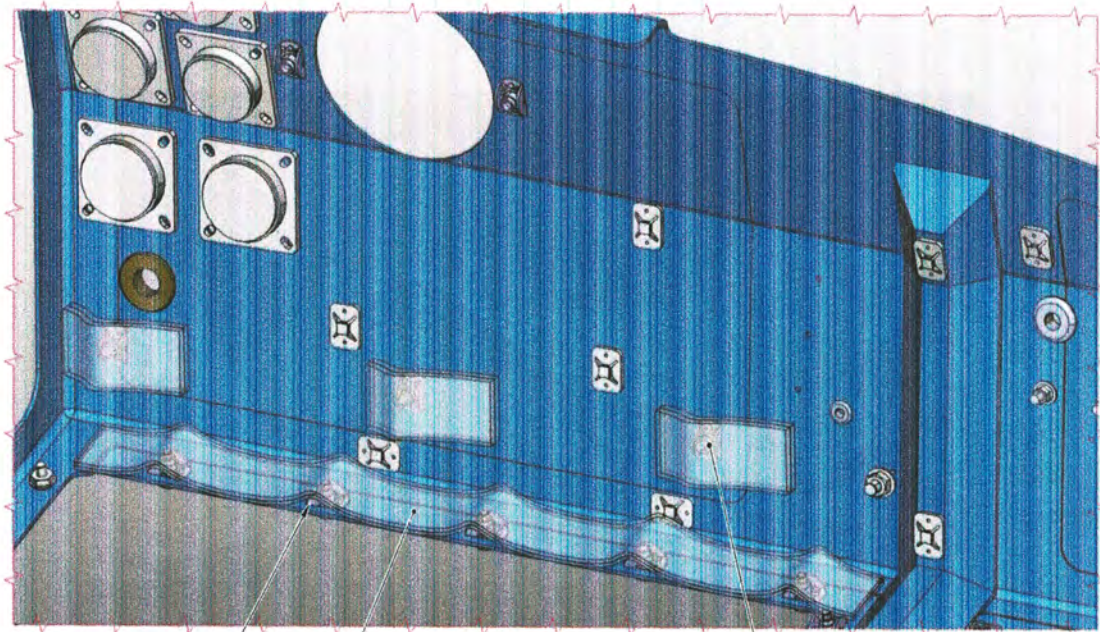
VIEW C

ANTI-FRETTING TAPES ON LH SIDE
(REFER TO FIGURE 1)

- 2.4 With reference Figure 2 View C, remove n°2 layers of the white tape from the anchor nuts and apply in the same position n°2 new layers of the white tape P/N AW005ME04T05305.

- 2.7 With reference to Figure 2 View C, remove n°2 layers of the white tape from the anchor nut and apply in the same position n°2 new layers of the white tape P/N AW005ME04T05305. If necessary, repeat for all the three anchor nuts.

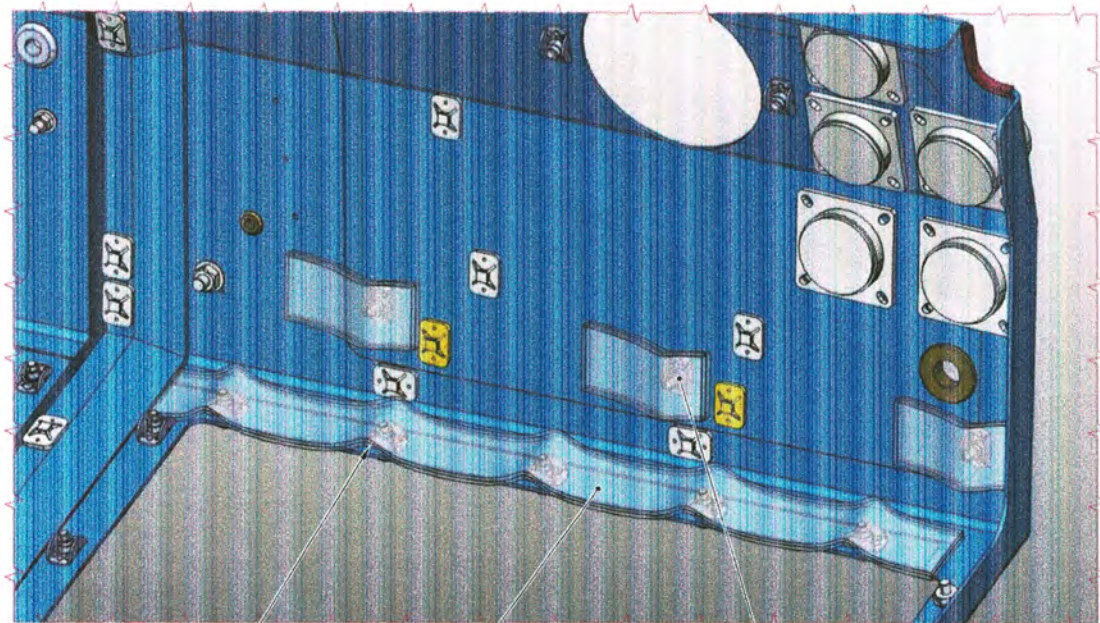
VIEW D

ANTI-FRETTING TAPES ON RH SIDE
(REFER TO FIGURE 1)

- 2.5 With reference to Figure 2 View D, repeat step 2.4 for the RH side.
- 2.6 With reference to Figure 1 Detail A and View B, to Figure 2 View C and View D, check for the condition of the n°2 layers of the white tape P/N AW005ME04T05305 on each of the n°6 anchor nuts P/N A407A3C2P (n°3 on the LH side and n°3 on the RH side).

- 2.8 With reference to Figure 2 View D, repeat step 2.7 for the RH side.
- 2.9 With reference to Figure 1 Detail A and View B, check for chafing damage of the cable harness and ensure that clearance exists between the cable harness and the anchor nuts P/N A407A3C2P and/or the screws at the indicated locations from n°1 thru n°16.

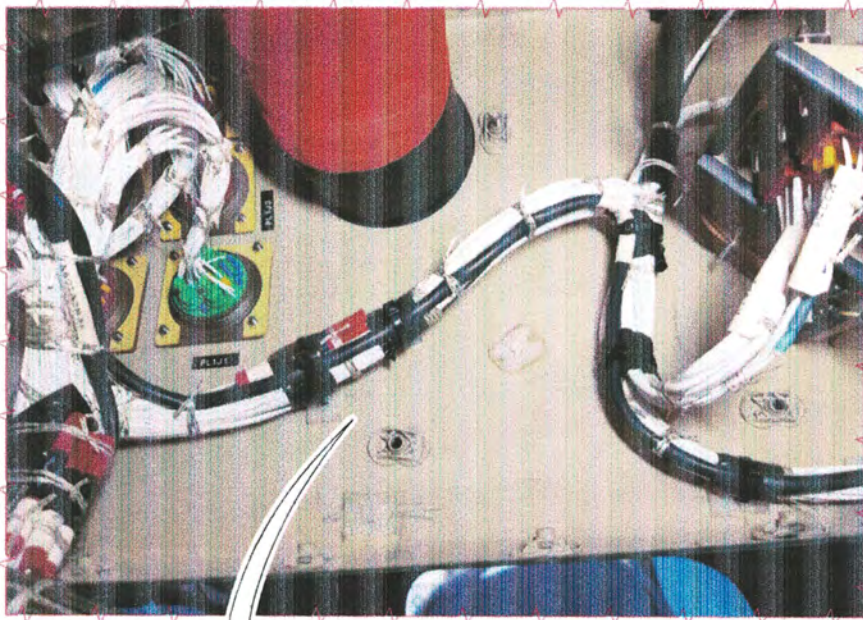
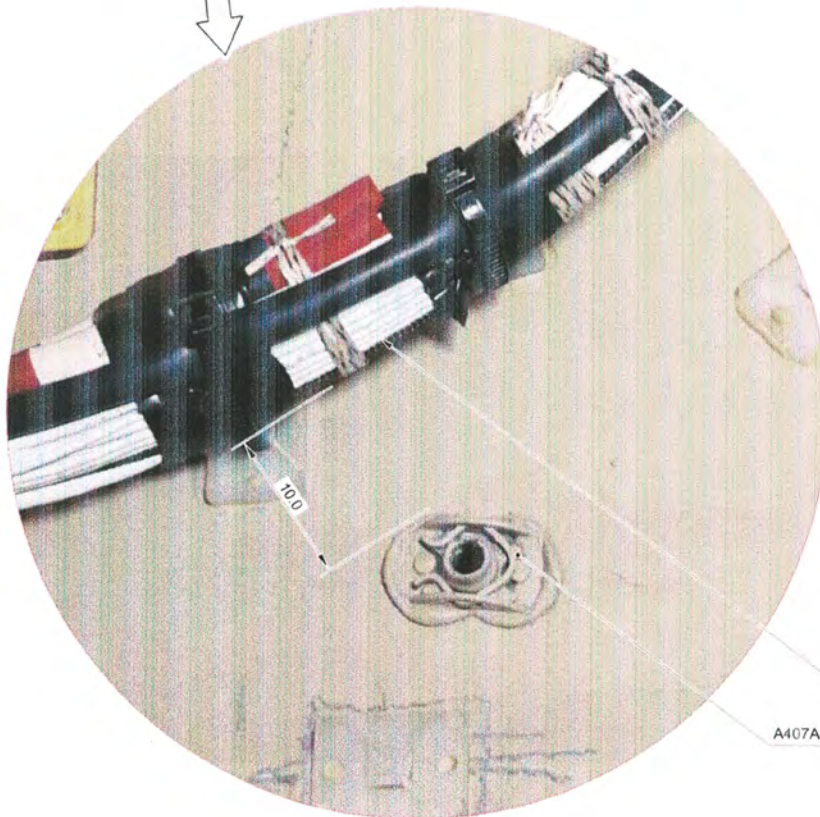
DETAIL E
(REFER TO FIGURE 1)

Perform the following step 2.10 if the clearance is NOT at least 10.0 mm and/or if the cable harnesses is installed BELOW the anchor nut.
