WORK CARD

EASA AD NO.: 2018-0112R1 ISSUED: 04 JUNE 2018 (ASB 139-450 DATE: MAY 28, 2019 REV.: D) - ATA 62 - MAIN ROTOR DAMPER INSPECTIONS (PART III)

LEONARDO HELICOPTER ITALY (LHI)

9M-BGH

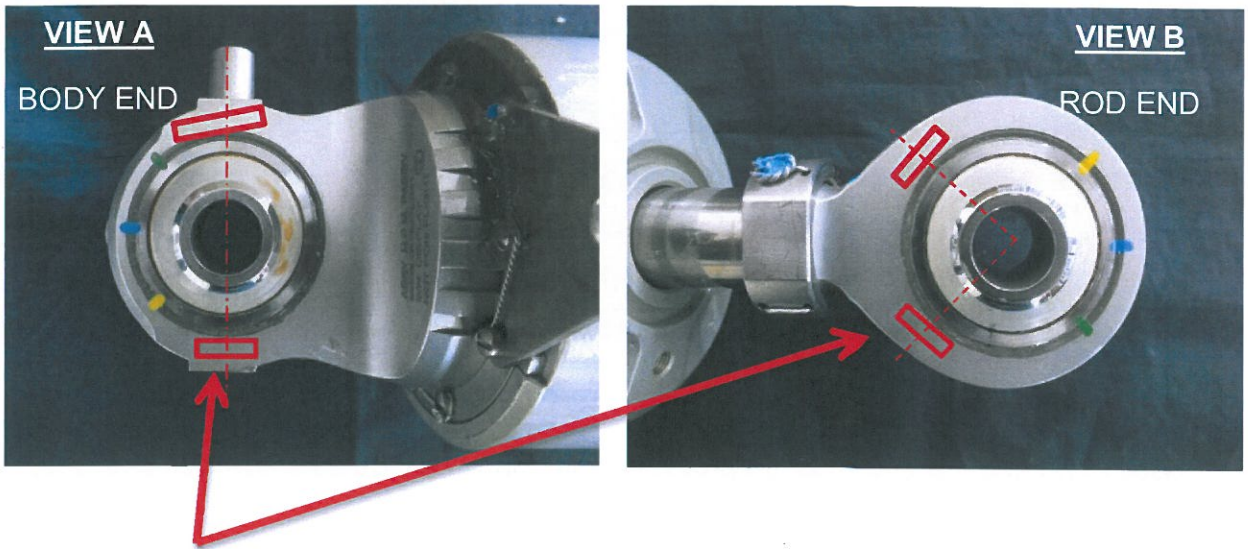
Figure 1

Areas to be inspected (two on body end and two on rod end) shown in red boxes
(one side shown, the other is symmetrical)

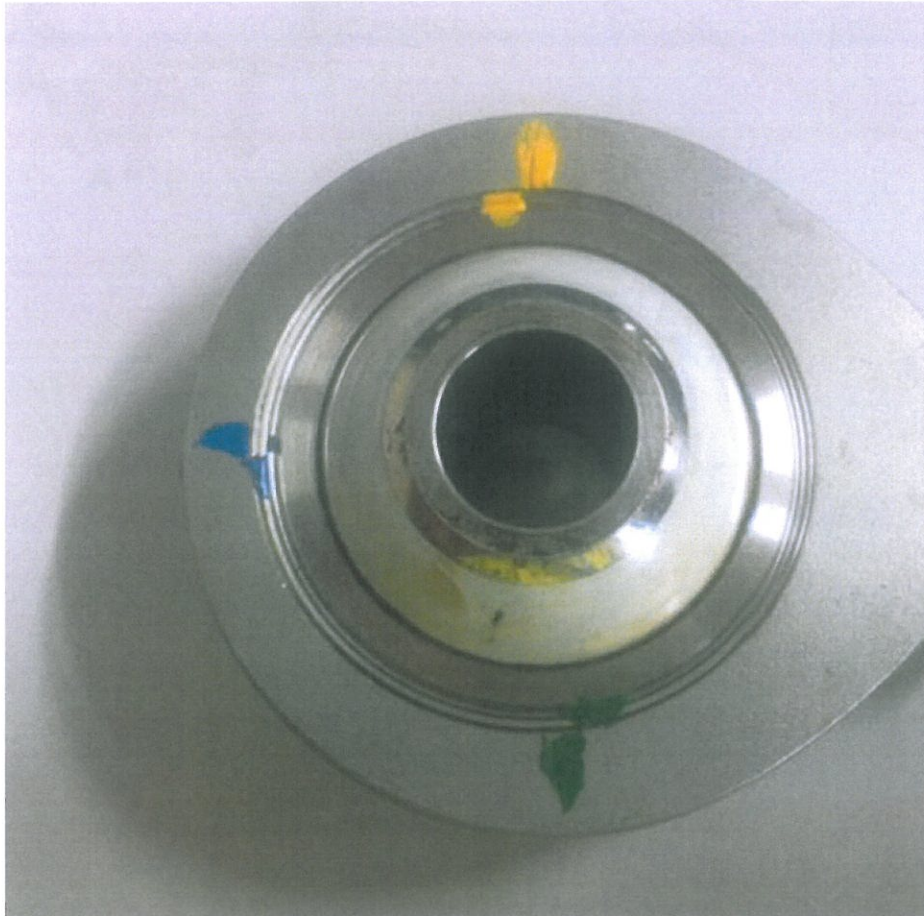
Figure 9

3. With reference to figures 8 and 9 perform the inspection as follows:
 - 3.1 Examine the bearing of the rod end (3) for rotation in the damper seat by looking for slippage marks misalignment. If you find rotation (as shown in figure 9), replace the rod end. Refer to AMP, see DM n° 39-A-62-22-02-01A-921A-B.

- 3.2 Examine the bearing of the body end (2) for rotation in the damper seat by looking for slippage marks misalignment. If you find rotation (as shown in figure 9), replace the damper (1). Refer to AMP, see DM n° 39-A-62-22-02-00A-520A-A and 39-A-62-22-02-00A-720A-A.

Sample of bearing rotation (slippage marks misalignment)

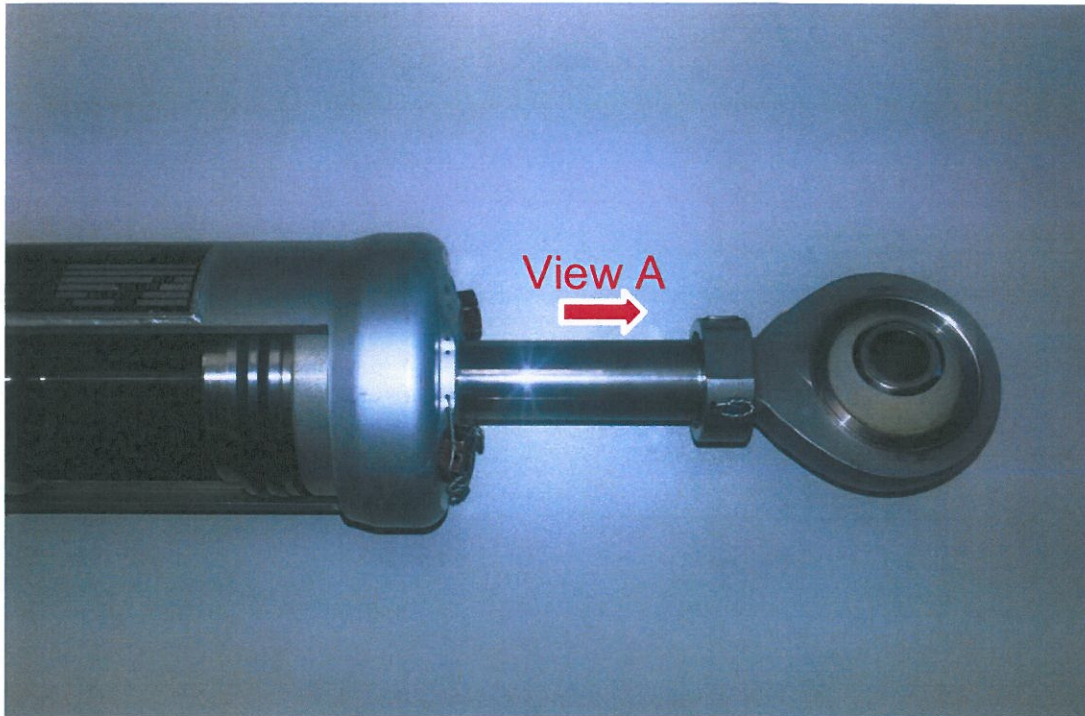
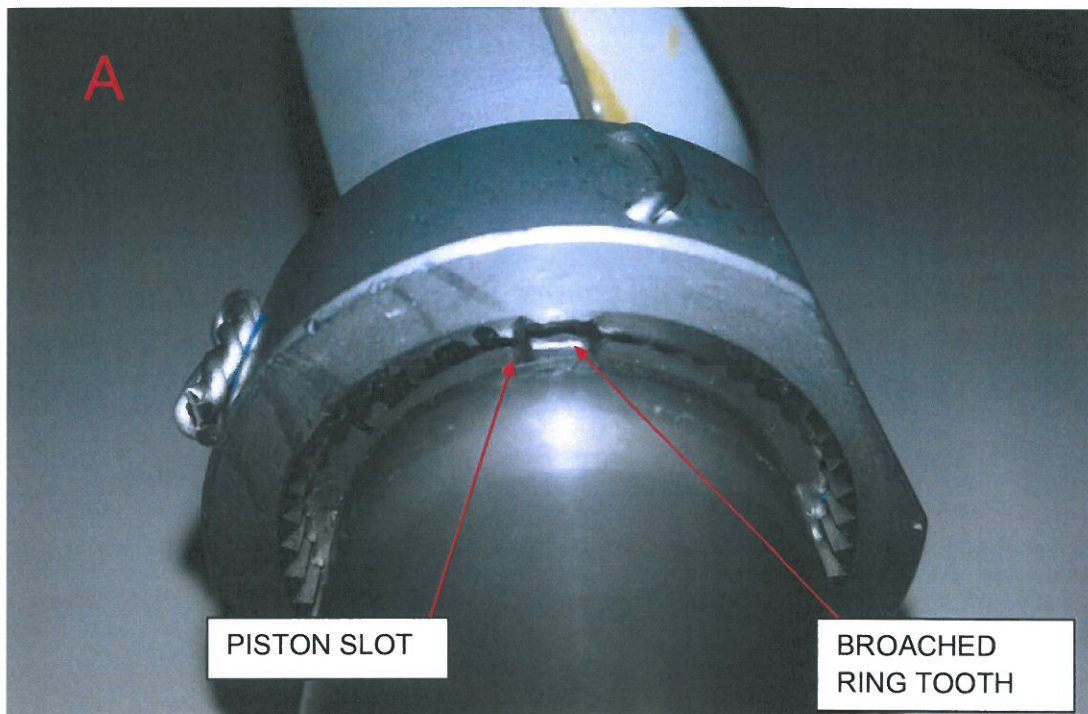
Figure 12

- 3.1 With reference to figures 11 and 12, using a mirror, check the four teeth of the broached ring (5) and relative four damper piston slots (4) for damage, correct engagement and alignment.
- 3.2 In case of findings (a sample of possible damage is shown in figure 13) contact Product Support Engineering (CSE.AW139.AW@leonardocompany.com) for further instruction.
4. Repeat step 3 to inspect the other MR dampers.
5. Return the helicopter to flight configuration and record for compliance with Part V of this Service Bulletin on the helicopter logbook.
6. Send the attached compliance form to the following mail box:
cse.aw139.aw@leonardocompany.com
As an alternative, gain access to My Communications section on Leonardo WebPortal and compile the "Service Bulletin Application Communication".

Area to be inspected for damage, correct engagement and alignment

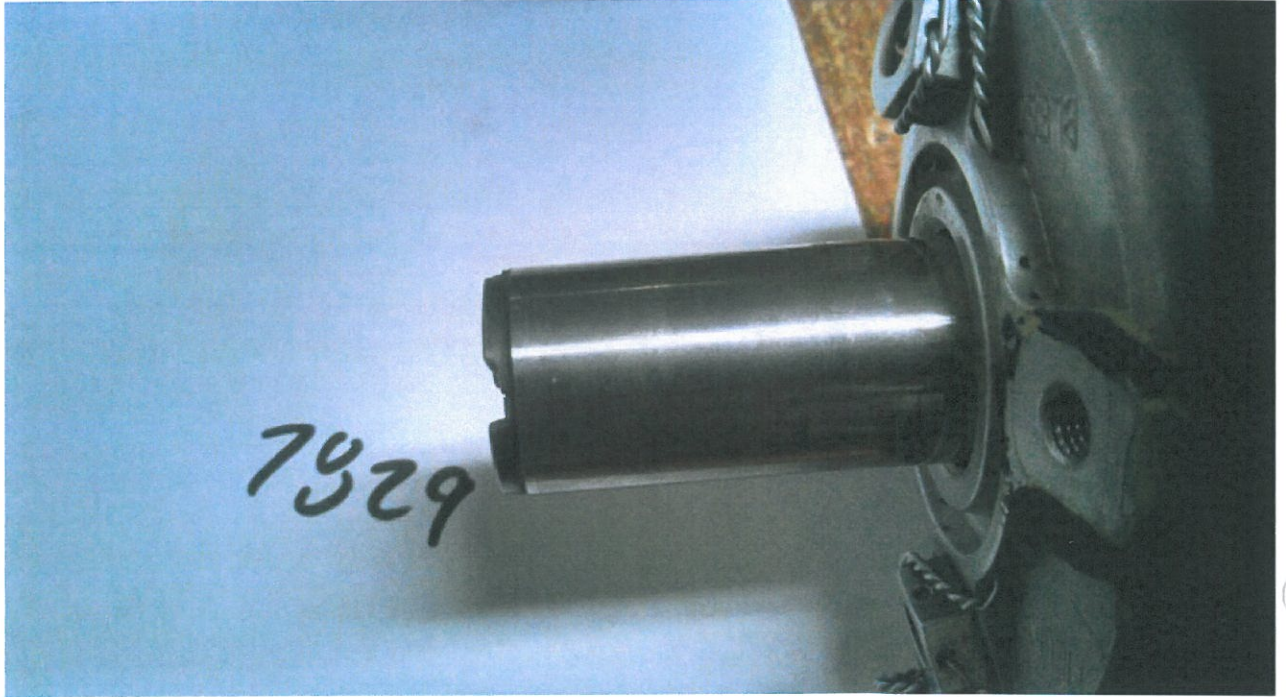
Figure 13

Sample of damage on piston slot

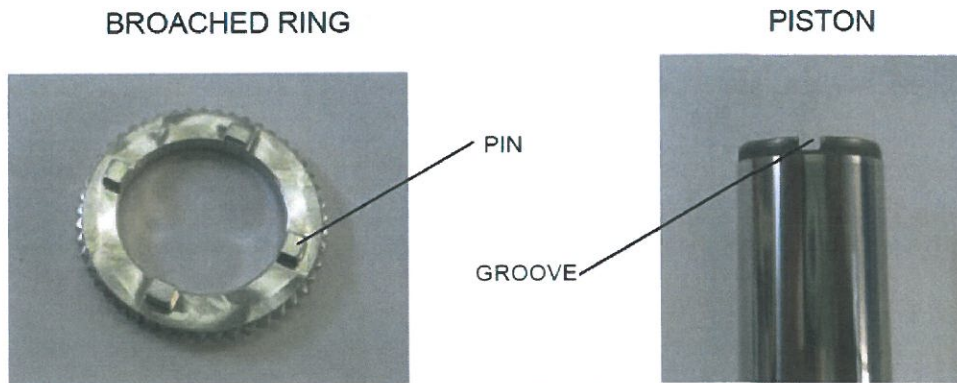
Figure 4 - Examples of acceptable broached ring and piston

10. With reference to Figure 3:
 - a. Inspect broached ring (1-50) for evidence of wear and damages, with particular attention to the four pins engaging the piston grooves. Refer to Figure 4 for an example of acceptable broached ring. In presence of wear or damages replace it with a new one.

- b. Visually inspect damper piston, in the locking grooves area, for wear, damages and cracks. Refer to Figure 4 for an example of acceptable piston. In presence of damages replace the damper.

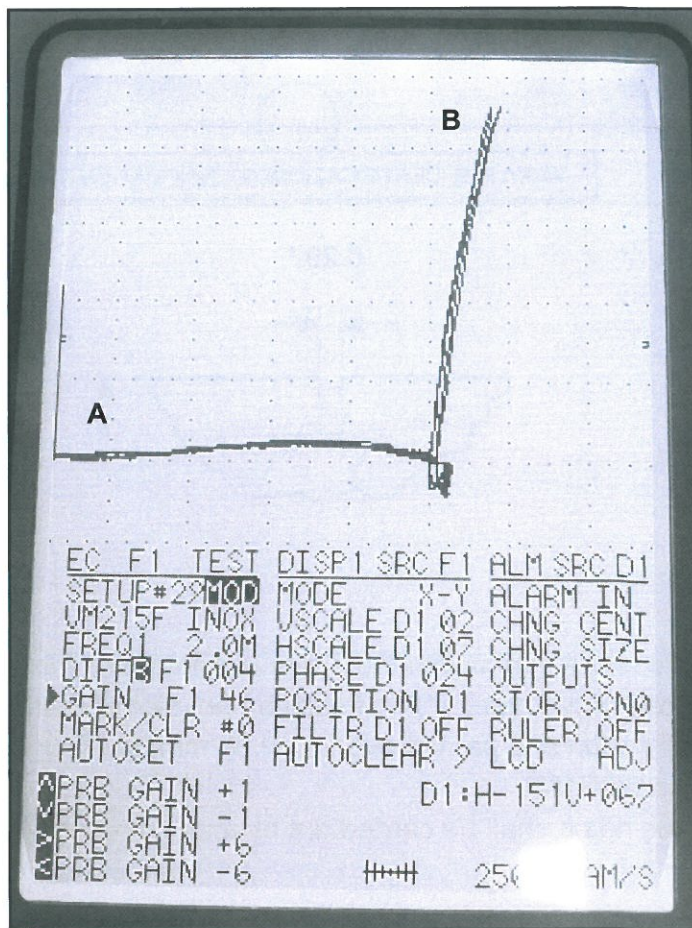
Figure B4

Typical signal from the calibration (A = lift-off signal, B = indication from reference notch 0.5 mm deep).
