EASA	AIRWORTHINESS DIRECTIVE

<p>AD No.: 2008-0108</p> <p>Date: 05 June 2008</p> <p>Note: This Airworthiness Directive (AD) is issued by EASA, acting in accordance with Regulation (EC) No 216/2008 on behalf of the European Community, its Member States and of the European third countries that participate in the activities of EASA under Article 66 of that Regulation.</p>	
<p>This AD is issued in accordance with EC 1702/2003, Part 21A.3B. In accordance with EC 2042/2003 Annex I, Part M.A.301, the continuing airworthiness of an aircraft shall be ensured by accomplishing any applicable ADs. Consequently, no person may operate an aircraft to which an Airworthiness Directive applies, except in accordance with the requirements of that Airworthiness Directive unless otherwise specified by the Agency [EC 2042/2003 Annex I, Part M.A.303] or agreed with the Authority of the State of Registry [EC 216/2008, Article 14(4) exemption].</p>

N° **139-129**

SUBJECT: COCKPIT DOORS WINDOWS REPLACEMENT

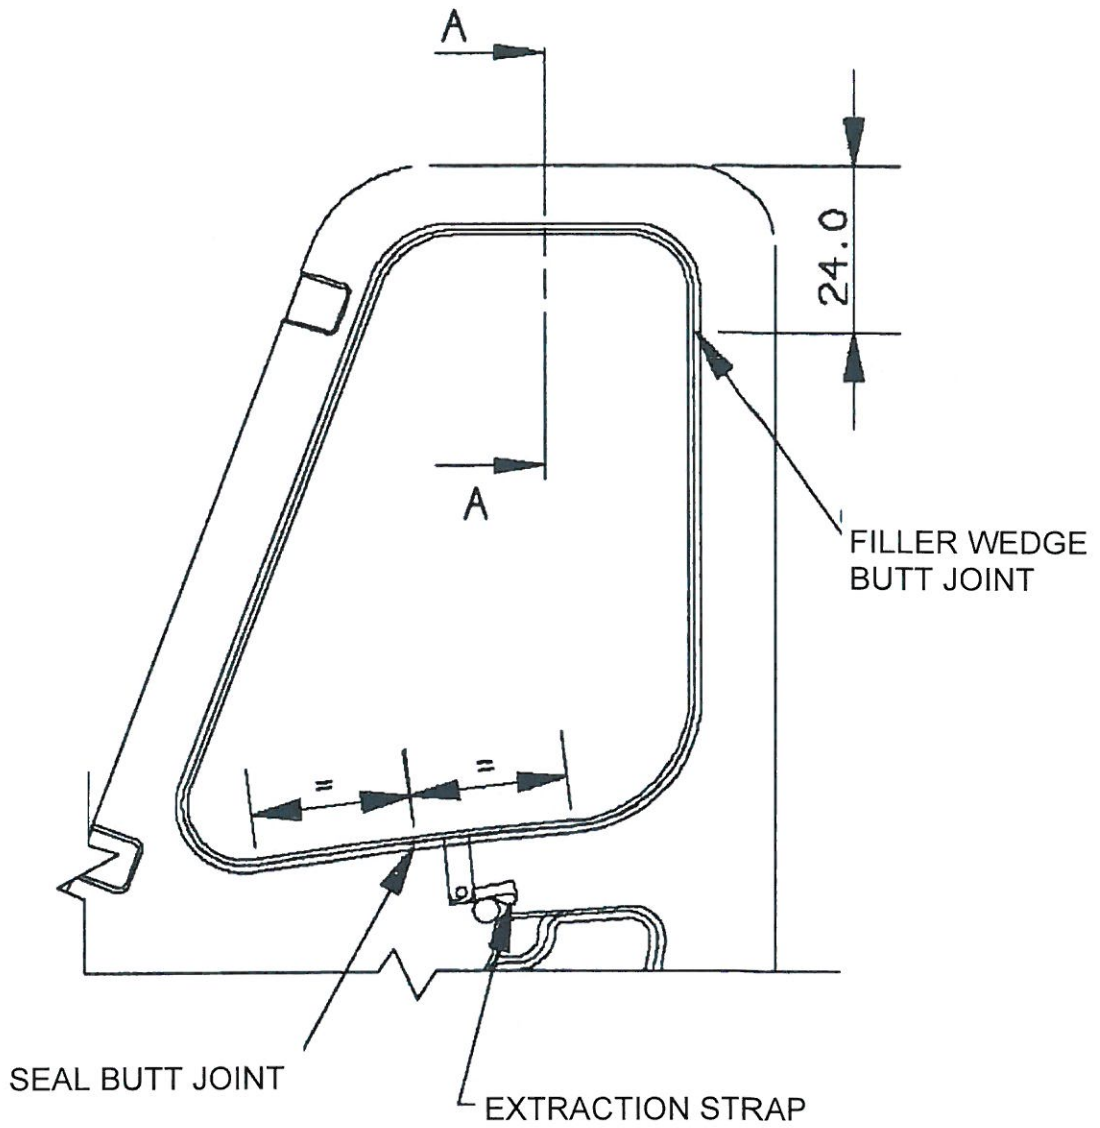
Figure 2

NOTE: LENGTH OF COCKPIT DOOR WINDOW FILLER WEDGE MUST BE 2320 mm

With reference to figure 2, make sure that the seal and the filler wedge length is 2320 mm.

- 7.5 Carefully put the seal on the door structure. Start from the middle top of the window frame. Make sure that the middle of the seal is aligned with the mark on the window frame. Refer to figure 2 to check the correct seal position.

- 7.6 At the end of the installation you have the seal butt joint at the middle bottom of the window frame. Refer to figure 2 to check the correct seal position.

9.6 At the end of installation you have the seal butt joint in position indicated in figure 2. Refer to figure 2 to check the correct filler wedge position.

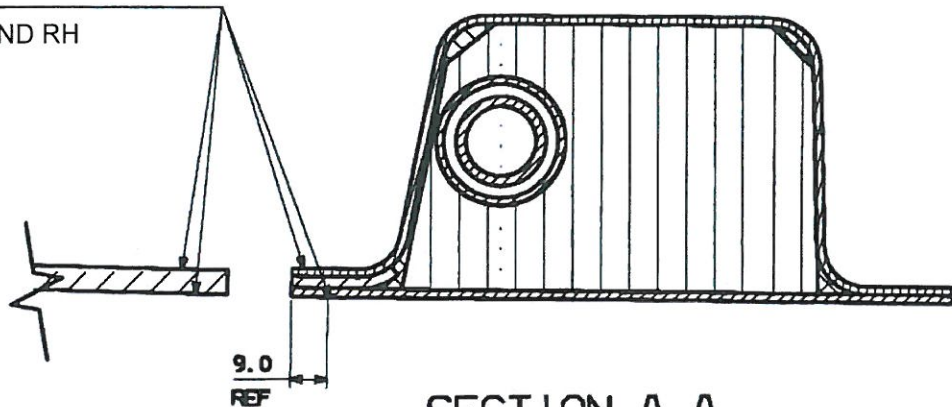
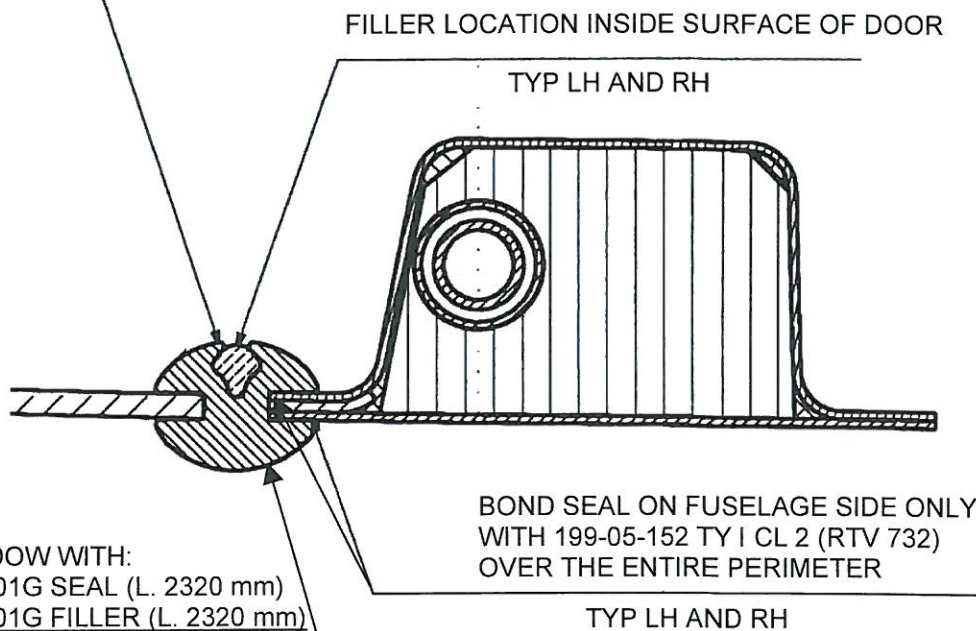
Figure 3

CLEAN WINDOW PANEL BORDER AND DOOR FRAME AND LIP
REMOVE TOP PAINT FOR A BAND EQUAL TO 9 mm

IT IS FORBIDDEN TO STRETCH THE FILLER TO DEFORM THE SECTION, TO MAKE INSTALLATION EASIER

INSTALL WINDOW WITH:
999-1700-48-101G SEAL (L. 2320 mm)
999-1700-49-101G FILLER (L. 2320 mm)

7. With reference to figure 3, install a new seal P/N 999-1700-48-101G as follows:

7.4 With reference to figures 3 and 4, bond the groove of the seal over the whole perimeter on fuselage side only with Adhesive (C126).

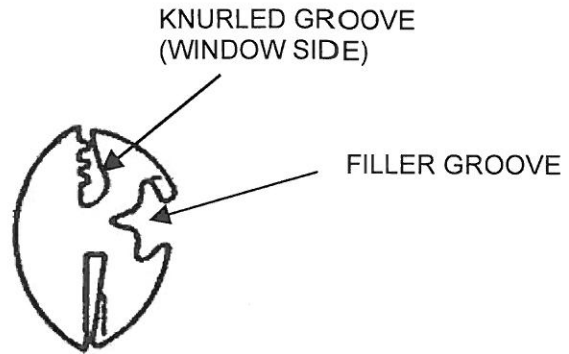
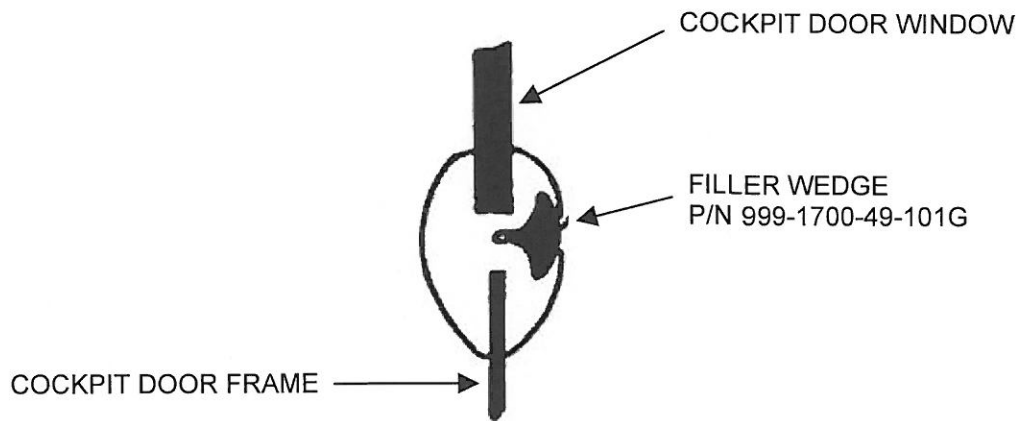
Figure 4

SEAL P/N 999-1700-48-101G

**SEAL P/N 999-1700-48-101G
INSTALLED**
