Airworthiness Directive

AD No.: 2020-0191

ATA 25 – Equipment / Furnishings – Forward Facing Central Seat(s) – Removal

SERVICE BULLETIN**N° 139-633****ALERT****DATE:** August 5, 2020**REV. :** A - September 2, 2020

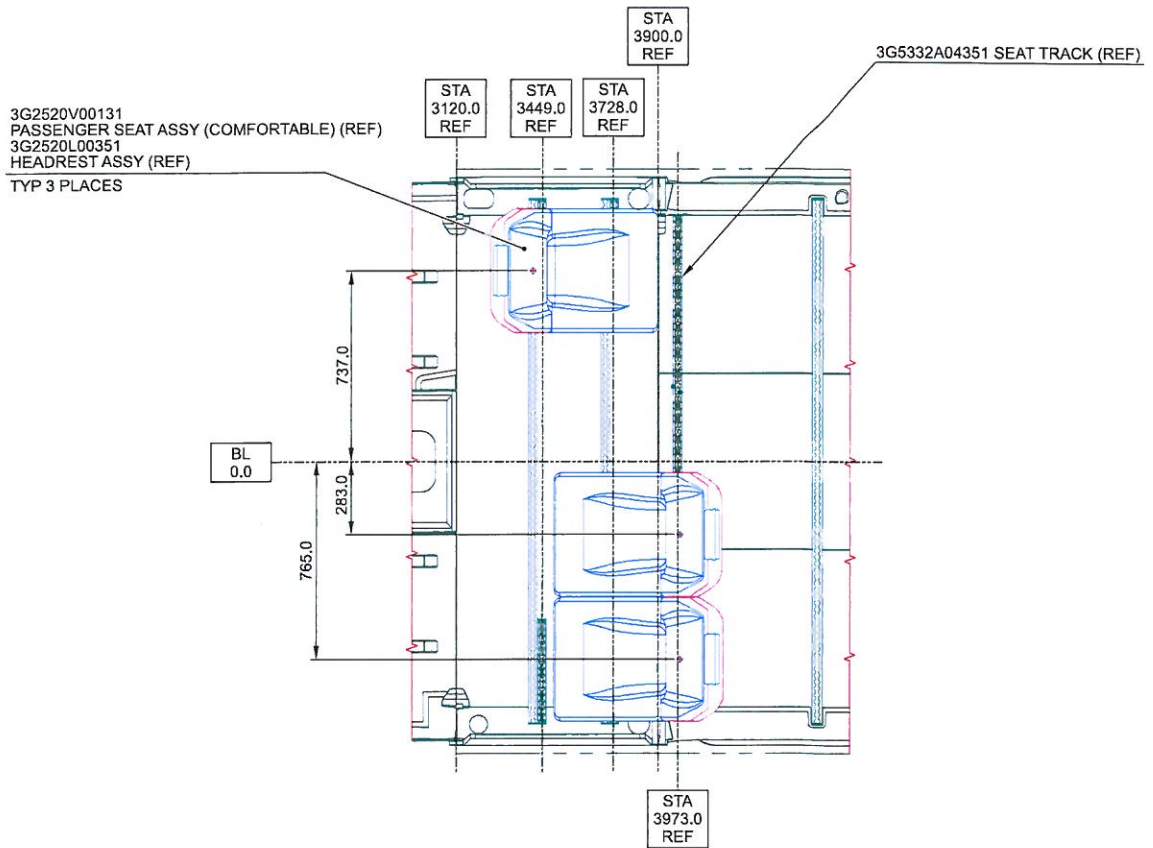
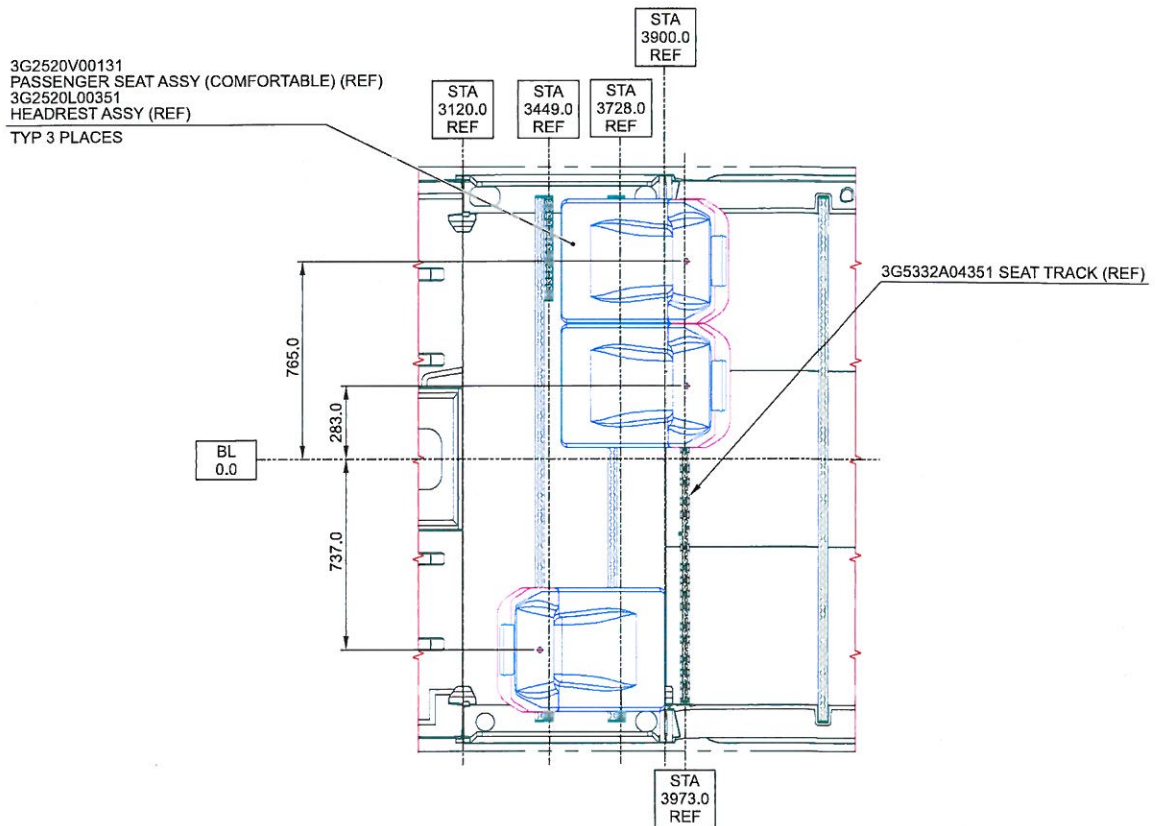
Figure 1

Revision A of this Service Bulletin has been developed to introduce kit P/N 3G2520F00611 (shown in newly added figures 1 and 8) among the affected configurations. Moreover, the illustration of “kit P/N 3G2520F00711 – REMOVAL” in Figure 9 has been changed, to amend a graphical error.

Affected seats configurations are shown in Figures 1 thru 6. The number of passenger cabin floor panels can be identified through the number of rivets rows at STA 4803 as shown in Figure 7:

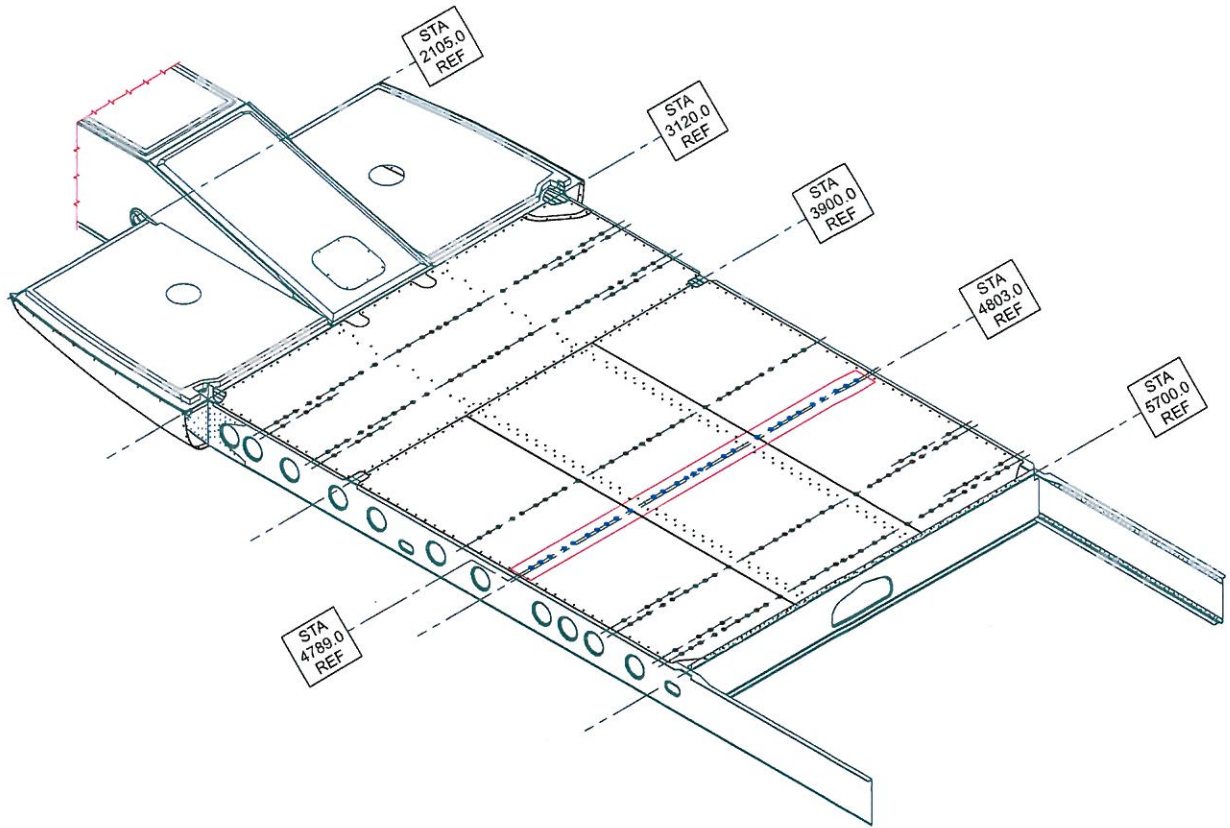
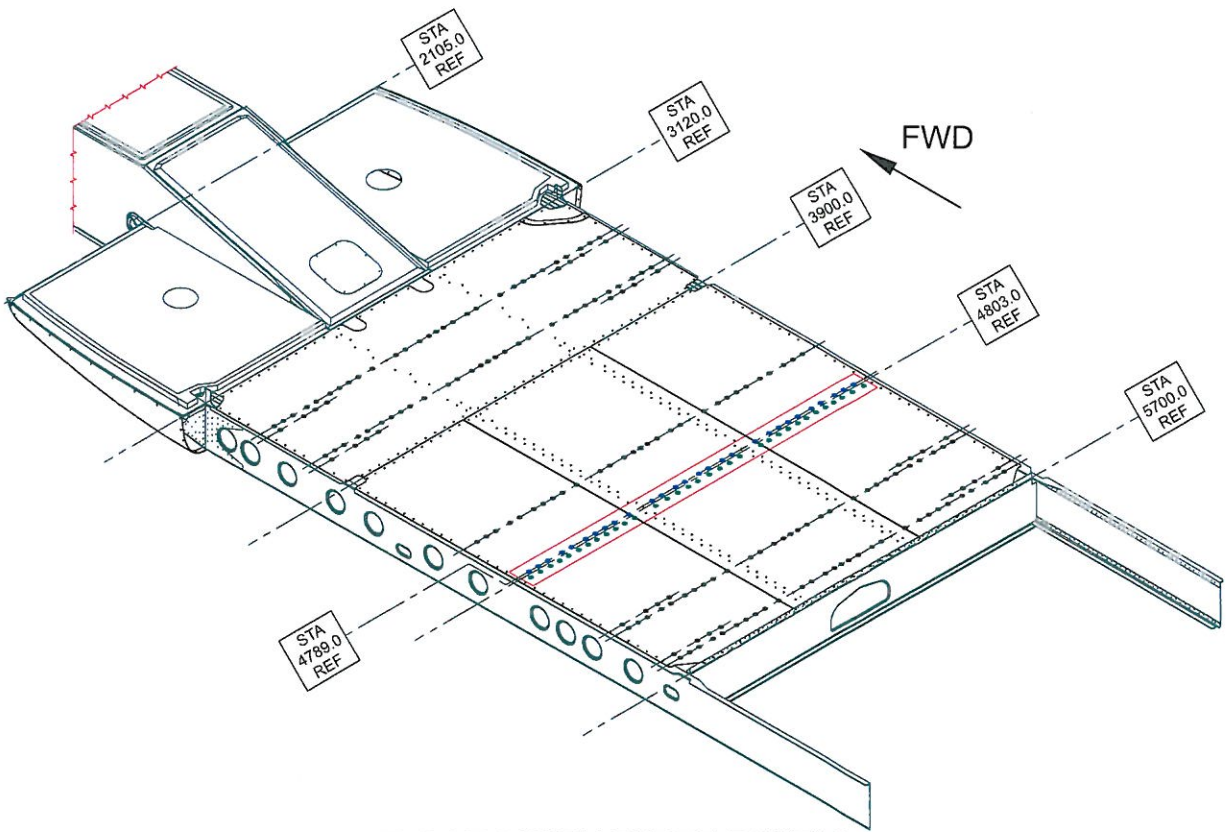
Figure 7

- n°1 rivets row identifies a TWO panels floor;
- n°2 rivets rows identify a THREE panels floor.

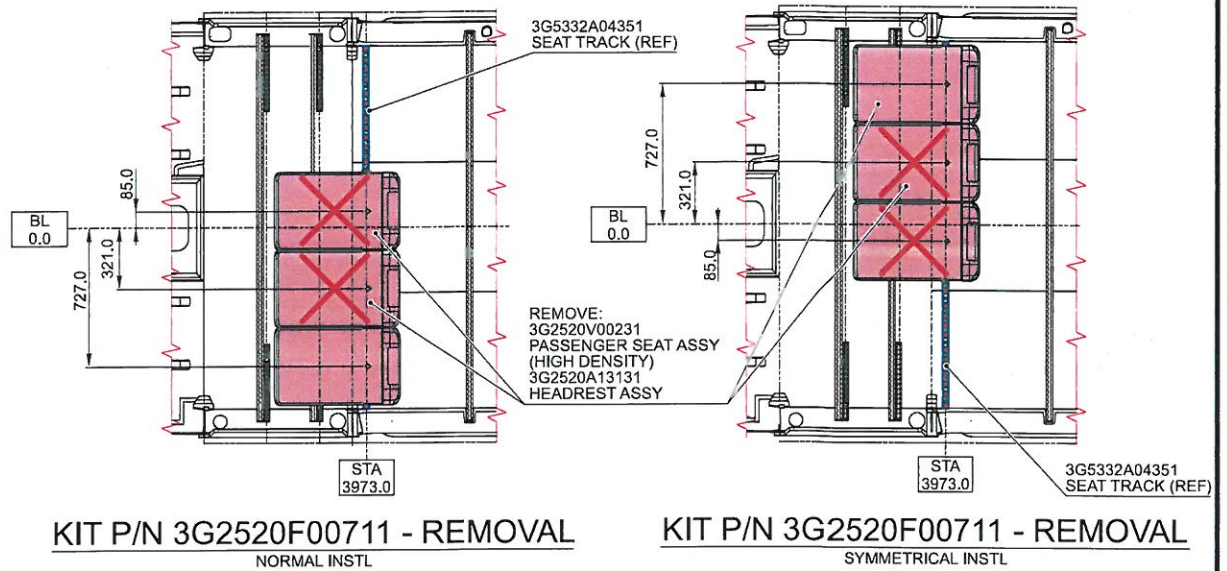
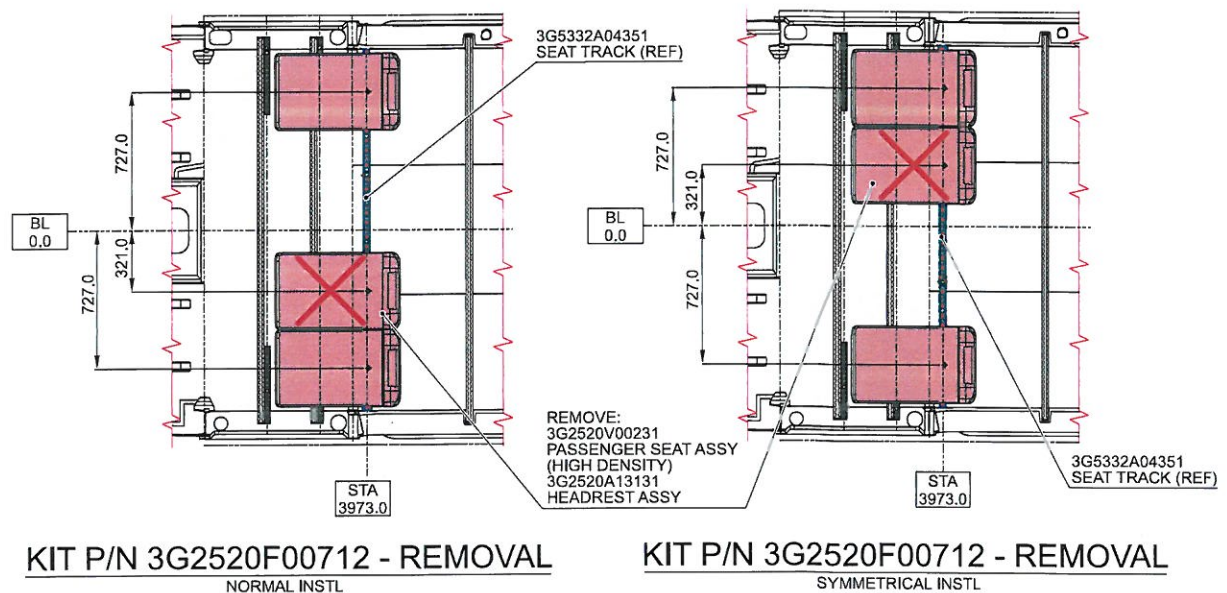
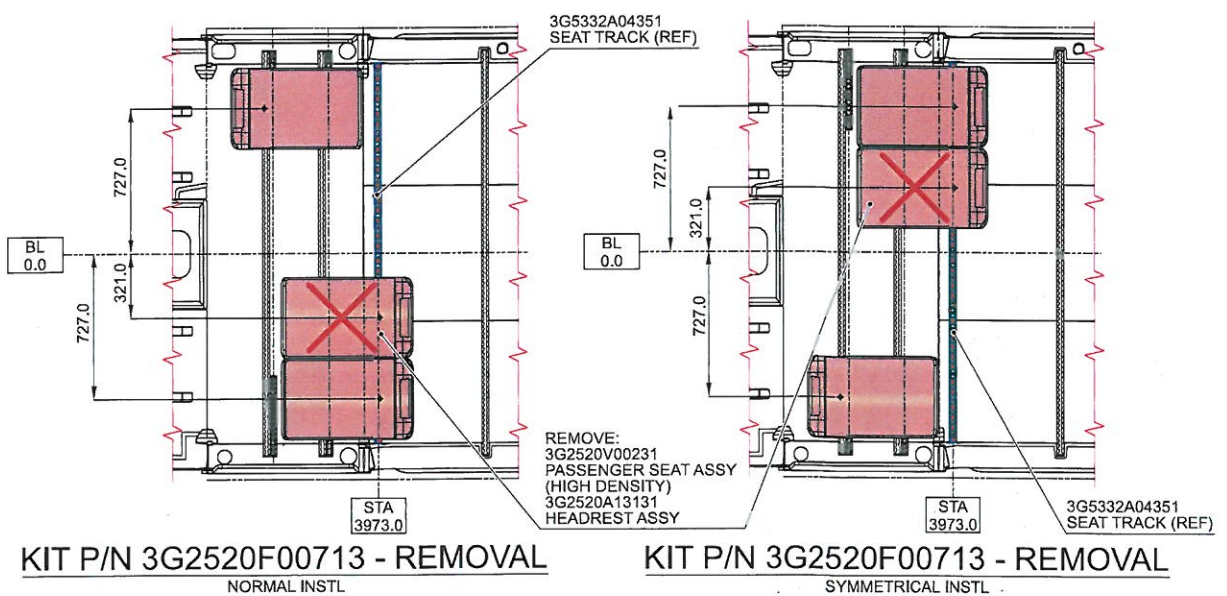
Helicopters that have complied with the first issue of this Service Bulletin have to check Figure 9 of Rev.A, to verify the correct seats configuration.

2. With reference to Figures 8 thru 13 and in accordance with AMP Section 25 applicable DM, remove the indicated 1st row central seat/seats (marked with a red X in the Figures).
3. In accordance with weight and balance changes, update the Chart A (see Rotorcraft Flight Manual, Part II, section 6).
4. Return the helicopter to flight configuration and record for compliance with this Service Bulletin on the helicopter logbook.
5. Send the attached compliance form to the following mail box:
