Airworthiness Directive

AD No.: 2019-0311

ATA 25, 95 – Equipment / Furnishings, Emergency Flotation System – Inflation Hoses – Inspection

ATA 95 - EMERGENCY FLOTATION SYSTEM, FLOAT SUPPLY HOSE INSPECTION OF

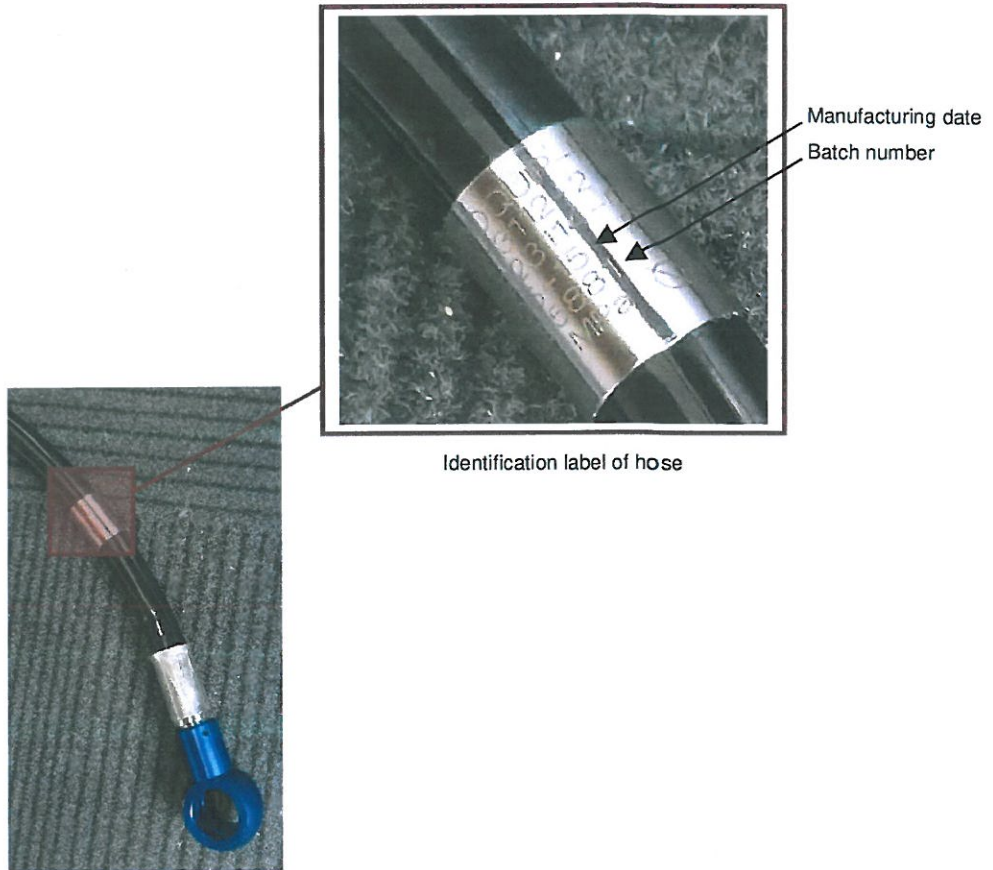
The manufacturing date of the float supply hose is found on the identification label of the hose (refer to Figure 1 in Annex A for location).

NOTE: The manufacturing date and the batch number are found on the identification label of the hose as shown for example in Figure 1.
