# WORKSHEET

SERVICE ORDER : 9 0 0 2 5 5 6 6 WORKSHEET NUMBER : 2022/31763/007-12

**AD No.:** 2021-0121

**ATA 63 - MGB BEARING LOCK-NUT REPLACEMENT**

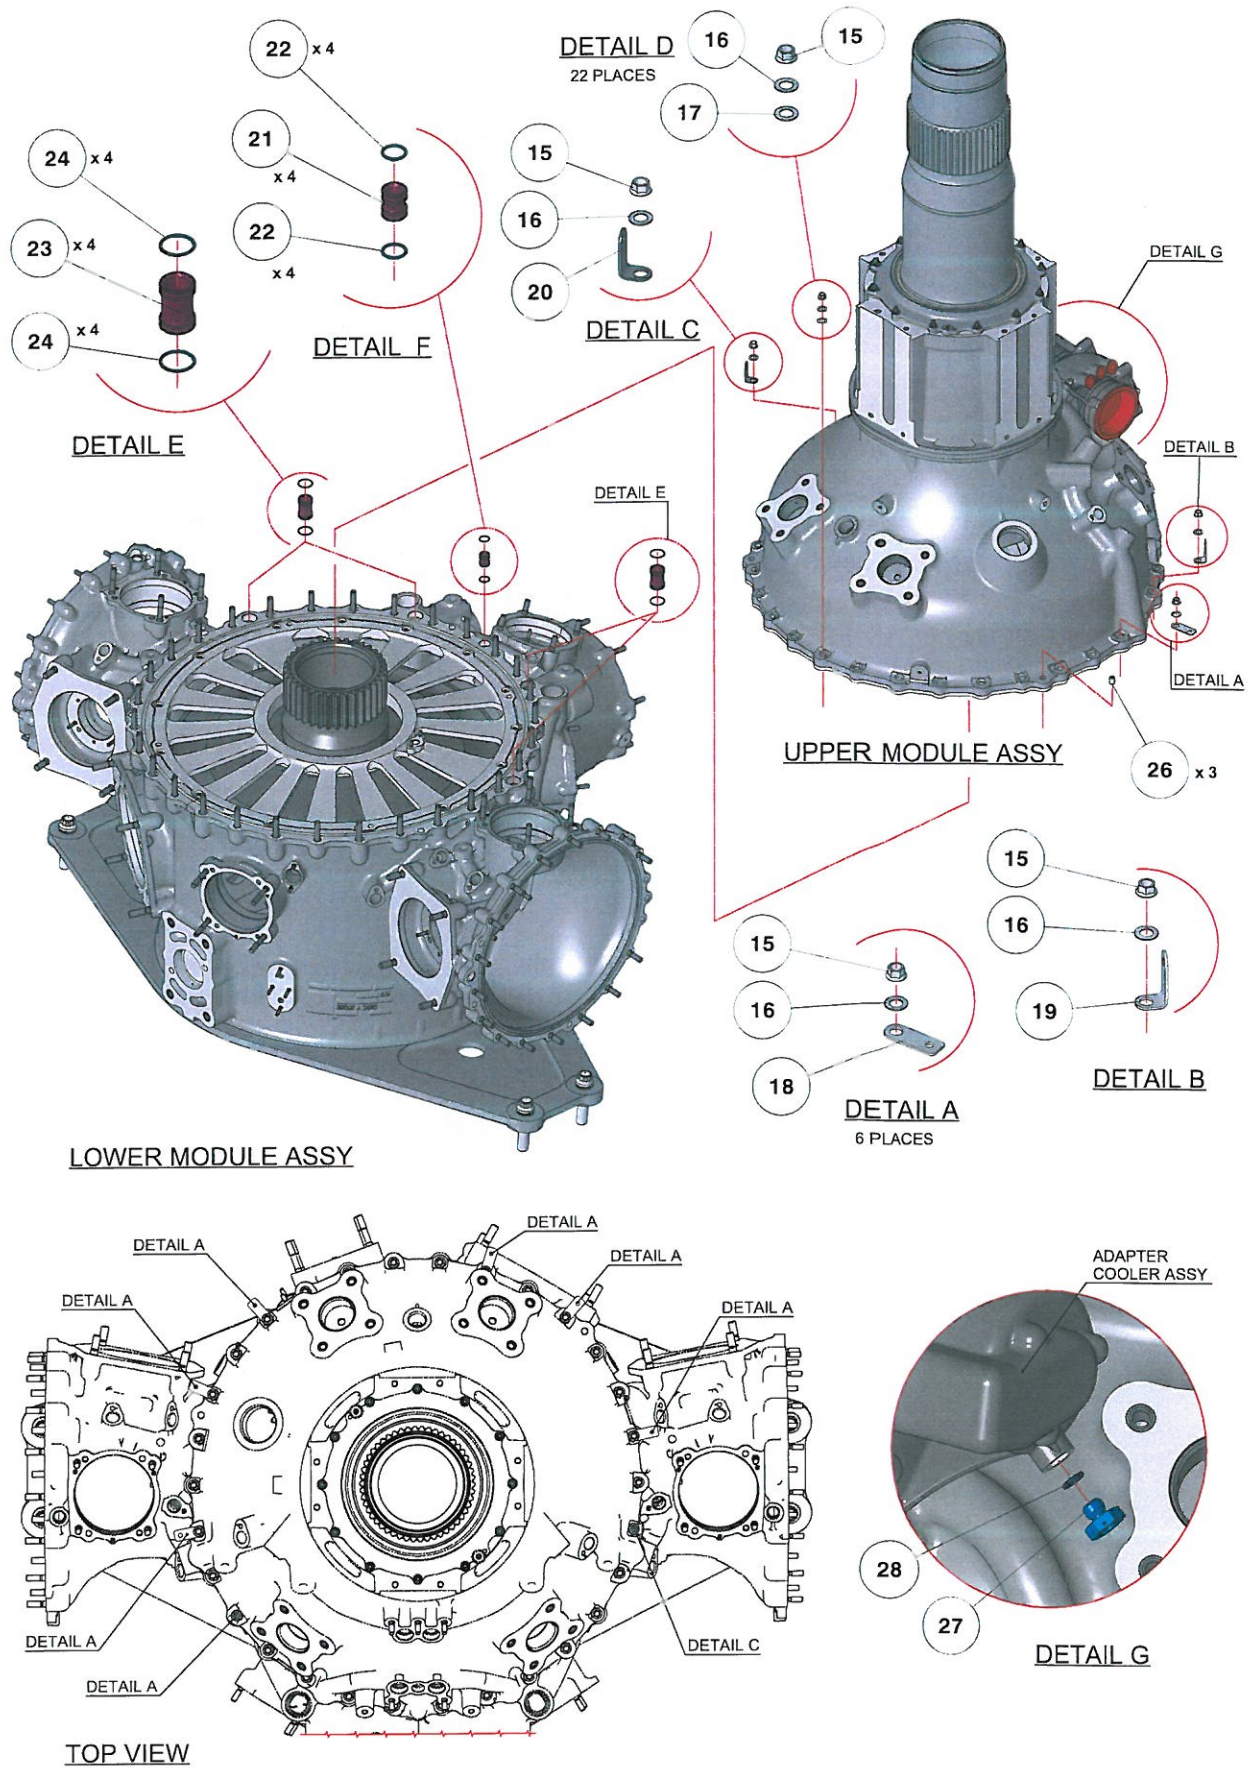
**Figure A2**

7. In accordance with AMP DM 39-A-63-20-00-00A-364A-A, perform the MGB leak check. With reference to figures A2 and A4 in Annex A, pay particular attention to:

- the junction between the upper module assembly and the main case assembly;
    - the lip seal (46).If no leakage is found, seal the junction line with sealing compound MC-780.
