Airworthiness Directive

AD No.: 2021-0259

ATA 53 – Fuselage – Tail Gearbox Fitting – Inspection / Replacement

ATA 53 – TAIL GEAR BOX FITTING INSPECTION

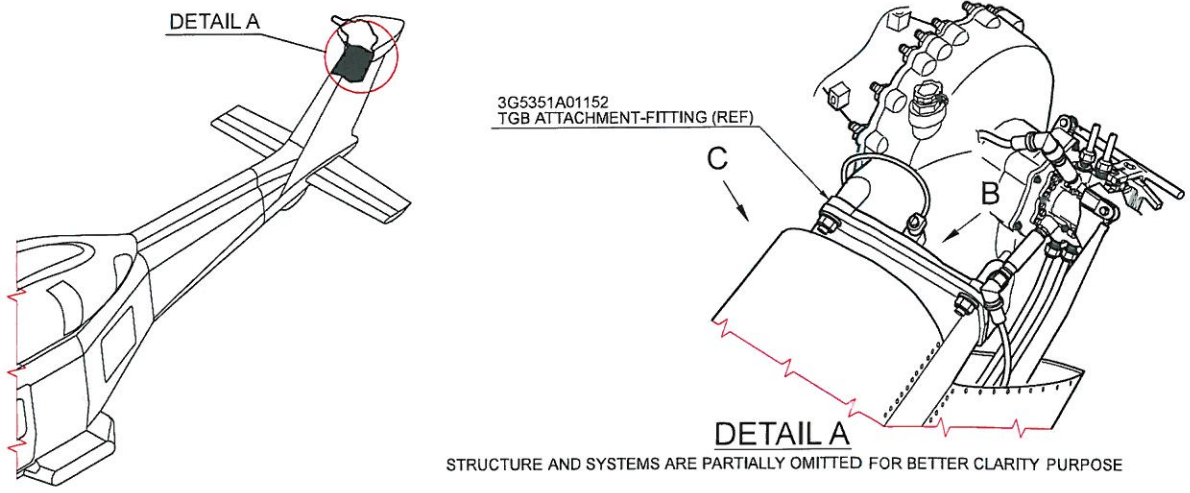
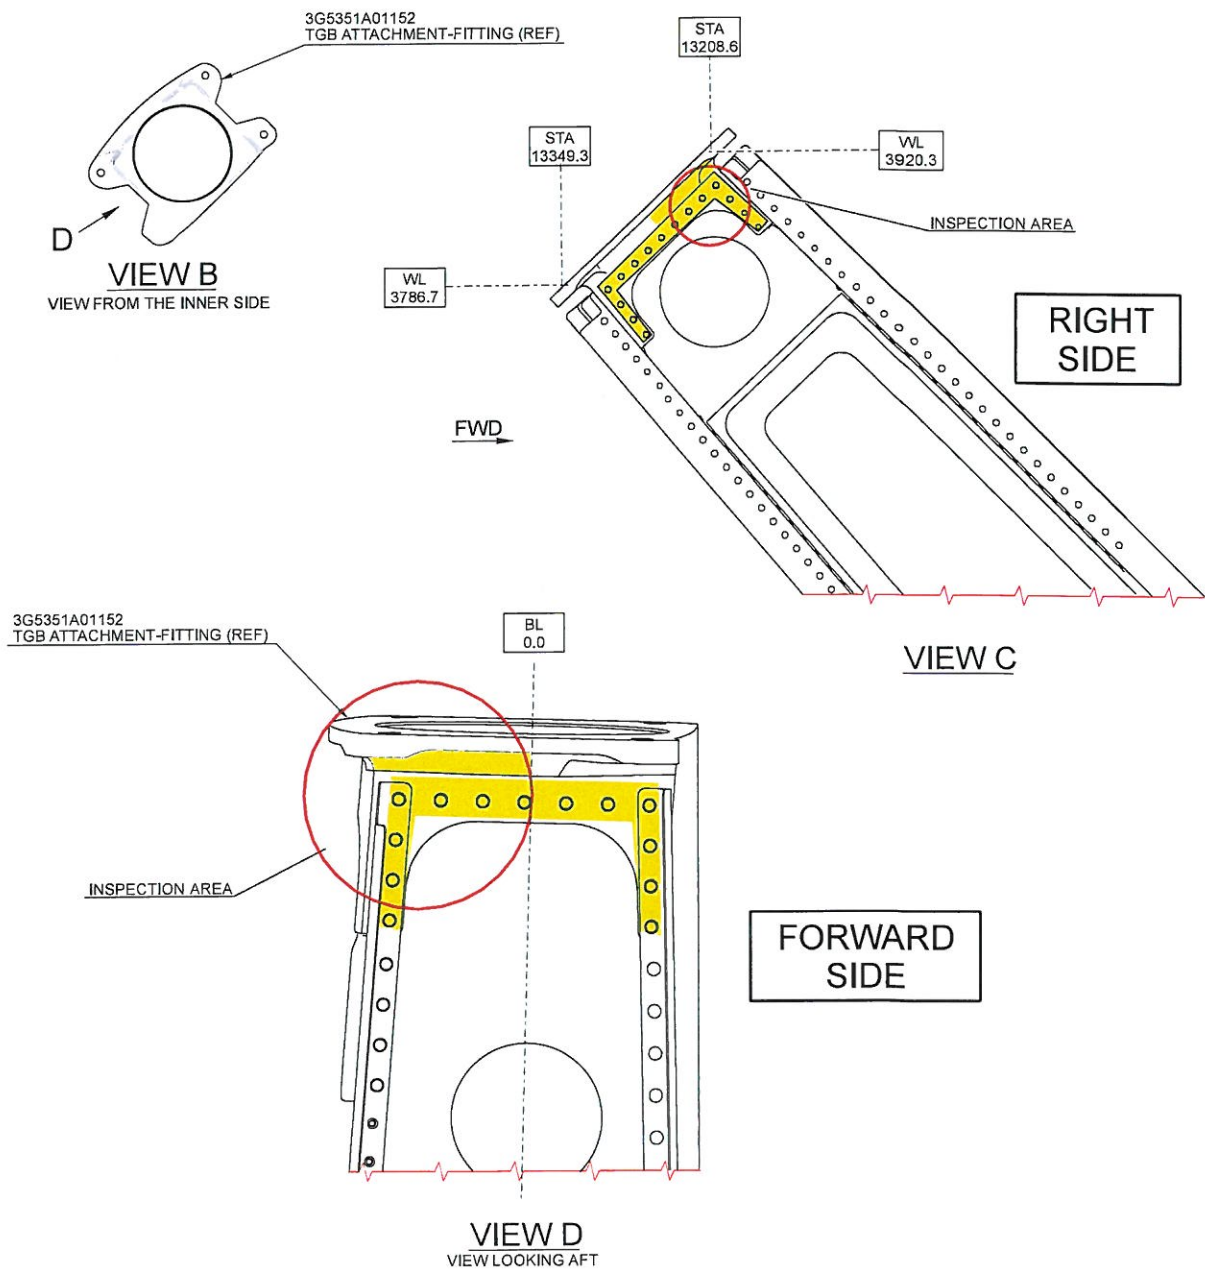
5. With reference to Figures 1 and 2 perform, with the use of a borescope, a detailed inspection for cracks of the RH and FWD sides of the TGB fitting (area delimited by circles in Figure 1) in accordance to the following procedure:
 - 5.1 Properly illuminate the area to inspect (if necessary use a flash light).
 - 5.2 Clean the area to inspect with the Cheesecloth (C028) and the Aliphatic naphtha (C059) or Cleaning solvent (C010).
 - 5.3 With reference to Figure 1 View C and View D, accurately examine the outer surfaces of the forward and right side of TGB fitting body above the horizontal row of fastener holes (area delimited by circles in figure), making sure there are not cracks or damage.
 - 5.4 Accurately examine the area around the vertical and horizontal row of fastener

6. In case of any finding resulting from the inspection required by step 5, take a picture of the crack and of the involved area and contact Product Support Engineering (engineering.support.lhd@leonardocompany.com) to send photos of the cracks. Record for compliance with Part I of this Service Bulletin on the helicopter logbook and immediately proceed with Part II.

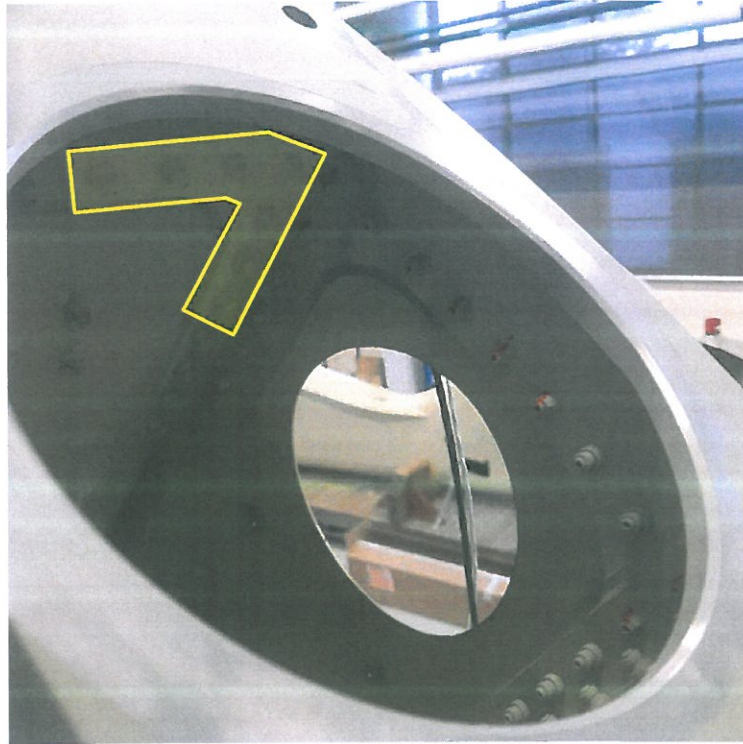
VIEW LOOKING FORWARD SIDE OF TGB FITTING
(FOR REFERENCE ONLY)

holes (refer also to Figure 2 “View looking forward side of TGB fitting”) of the inner forward side of the tail gearbox attachment-fitting.

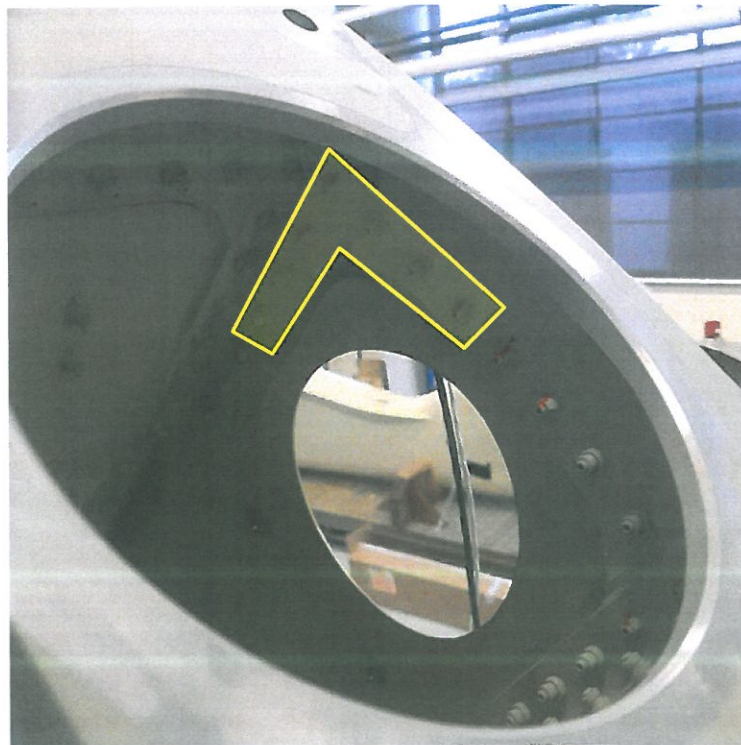
VIEW LOOKING RIGHT SIDE OF TGB FITTING
(FOR REFERENCE ONLY)

- 5.5 Accurately examine the area around the vertical and horizontal row of fastener holes (refer also to Figure 2 “View looking right side of TGB fitting”) of the inner right side of the tail gearbox attachment-fitting.
