LEONARDO MALAYSIA SDN.BHD.		WORK CARD		SERVICE ORDER NUMBER: 90025566		WORKCARD NUMBER: 2022/31763/004-05	
		TITLE: EASA AD NO.: 2021-0044R1 ISSUED: 12 MAY 2022 (ASB 139-661 DATE: MAY 9, 2022 REV.: B) - ATA 24 - OVERHEAD PANEL INSPECTION (PART II)		CUSTOMER: LEONARDO HELICOPTER ITALY (LHI)			
REGISTRATION: 9M-BGH	AIRFRAME HOURS: 300:40	#1 ENGINE	SERIAL NUMBER: PCE-KB1931	#2 ENGINE	SERIAL NUMBER: PCE-KB1885	APU	SERIAL NUMBER: N/A
SERIAL NUMBER: 31763	LANDINGS: 838		HOURS: 300:40		HOURS: 300:40		HOURS: 300:40

AD No.: 2021-0044R1

SERVICE BULLETIN**N° 139-661****ALERT****DATE:** February 4, 2021**REV. :** B - May 9, 2022

TITLE**ATA 24 – OVERHEAD PANEL INSPECTION****REVISION LOG**

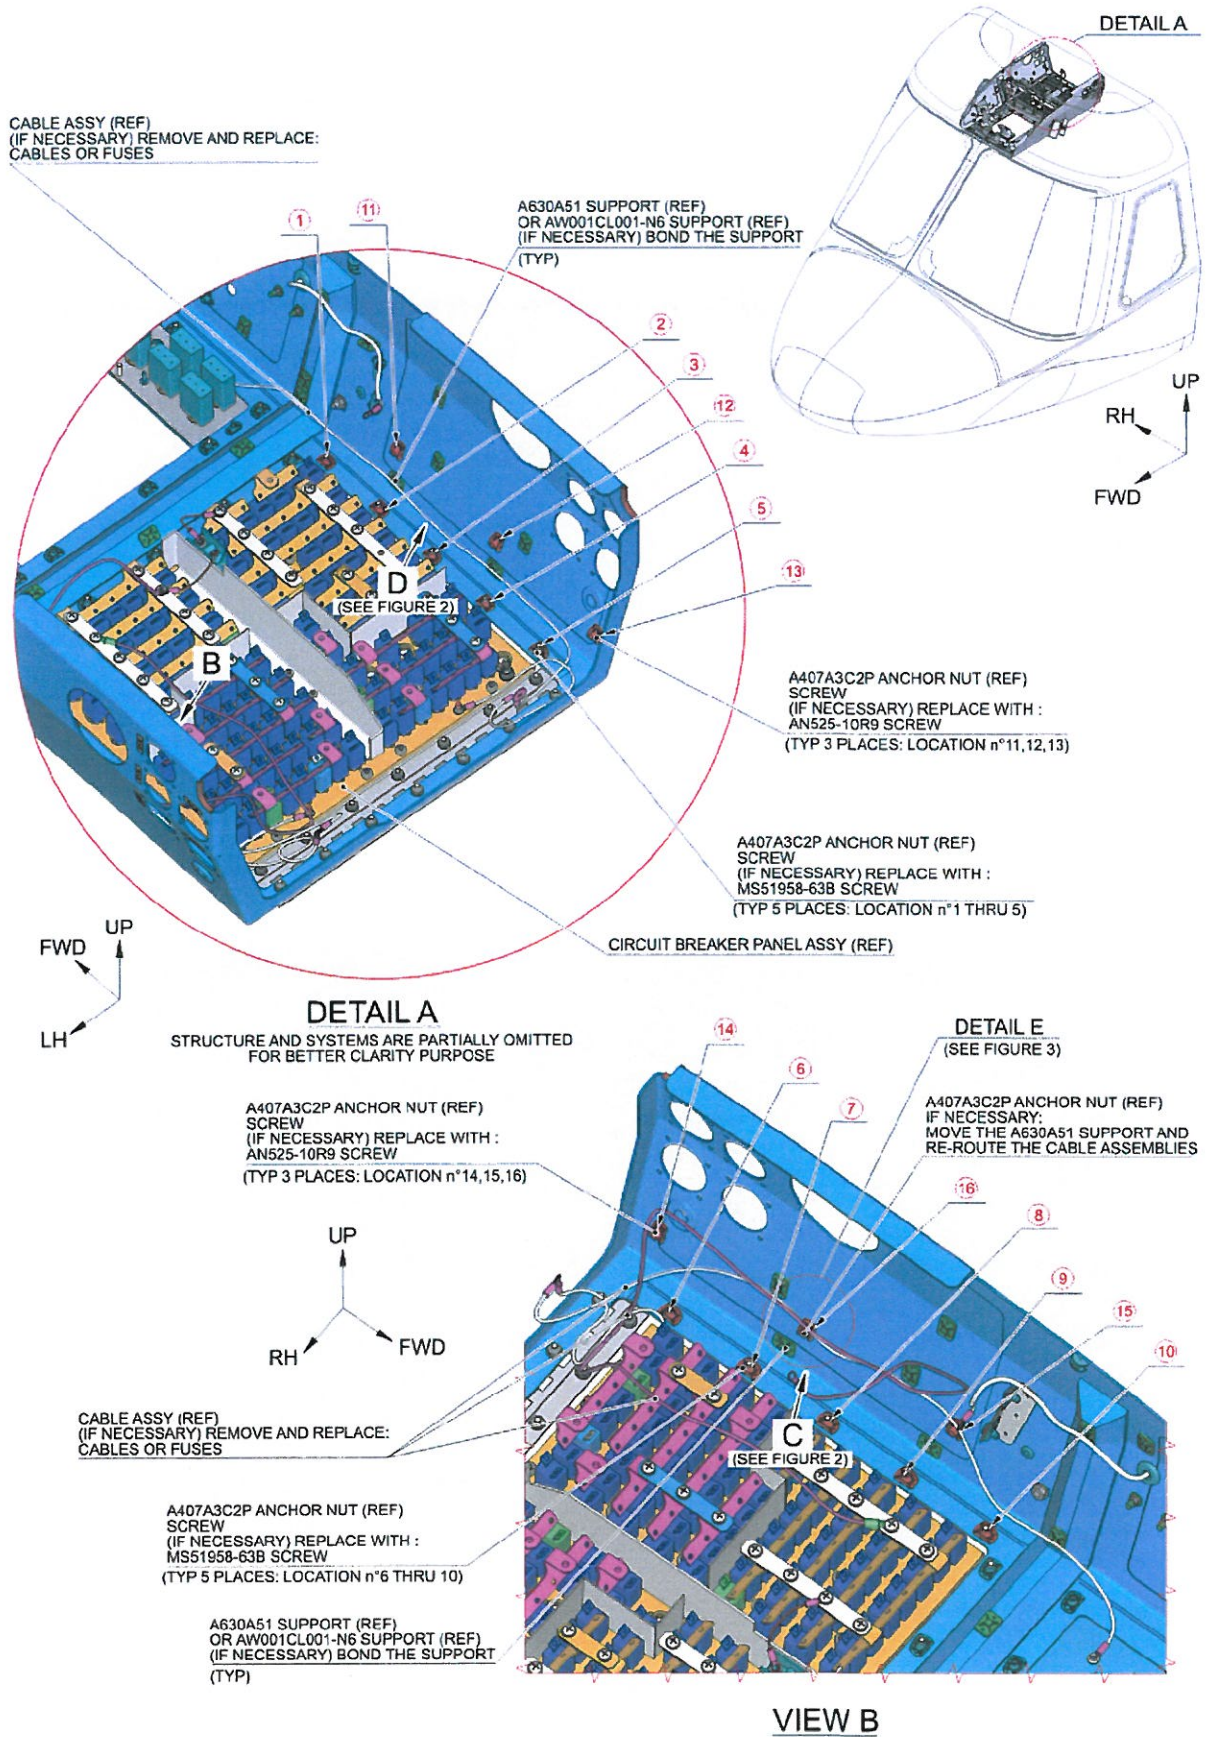
NO	SOURCE	TASK / REFERENCE	REMARKS	MECHANIC SIGN	* AH SIGN & STAMP	DATE
		2.10 WITH REFERENCE TO FIGURE 1 DETAIL A AND VIEW B, CHECK FOR CHAFING DAMAGE OF THE CABLE HARNESS AND ENSURE THAT CLEARANCE EXISTS BETWEEN THE CABLE HARNESS AND THE ANCHOR NUTS P/N A407A3C2P AND/OR THE SCREWS AT THE INDICATED LOCATIONS FROM N°1 THRU N°16.	SATISFACTORY NIL FINDINGS	adh	adh

- 2.4 With reference to Figure 1 Detail A and View B, check for chafing damage of the cable harness and ensure that clearance exists between the cable harness and the anchor nuts P/N A407A3C2P and/or the screws at the indicated locations from n°1 thru n°16.

- 2.9 With reference to Figure 2 View D, repeat step 2.8 for the RH side.
- 2.10 With reference to Figure 1 Detail A and View B, check for chafing damage of the cable harness and ensure that clearance exists between the cable harness and the anchor nuts P/N A407A3C2P and/or the screws at the indicated locations from n°1 thru n°16.

2.11 WITH REFERENCE TO FIGURE 1 DETAIL A AND VIEW B, REMOVE AND REPLACE THE DAMAGED CABLES OR FUSES.				
		2.12 IN ACCORDANCE WITH THE APPLICABLE STEPS OF AMP DM 39-A-24-91-01-00A-720A-A AND WITH REFERENCE TO FIGURE 1 DETAIL A, CLOSE THE CIRCUIT BREAKER PANEL ASSY.	SATISFACTORY NIL FINDINGS	adh	adh

- 2.11 With reference to Figure 1 Detail A and View B, remove and replace the damaged cables or fuses.
- 2.12 In accordance with the applicable steps of AMP DM 39-A-24-91-01-00A-720A-A and with reference to Figure 1 Detail A, close the circuit breaker panel assy.
3. In case of findings, contact Product Support Engineering (engineering.support.lhd@leonardo.com) to report about the results of the inspections requested by step 2.
4. Return the helicopter to flight configuration and record for compliance with Part II of this Service Bulletin on the helicopter logbook.
5. Send the attached compliance form to the following mail box:

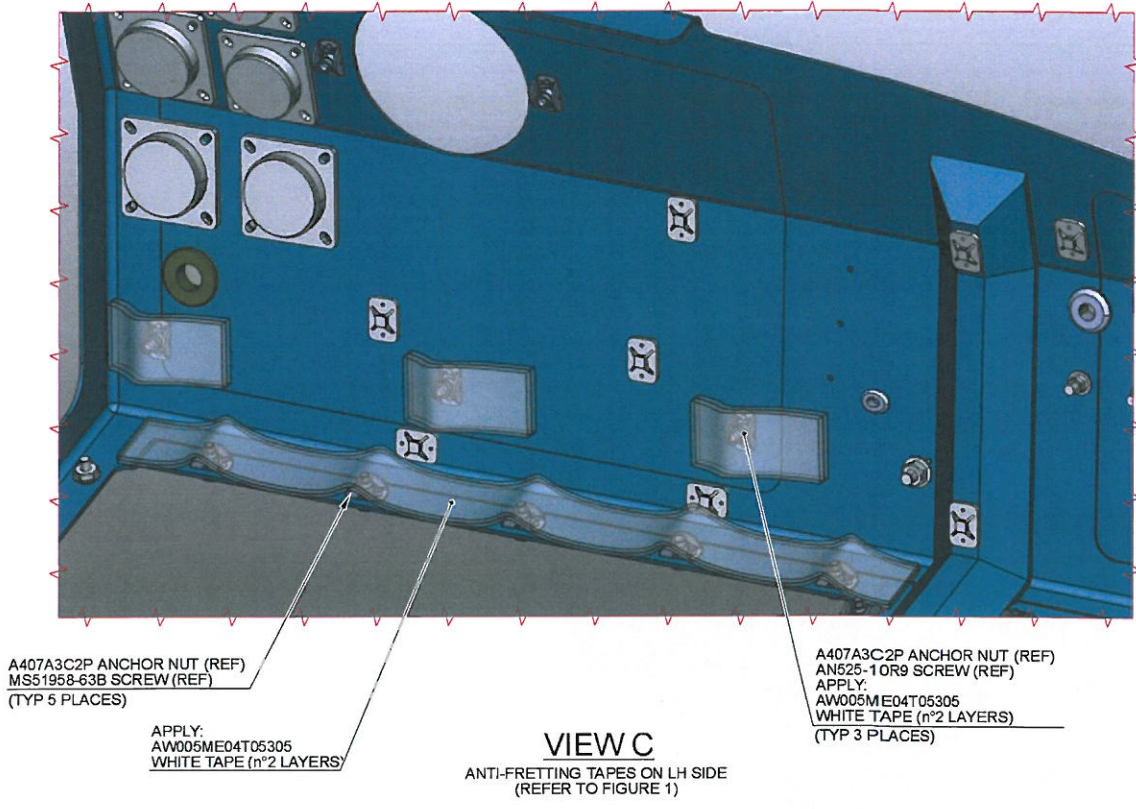
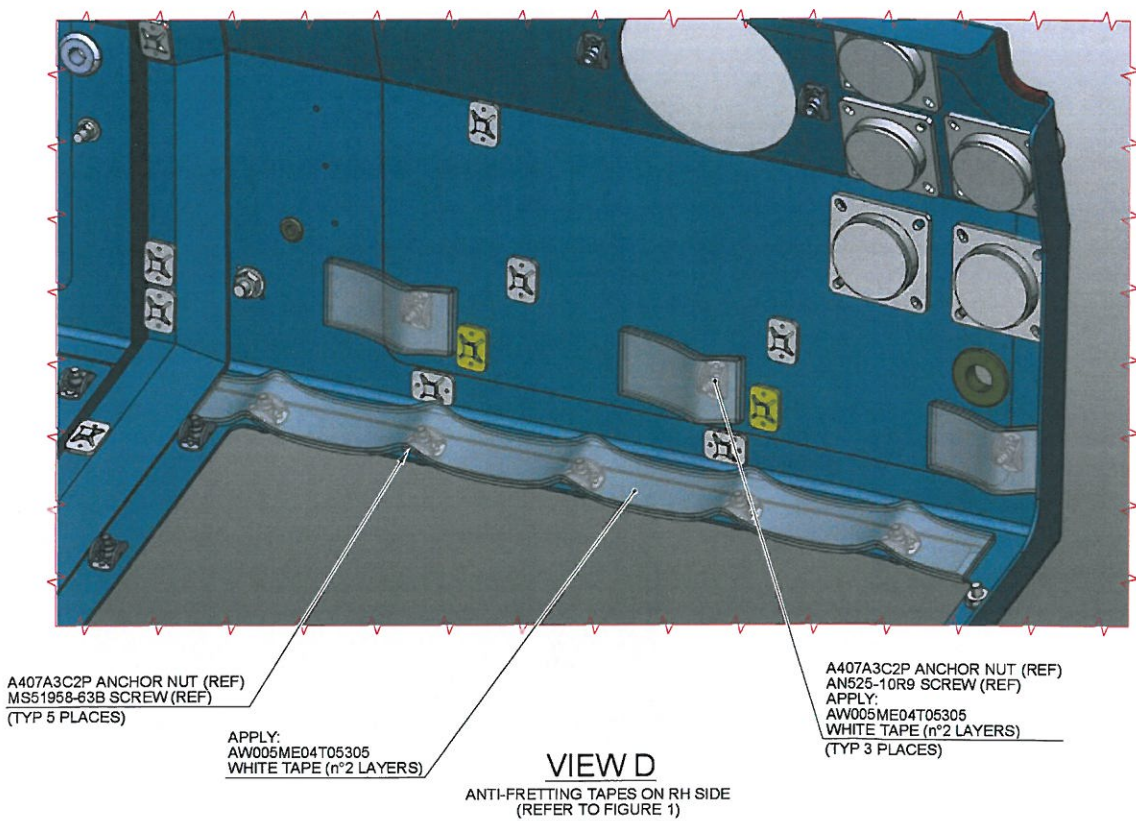
NO	SOURCE	TASK / REFERENCE	REMARKS	MECHANIC SIGN	* AH SIGN & STAMP	DATE
		2.6 WITH REFERENCE TO FIGURE 1 DETAIL A AND VIEW B, TO FIGURE 2 VIEW C AND VIEW D, CHECK FOR THE CONDITION OF THE N°2 LAYERS OF THE WHITE TAPE P/N AW005ME04T05305 (OR EQUIVALENT P/N LISTED IN CONSUMABLE LIST) ON EACH OF THE N°6 ANCHOR NUTS P/N A407A3C2P (N°3 ON THE LH SIDE AND N°3 ON THE RH SIDE).	SATISFACTORY NIL FINDINGS TAPE < 30mm	<i>act</i>	<i>act</i>

- 2.6 With reference to Figure 1 Detail A and View B, to Figure 2 View C and View D, check for the condition of the n°2 layers of the white tape P/N AW005ME04T05305 (or equivalent P/N listed in consumable list) on each of the n°6 anchor nuts P/N A407A3C2P (n°3 on the LH side and n°3 on the RH side).

2.8 WITH REFERENCE TO FIGURE 2 VIEW C, REMOVE N°2 LAYERS OF THE WHITE TAPE FROM THE ANCHOR NUT AND APPLY IN THE SAME POSITION N°2 NEW LAYERS OF THE WHITE TAPE P/N AW005ME04T05305 (OR EQUIVALENT P/N LISTED IN CONSUMABLE LIST). IF NECESSARY, REPEAT FOR ALL THE THREE ANCHOR NUTS.				
		NOTE PERFORM THE FOLLOWING STEP 2.9 ONLY IF YOU NEED TO REPLACE THE PROTECTIVE TAPE ON THE RH SIDE.	NOT APPLICABLE NO REPLACEMENT REQUIRED	NA	<i>act</i>

2.9 WITH REFERENCE TO FIGURE 2 VIEW D, REPEAT STEP 2.8 FOR THE RH SIDE.
