WORK CARD

EASA AD 2022-0209-E ISSUED: 12 OCTOBER 2022 (EASB 139-731 DATE: OCTOBER 11, 2022 REV. : /) - ATA 00 – FORWARD CABIN ROOF CEILING HARNESS INSPECTION (PART I)

LEONARDO HELICOPTER ITALY (LHI)

REGISTRATION:	9M-BGH	AIRFRAME HOURS:	300:40	#1 ENGINE	SERIAL NUMBER:	PCE-KB1931	#2 ENGINE	SERIAL NUMBER:	PCE-KB1885	APU	SERIAL NUMBER:	N/A
SERIAL NUMBER:	31763	LANDINGS:	838		HOURS:	300:40		HOURS:	300:40		HOURS:	N/A

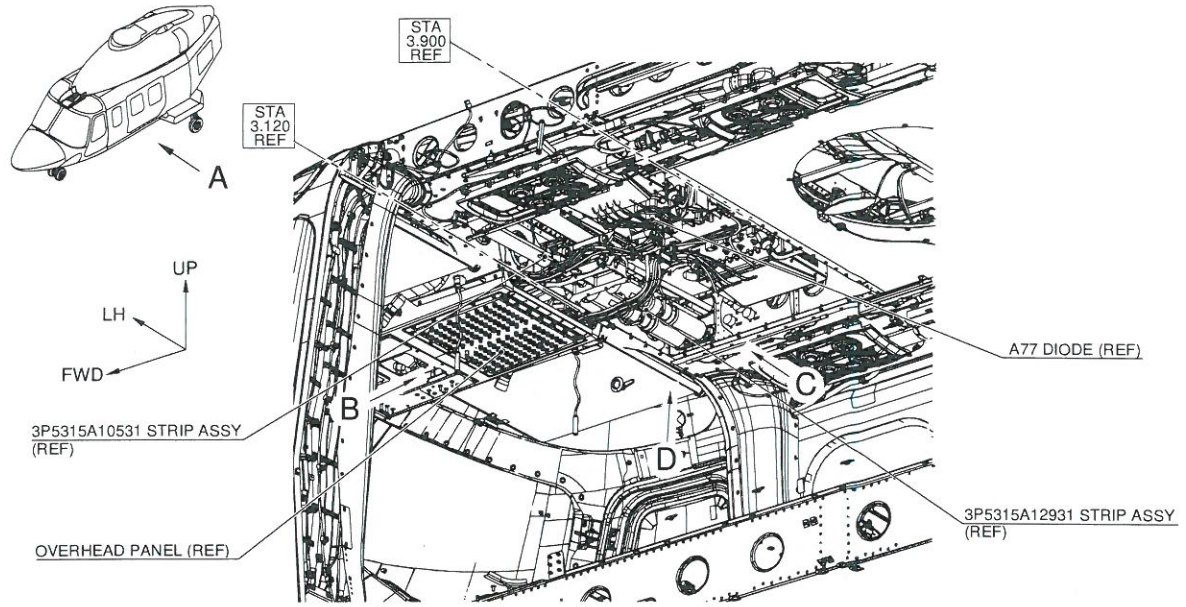
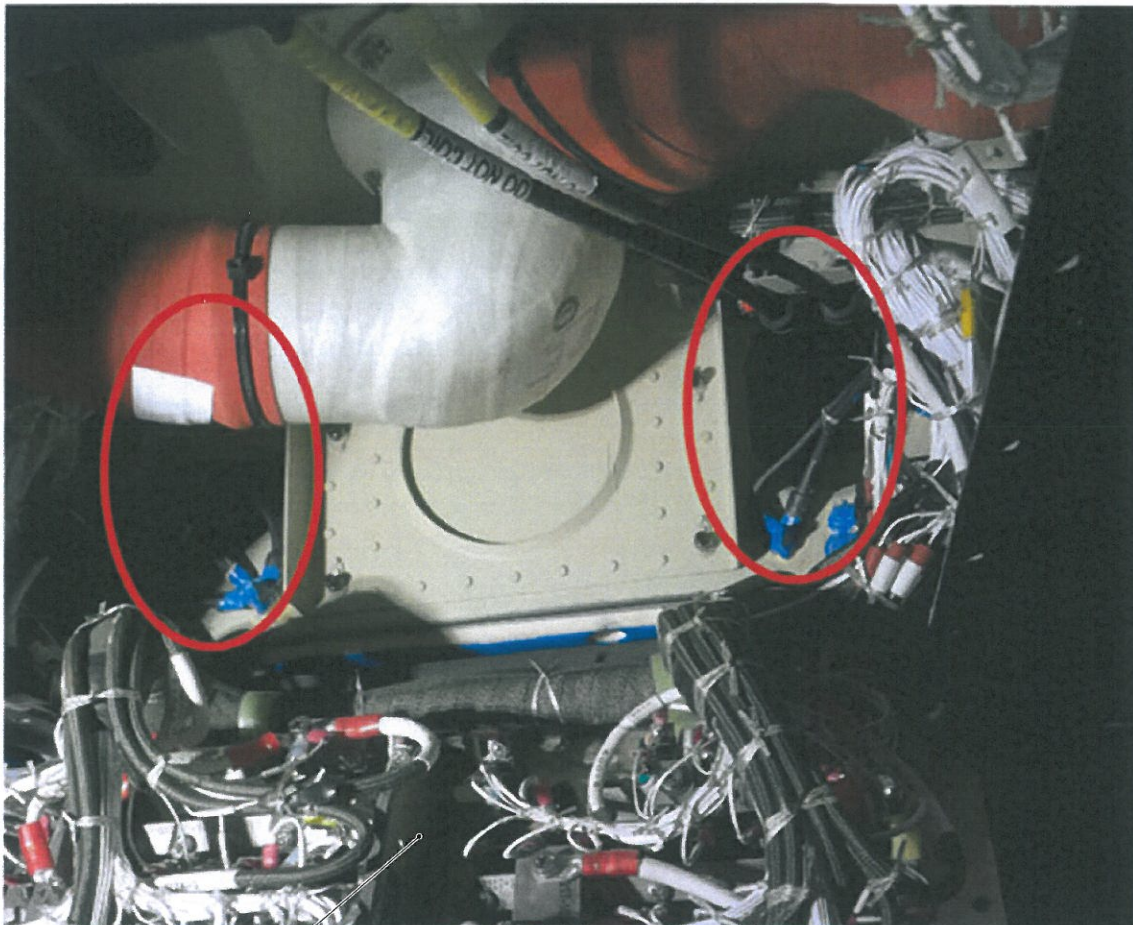
Figure 1

2.1.2 WITH REFERENCE TO FIGURE 1, INSERT THE BORESCOPE INSIDE THE LIGHTENING HOLES SHOWED TO ACCESS THE AREA OF THE INSPECTION.	SATISFACTORY NIL FINDINGS	<i>ad</i>	<i>ad</i>

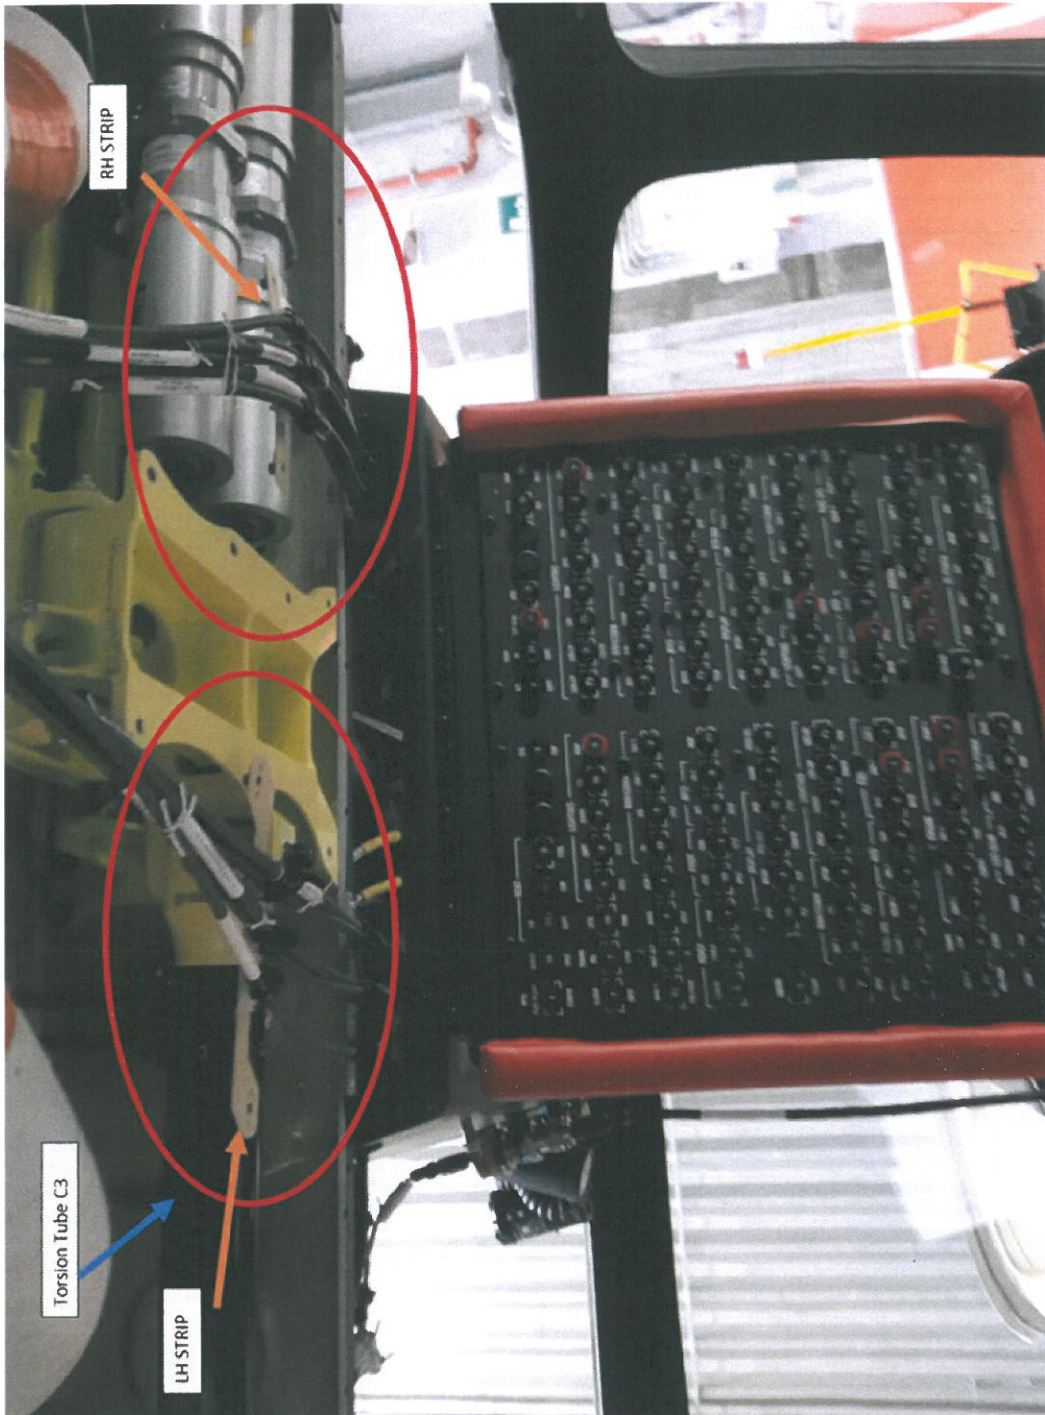
Figure 2

NO	SOURCE	TASK / REFERENCE	REMARKS	MECHANIC SIGN	* AH SIGN & STAMP	DATE
		3.2 WITH REFERENCE TO FIGURE 2, PERFORM A VISUAL INSPECTION OF THE TORQUE TUBE C3 P/N 3E6711A00433. MAKE SURE THAT THERE IS NO DAMAGE ON THE TUBE. IF DAMAGE IS FOUND, CONTACT PRODUCT SUPPORT ENGINEERING (ENGINEERING.SUPPORT.LHD@LEONARDO.COM) IN ORDER TO RECEIVE FURTHER INSTRUCTION.	NOT APPLICABLE REFER 2.1.4 AND 2.1.5	N/A	<i>asl</i>

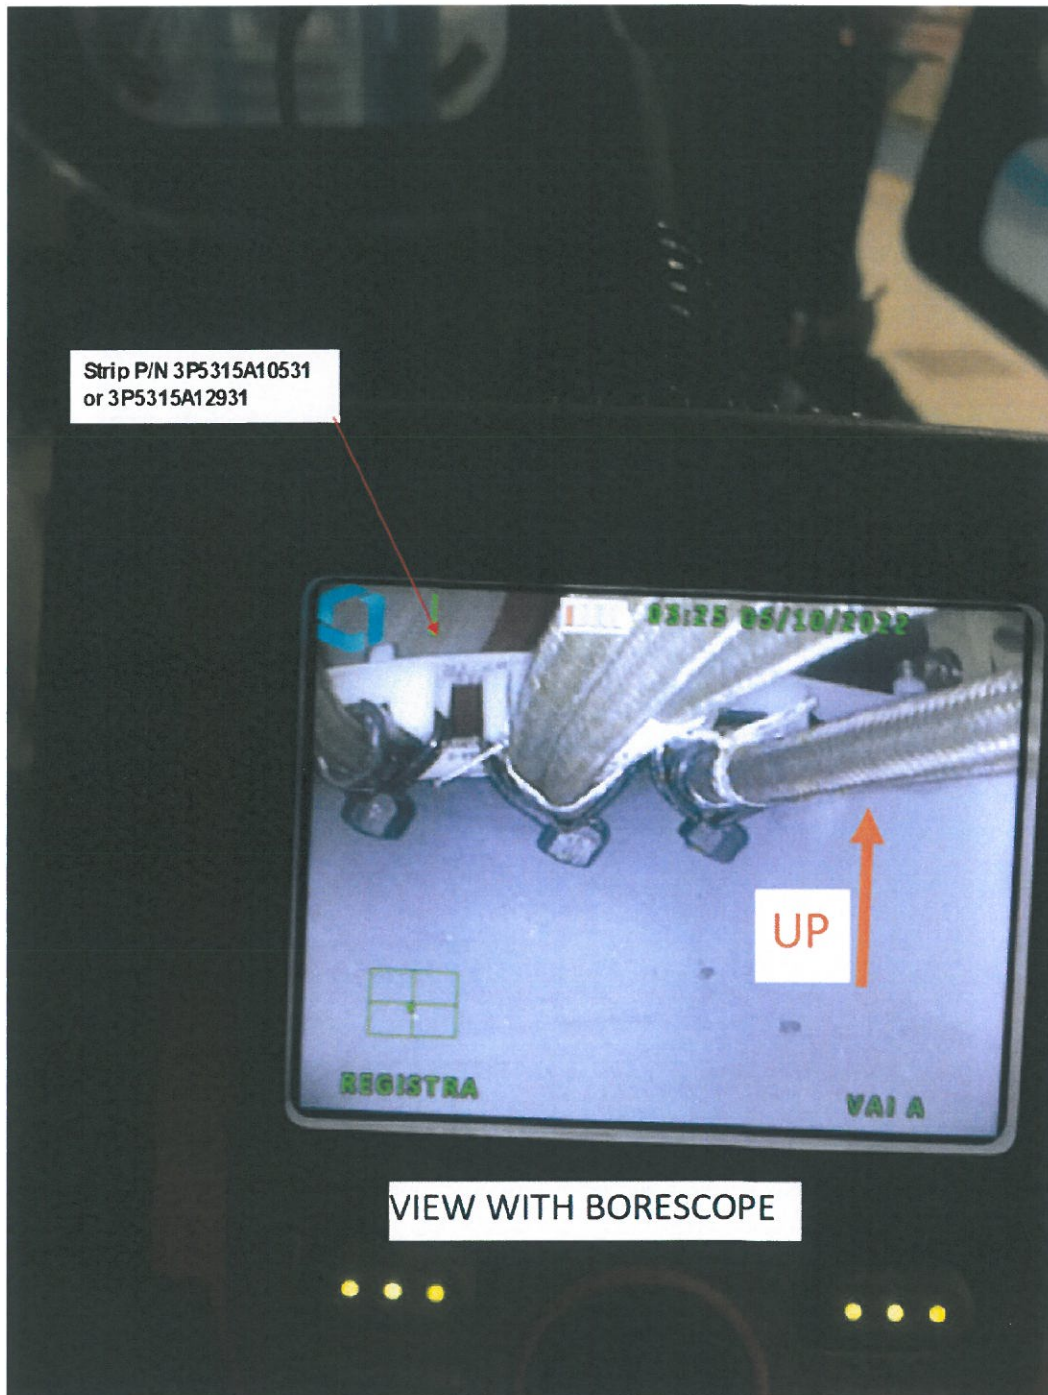
Figure 3

31/10/22
		NOTE WHEN C/A INSTALLATION IS CORRECT, C/A ARE INSTALLED BELOW THE RH/LH STRIPS P/N 3P5315A10531 AND P/N 3P5315AA12931, AS SHOWN IN FIGURE 3.	-	-	-	-

NO	SOURCE	TASK / REFERENCE	REMARKS	MECHANIC SIGN	* AH SIGN & STAMP	DATE
		2.1.4 IF C/AS ARE INSTALLED ABOVE THE STRIPS P/N 3P5315A10531 AND/OR P/N 3P5315A12931 AS PER FIGURE 4 "INCORRECT INSTALLATION", GO TO STEP 3.	SATISFACTORY C/AS AS PER FIGURE 3	<i>adl</i>

2.1.5 IF C/AS ARE INSTALLED CORRECTLY AS SHOWN IN FIGURE 3, GO TO STEP 5 AND CLOSE SB PART I APPLICATION.	SATISFACTORY C/AS AS PER FIGURE 3	<i>adl</i>
