## ARRIEL 2

**Subject: M02 compressor module. Bonding of sleeve in the bleed-valve mounting boss.**

**Incorporation of modification TU 70A.**

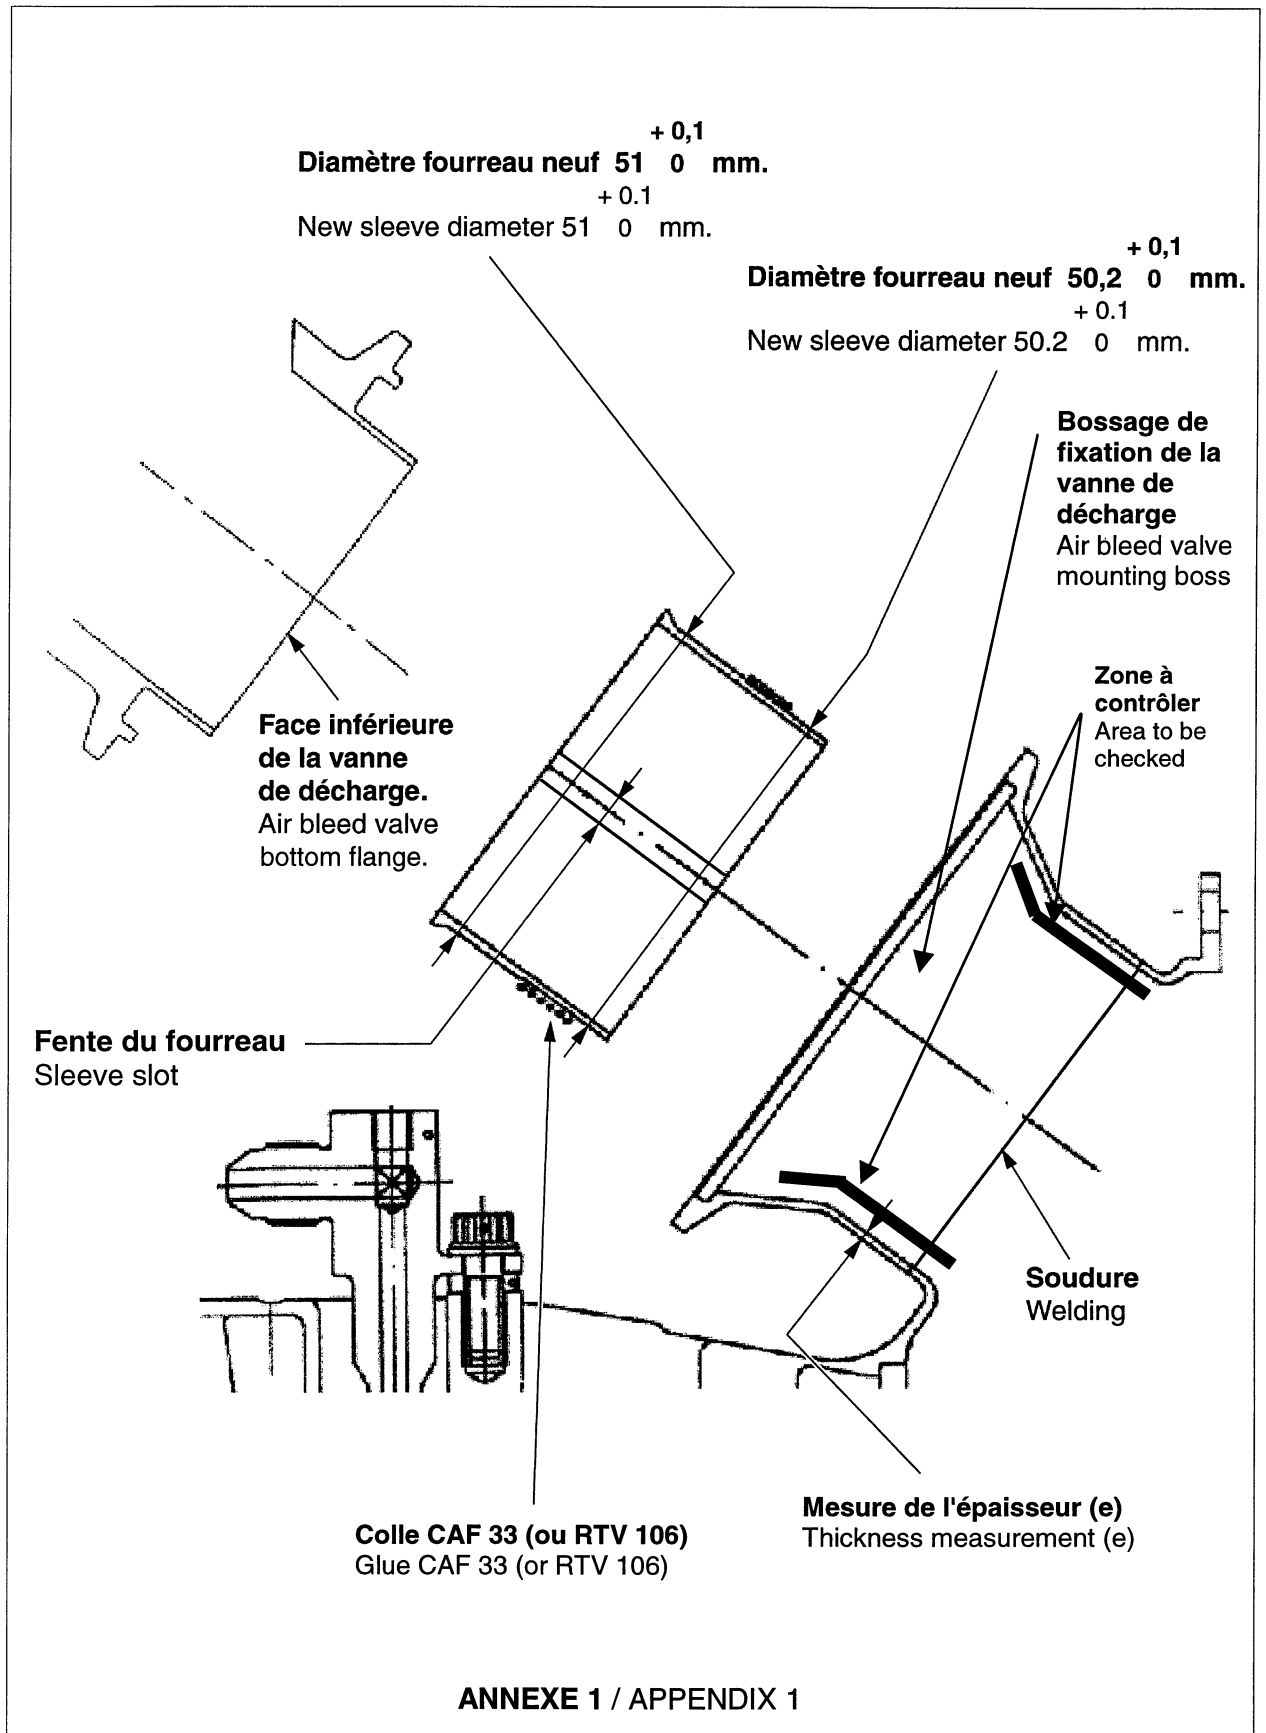
Eliminate sleeve fluttering in the bleed-valve mounting boss.

This fluttering may cause damage to the sleeve, bleed-valve mounting boss and bleed-valve bottom flange.

This modification consists in bonding the sleeve in the bleed-valve mounting boss.

- (e) Apply a thin layer (0.6 mm approx.) of black CAF 33 (or RTV 106) glue to 50.2 diameter over a width between 5 to 6 mm using a clean spatula and avoiding any excess glue.

- (f) Install the sleeve in abutment on the bleed-valve mounting boss bottom.
