PRATT & WHITNEY CANADA
SERVICE BULLETIN

P&WC S.B. No. 28197R8

TURBOSHAFT ENGINE
SEAL, STARTER GENERATOR PAD/FCU PAD/ACCESSORY PAD - REPLACEMENT OF
MODEL APPLICATION

PW206A, PW206B, PW206B2, PW206C, PW206E, PW207D, PW207E, PW207K

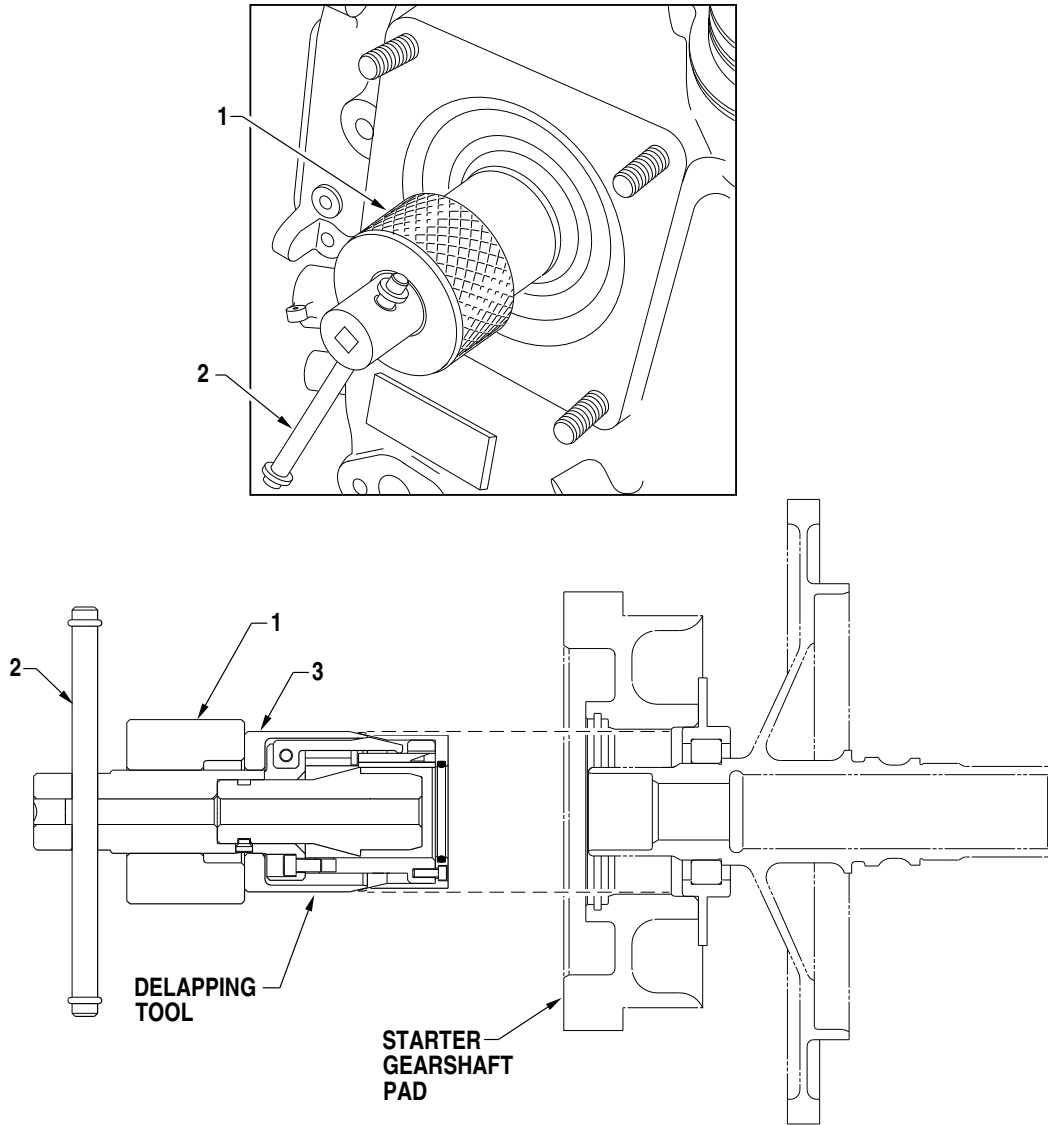
Tool PWC64886 - Installation of
Figure 1

INSTALLATION TYPICAL FOR OTHER GEARSHAFT LOCATIONS

(3) Rework the surface-finish of the gearshaft as follows (Ref. Fig. 1):

(a) Install the tool (PWC64886) on the gearshaft seal journal.

(b) Push the tool on the gearshaft, turn and push collar (Item 3) to ensure it is engaged, and screw the nut (item 1) until the tool starts turning.

(c) Turn the handle (Item 2) six revolutions.

(d) Remove the tool and clean the gearshaft with a cloth dampened with approved solvent. Air dry completely or blow dry with clean dry shop air (Ref. MM 71-00-00).

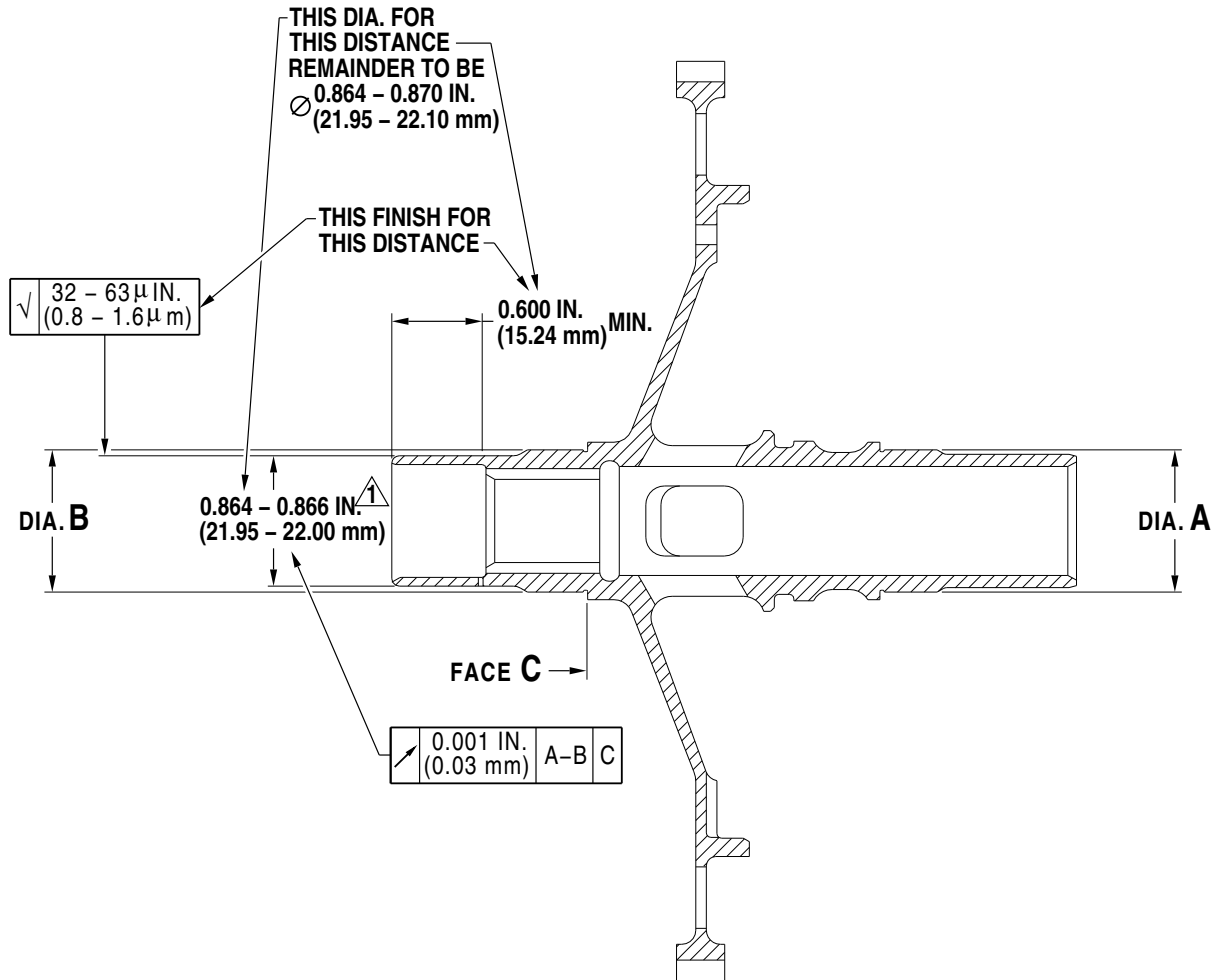
Starter Generator Drive Gearshaft - Rework of
Figure 3

⚠ DIAMETER MAY BE 0.001 IN. (0.025mm) UNDER MINIMUM AFTER REWORK.

- (2) Retain the retaining-ring for installation of seal.
- (3) Do an inspection of the gearshaft surface finish in area shown and make sure it is 32 μ in. (0.8 μ m) to 63 μ in. (1.6 μ m) (Ref. Fig. 3, 4, 5).
- (4) If the gearshaft surface finish is not within tolerance, rework the surface finish as follows (Ref. Fig. 1):

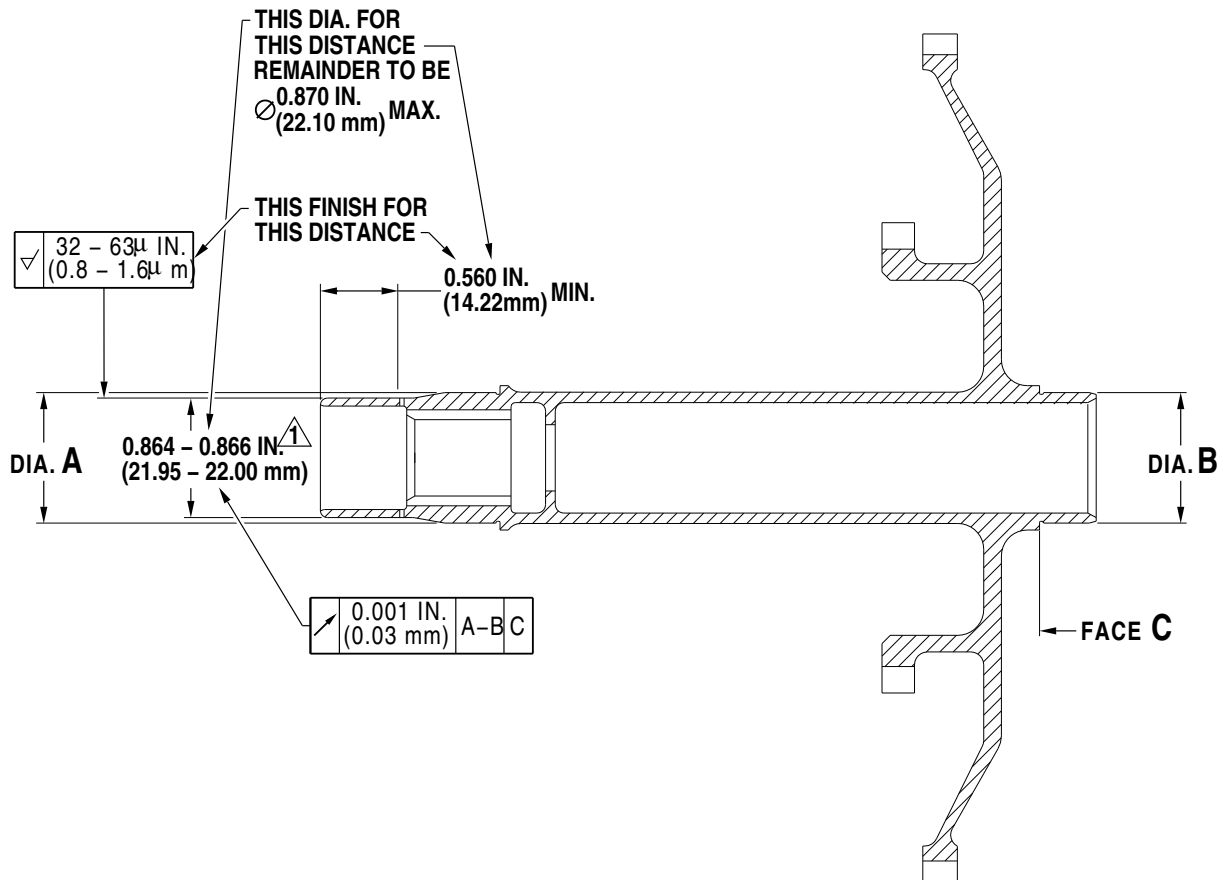
Fuel Control Drive Gearshaft - Rework of
Figure 4

DIAMETER MAY BE 0.001 IN. (0.025mm) UNDER MINIMUM AFTER REWORK.

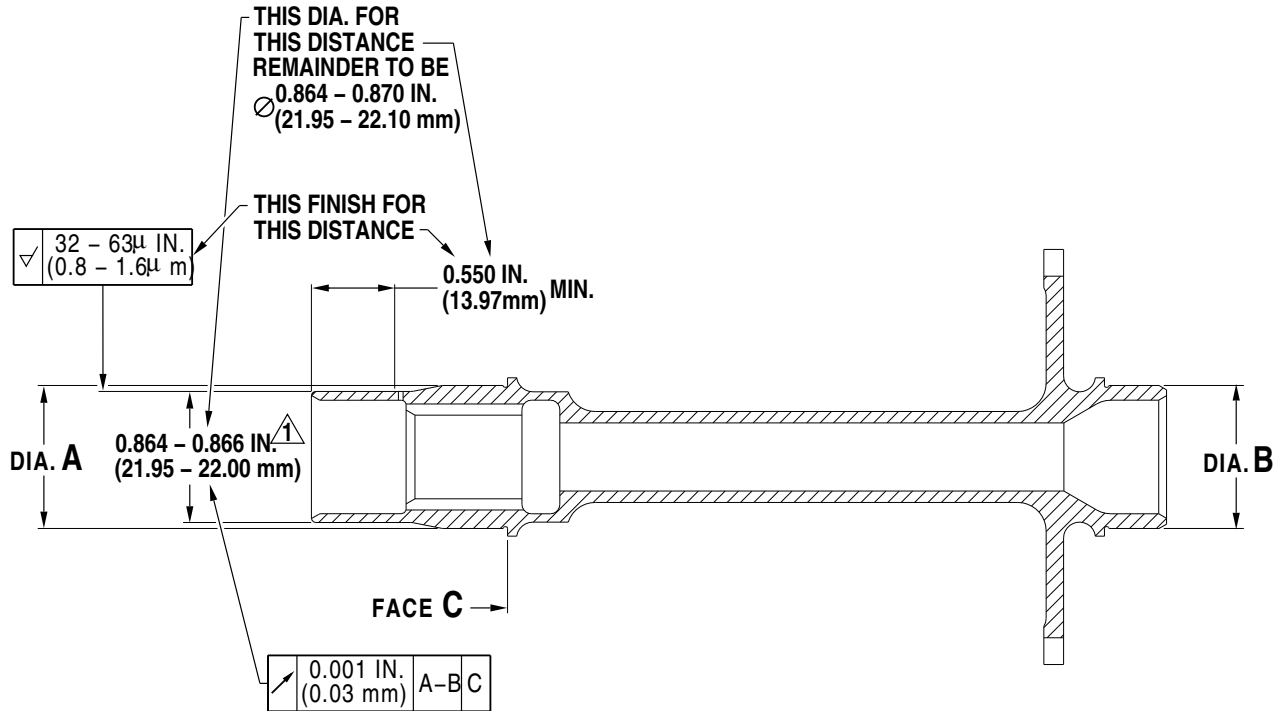
Alternator Drive Gearshaft - Rework of
Figure 5

¹ DIAMETER MAY BE 0.001 IN. (0.025mm) UNDER MINIMUM AFTER REWORK.
