SERVICE BULLETIN

DMC:	342-49-035 – SERVICE BULLETIN
Title:	Introduction of an APU Fuel Leak Check
Issue number:	002
Issue Date:	16-03-2021

Applicability: In-service APUs with more than 3,000 cycles and equipped with at least one fuel line P/N 942006 (pre SB 342-49-026 configuration)

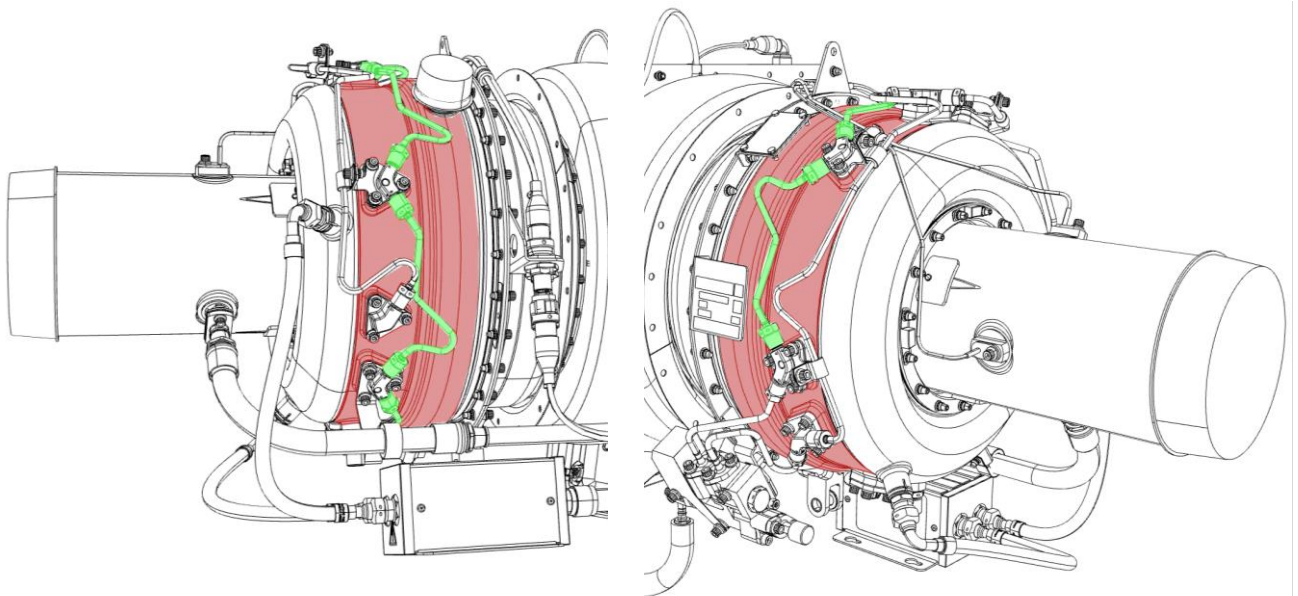
Figure 1: Identification of areas where the application of an absorbent is recommended

Following a few occurrence of APU fuel line leakage, Safran Power Units decides to introduce an APU Fuel Leak Check in order to prevent a possible fuel leakage, which could induce a fire risk. This event is classified as a minor safety impact.

1. If the APU is installed in the helicopter, open the APU access doors 461A, 462A, 463A and 481A.
2. Clean the main burners manifold and the combustion casing with a cloth.
3. Apply an absorbent (e.g. talcum) over the main burners manifold and the combustion casing (see colored areas in Figure 1).

6. If the APU is installed in the helicopter, open the APU access doors 461A, 462A, 463A and 481A.
7. Inspect each pipe of the main burners manifold (in green on Figure 1) for fuel leaks.
8. If fuel leak is detected:
 - 8.1. Inform Safran Power Units (refer to para. 3.5.2).
 - 8.2. Replace the five fuel lines of the main burners manifold as per the instructions of the DMC 89-A-49-31-05-00A-520A-B and 89-A-49-31-05-00A-720A-B.

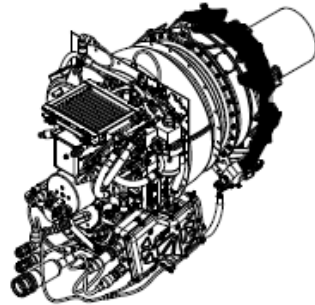
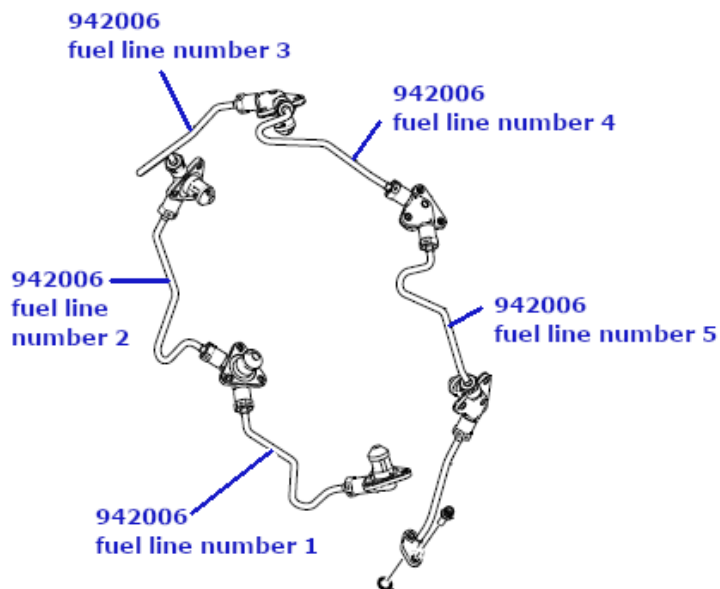
Figure 2: Location of the detected fuel leak

- Location of the leak (used the figure below and the fuel line number),
- Picture and/or video of the detected leak,
- Detail description of the finding,
- Specify if the fuel lines have been replaced due to the presence of the fuel leak.
