SERVICE BULLETIN

DMC:342-49-023 – SERVICE BULLETINTitle:Introduction of criteria for boroscopic inspectionIssue number:002Issue Date:09-05-2022

This Service Bulletin (SB) is applicable to all APU power plant fitted on Leonardo Helicopters AW189 or AW149 helicopters.

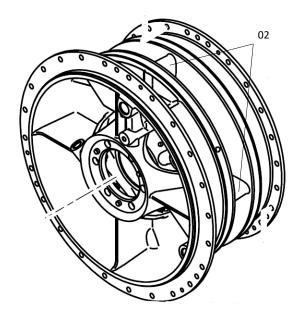
Figure 1 – Air intake casing

LOC	OBSERVATION	CODE	CRITERIA
02	CRACK(S)	085	NO TOLERANCE

3.3.2.4. If damages are detected in Step 3.3.2.1, Step 3.3.2.2 and Step 3.3.2.3 (cracks, impact...), contact SAFRAN POWER UNITS.

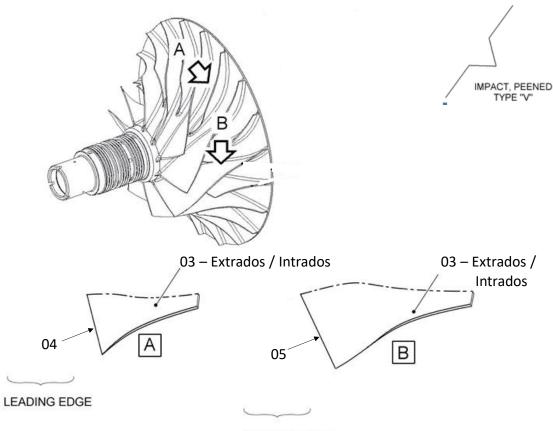
LOC	OBSERVATION	CODE	CRITERIA
01	CRACK(S)	085	NO TOLERANCE
03	IMPACT	099	TYPE V NO TOLERANCE
04	IMPACT	099	TYPE V NO TOLERANCE
05	IMPACT	099	TYPE V NO TOLERANCE

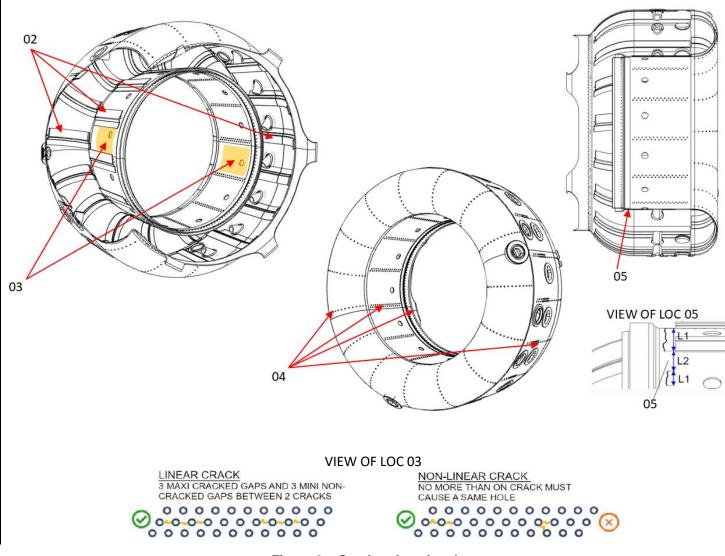
Figure 3 – Combustion chamber

LOC	OBSERVATION	CODE	CRITERIA
01	BURNING	058	COLORATION: ACCEPTABLE
02	BROKEN	052	NO MORE THAN 30% OF LOSS OF MATERIAL ON MAX 3 DEFLECTORS
03	CRACK(S)	085	LENGTH MAX 30MM
04	CRACK(S)	085	- LINEAR CRACK BETWEEN HOLES: 3 MAXI CRACKED GAPS AND 3 MINI NON-CRACKED GAPS BETWEEN 2 CRACKS
			-NON-LINEAR CRACK: NO MORE THAN ONE CRACK MUST CAUSE A SAME HOLE
05	CRACK(S)	085	LONGITUDINAL: LENGTH (L1) MAX. 50MM ON NO MORE THAN 3 AREAS WITH CLEARANCE BETWEEN CRACKS 20 MM (L2)

NOTA : LOC 01 is applicable to the whole part.

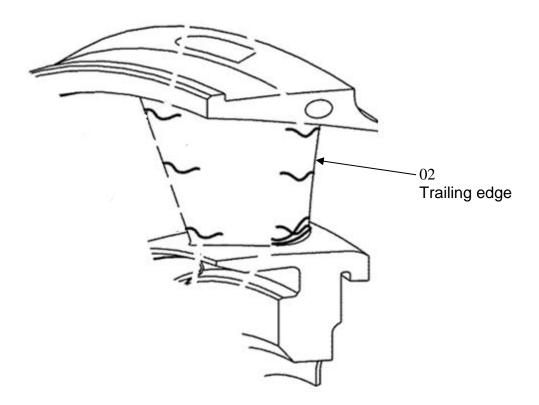
Figure 4 – 2nd stage turbine nozzle

LOC	OBSERVATION	CODE	CRITERIA
02	CRACKS ON TRAILING EDGE	085	NO TOLERANCE

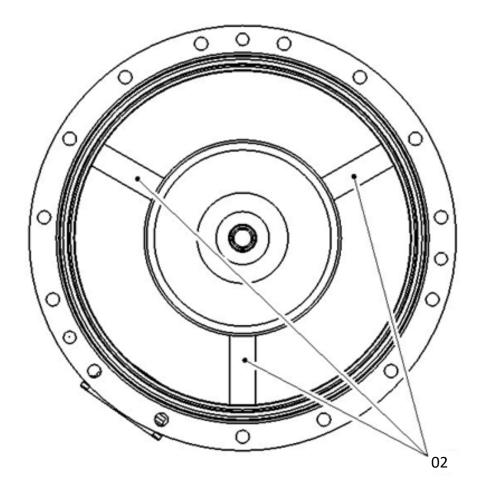
Figure 6 – Exhaust cone arms

LOC	OBSERVATION	CODE	CRITERIA
02	CRACKS IN WELD SEAM	902	NO TOLERANCE
