No. 3613-S-00

SAFETY INFORMATION NOTICE

Risks related to maintenance, repair & modification in the engine compartment (designated fire zone)

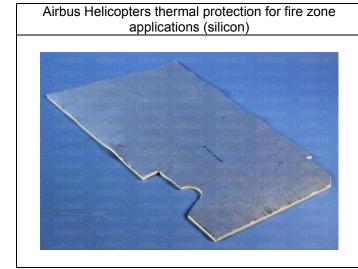
Indeed, fiberglass based engine compartment seals were replaced with aramid fiber based seals.

Moreover, silicon-based foams used for the thermal protection of the engine cowlings were replaced with polyurethane. Airbus Helicopters would like to point out that although of similar aspect, polyurethane foams do not satisfy the requirements for fire and heat resistance in a fire zone.

Pending the final investigation results, Airbus Helicopters would like to remind customers that the engine compartment is a designated fire zone and must resist and contain potential fire in accordance with type certification requirements. Therefore:

- Maintenance in the engine compartment must be performed as defined in the Airbus Helicopters technical publications.
 - Within this scope, Airbus Helicopters would like to remind customers of the release of Safety Information Notice No. 3496-S-71 concerning the "Inspection and maintenance of the engine compartment seals".
- Repairs in the engine compartment must be performed with recommended components according to the Airbus Helicopters technical publications.
- Only Airbus Helicopters-designed parts must be installed as spare parts on the helicopter fleet.
