SAFETY INFORMATION NOTICE

Risks related to maintenance, repair & modification in the engine compartment (designated fire zone)

No. 3613-S-00

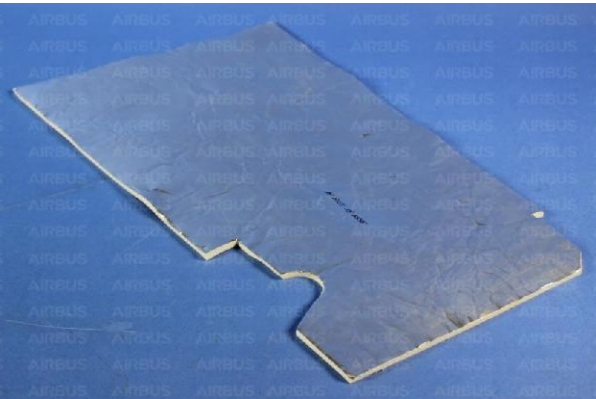
Airbus Helicopters thermal protection for fire zone applications (silicon)	Replacement part not for fire zone applications (polyurethane)

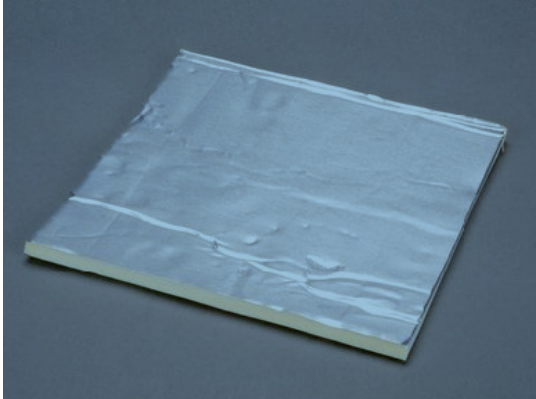
Moreover, silicon-based foams used for the thermal protection of the engine cowlings were replaced with polyurethane. Airbus Helicopters would like to point out that although of similar aspect, polyurethane foams do not satisfy the requirements for fire and heat resistance in a fire zone.

- Maintenance in the engine compartment must be performed as defined in the Airbus Helicopters technical publications.
Within this scope, Airbus Helicopters would like to remind customers of the release of Safety Information Notice No. 3496-S-71 concerning the "Inspection and maintenance of the engine compartment seals".
- Repairs in the engine compartment must be performed with recommended components according to the Airbus Helicopters technical publications.
- Only Airbus Helicopters-designed parts must be installed as spare parts on the helicopter fleet.
