SAFETY INFORMATION NOTICE

SUBJECT: NAVIGATION

Pitot tubes and static port protections

No. 3783-S-34

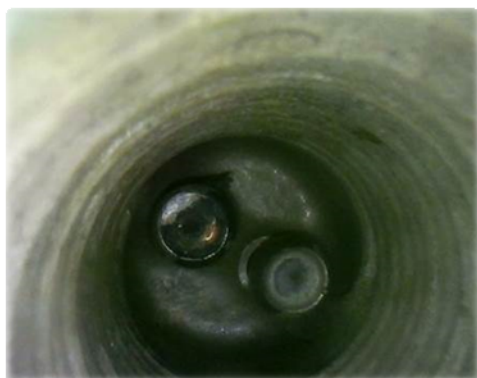
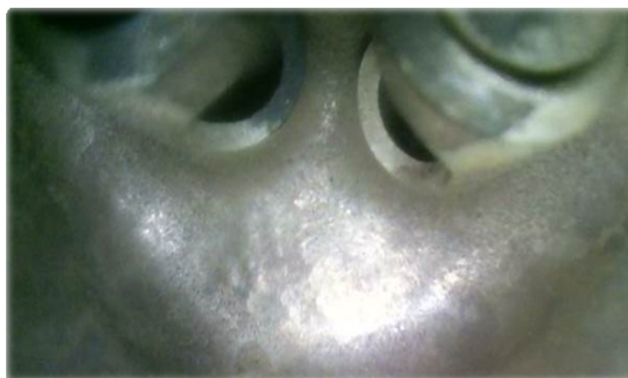
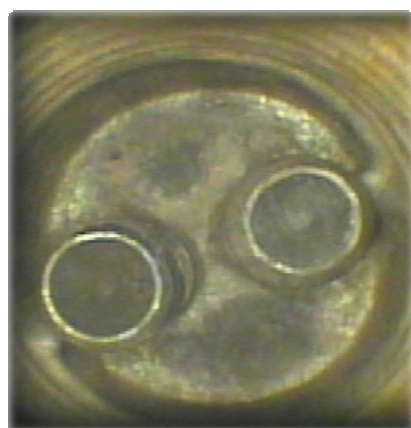
You can find hereafter pictures of a clean pitot:

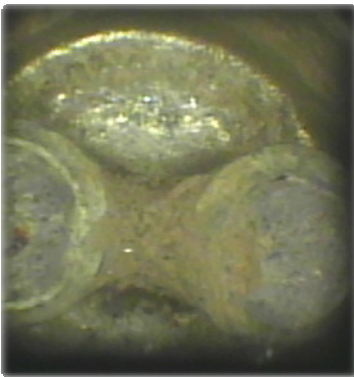
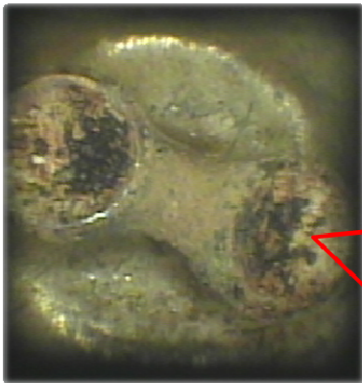
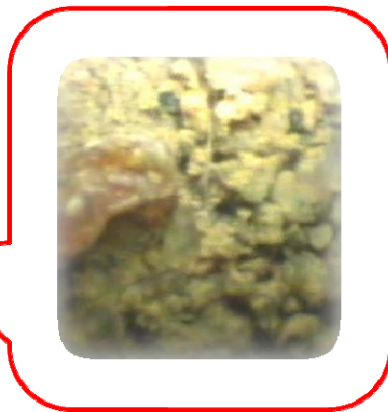
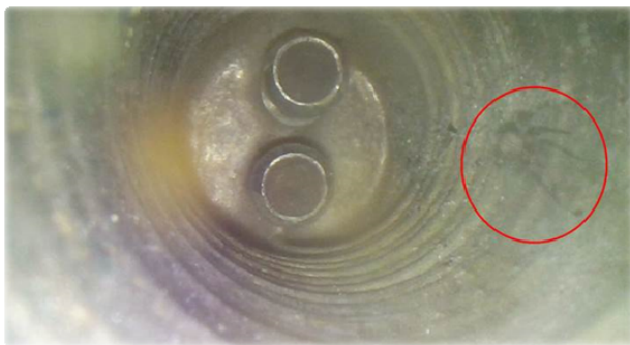
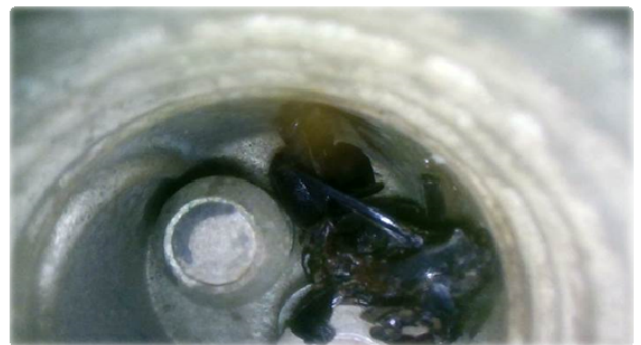
Airbus Helicopters has been informed by one of its Customers that a porous material (mixture of organic material and dust) partially blocking the entry of air into the pitot tubes of his aircraft has been detected after a borescope inspection.

And examples of pitot tubes with foreign object stuck in it:

With this SIN, Airbus Helicopters wishes to remind operators that it is important to carefully install the pitot heads and static pressure port protections as soon as possible after the helicopter has landed.

The blanking caps must be in good condition (check their condition before installation) and are available through the "Tools & Ground Support Equipment" catalog.
