No. 3792-S-05

## **SAFETY INFORMATION NOTICE**

SUBJECT: TIME LIMITS - MAINTENANCE CHECKS

Treatment of damages during regular inspections - Flight safety

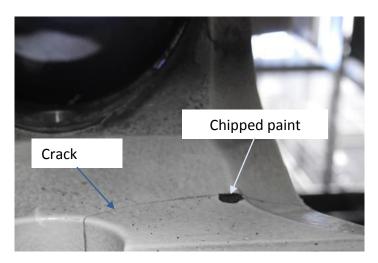
Airbus Helicopters has been informed of a crack in a main rotor sleeve. Analysis revealed that this crack had started to propagate, causing a risk of rupture.

Preliminary analysis on the affected part identified that the crack was a fatigue crack that initiated from a significant corrosion pit. This corrosion pit was located in an area of the sleeve with chipped paint. The surface protection had not been touched up.

The extent and kinetics of the corrosion seem to demonstrate that this area remained without paint and without protection for a long time.

With this Safety Information Notice, Airbus Helicopters reminds you of how important it is to treat any damage on these parts (scratch, wear, corrosion, crack, etc.) as early as possible following their discovery during scheduled maintenance and in compliance with the applicable documentation.

In particular, during regular visual inspections (Flight-related inspection, ALF, GVI, etc.), special attention must be paid to the condition of the paint (chips or cracks) or local corrosion.
